Steam Pump Ranch Condition Assessment Report

for the Town of Oro Valley
December, 19 2014

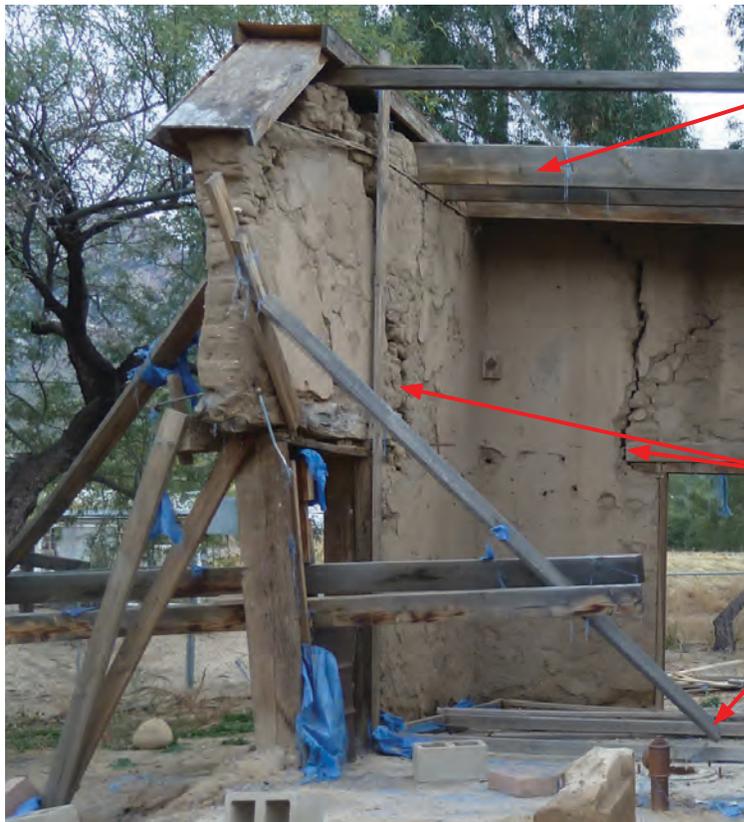
Fig 1.04: Pump Room, Looking at the Southeast Corner

Roof: Roof is completely gone. Remaining joists are in fair condition. Due to roof having fallen down the adobe walls have lost support at the top of the wall and are more susceptible to collapse from a windstorm.

See recommendation above.

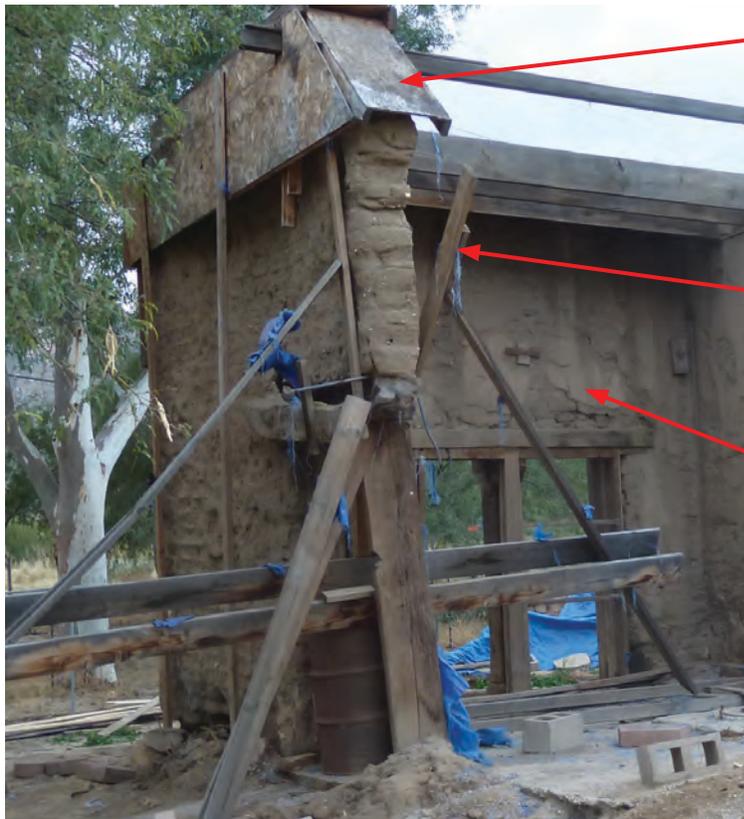
Fig 1.05: Pump Room East Wall

Wall: Existing parapet is covered with plywood cap. Adobe has separated from the bond beam / plate and adjoining wall.

Wall: Evidence of wall deterioration from water leaks from roof. Portions of adobe wall not covered with tarp during the initial visit.

See recommendation in Fig. 1.04.

Loosely cover walls with tarp to prevent adobe from eroding from driving rain. Attach tarp in a manner to allow water and moisture to escape.

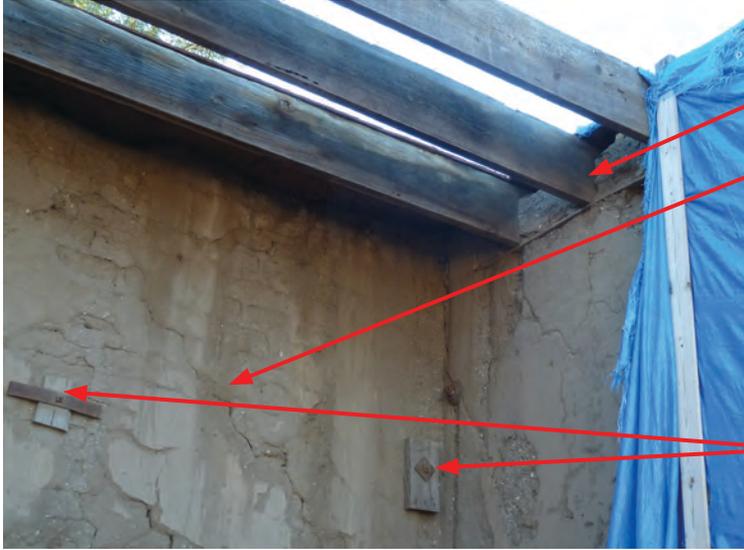
Fig 1.09: Southwest Corner at Joists

Roof and Walls: Southwest corner appears to be in fair condition. Minor deterioration of adobe from water getting in at the top of the parapet.

See recommendations from Fig. 1.04. See recommendations from Fig. 1.05.

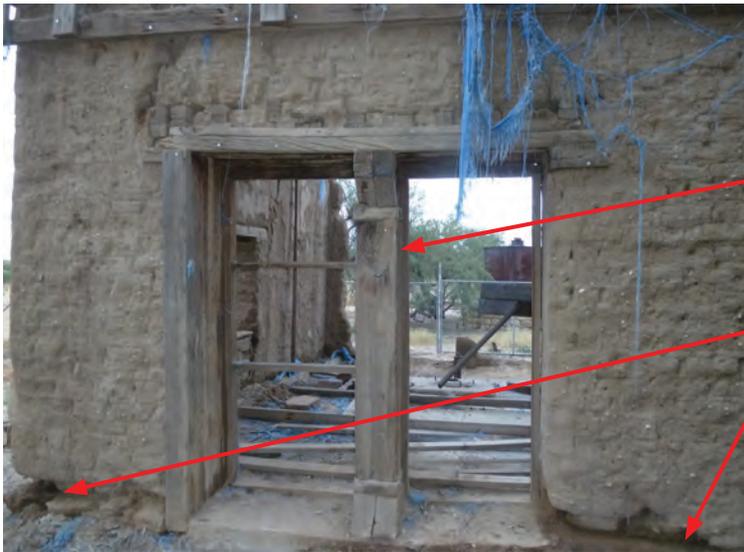
Fig 1.10: South Wall of Pump Room, Looking into the Pump Room

Door: Header and frame supports appear to be stable.

See recommendations in Fig. 1.04 and 1.08.

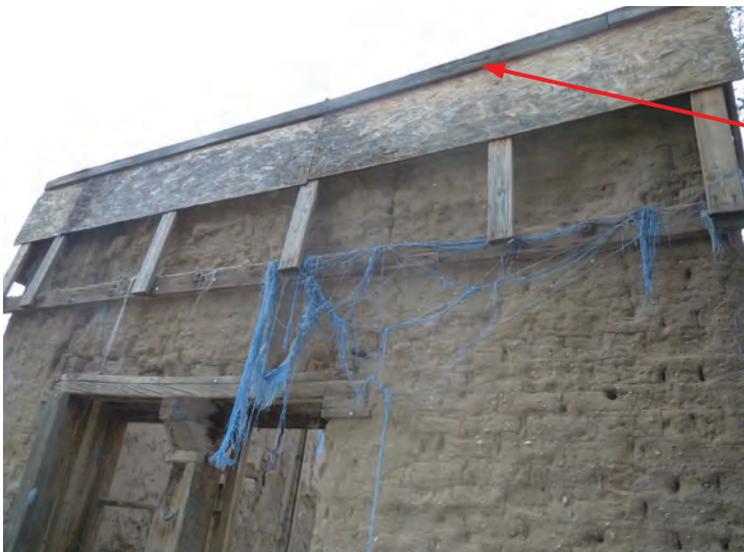
Fig 1.11: South Wall of Pump Room, Looking into the Pump Room

Wall: Plywood cap at top of adobe wall appears to be protecting the top of the adobe.

Wall: Cracks in adobe wall

Cover with tarp, see recommendation in Fig. 1.05.

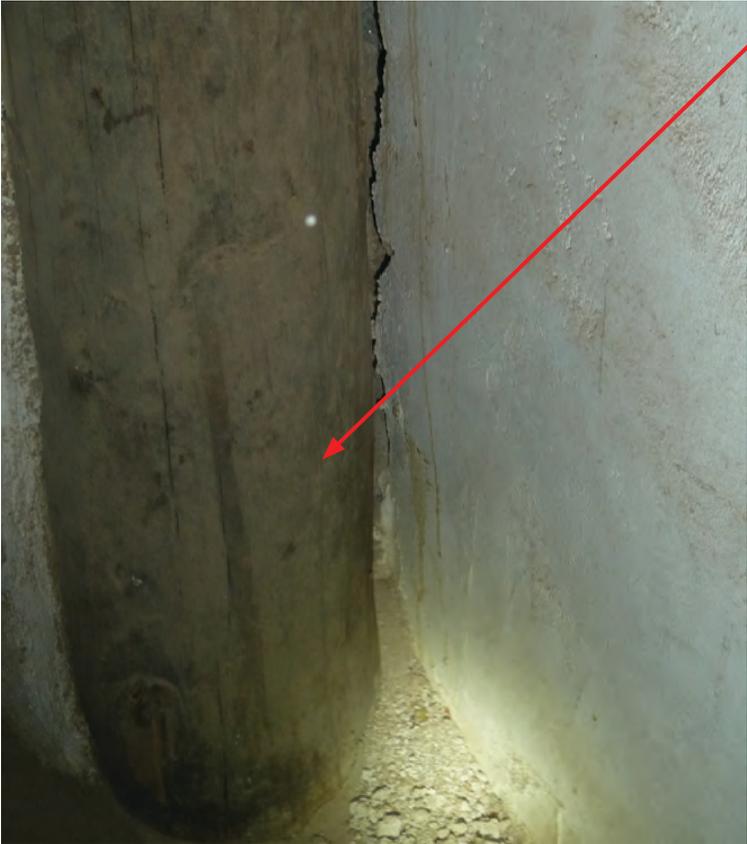
Fig 2.20: Northwest Corner in Basement

Basement: Dirt collecting at base of wood column. Possible Rodent activity.

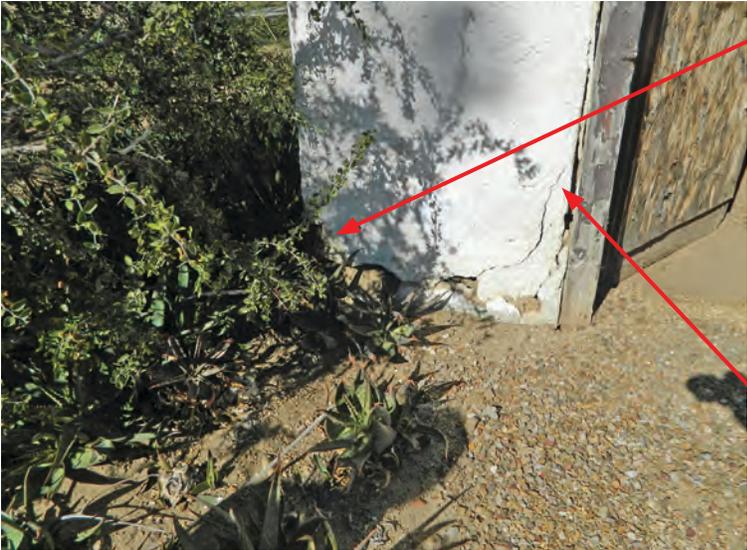
Fig 3.10: Bunk House A, Southwest corner

Walls: Adobe missing at corner.

Refer to recommendations on Fig. 3.05.

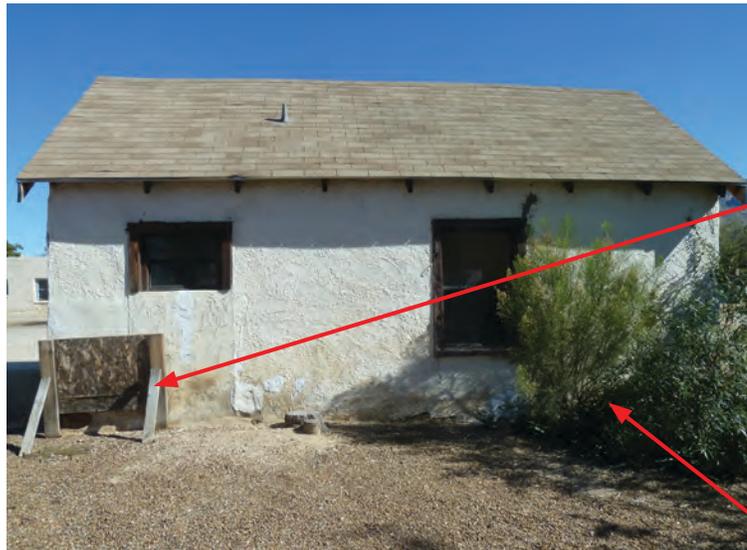
Fig 3.12: Bunk House A, West Elevation

Walls: Damaged adobe. Same location as Fig. 3.11.

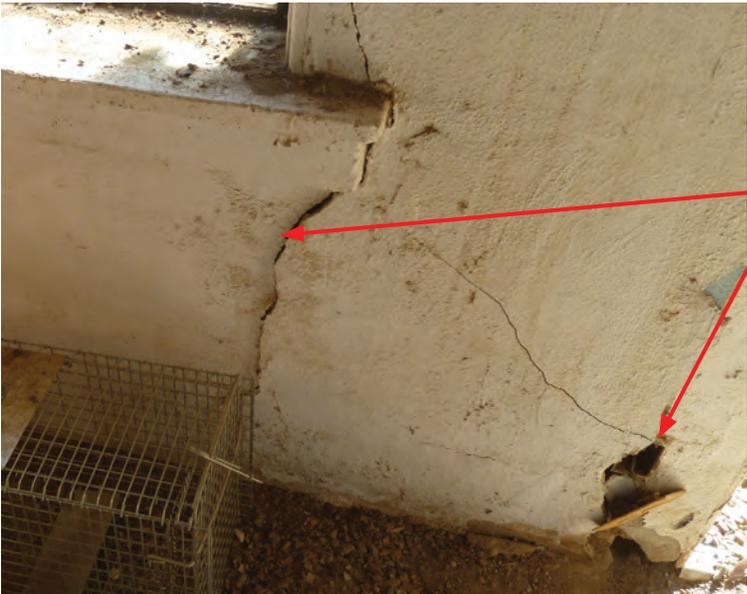
Fig 3.15: Bunk House A, South Elevation, Interior of Bunkroom

Walls: Crack by South window and crack by South door. Caused by water collecting at base of wall and/or water leaking from window

Not critical to stabilization.

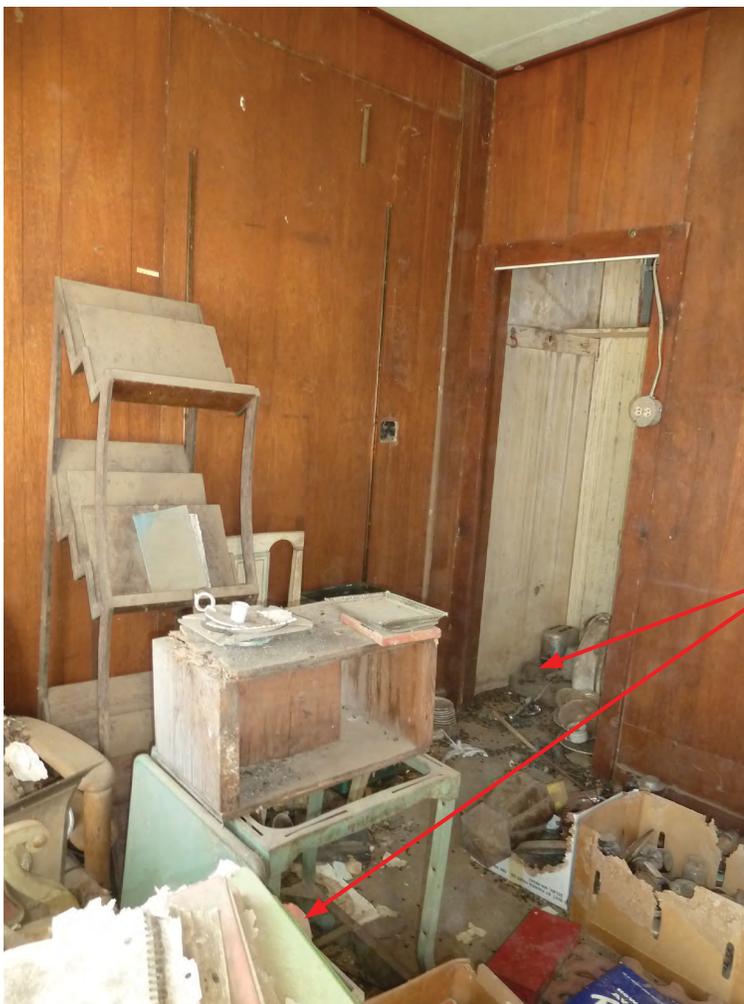
Fig 3.18: Bunk House B, South Bunkroom, Northwest Corner

Floor: Dirt and stored items. Unable to see condition of floor.

Remove dirt, debris and stored items to reduce places for rodents to live.

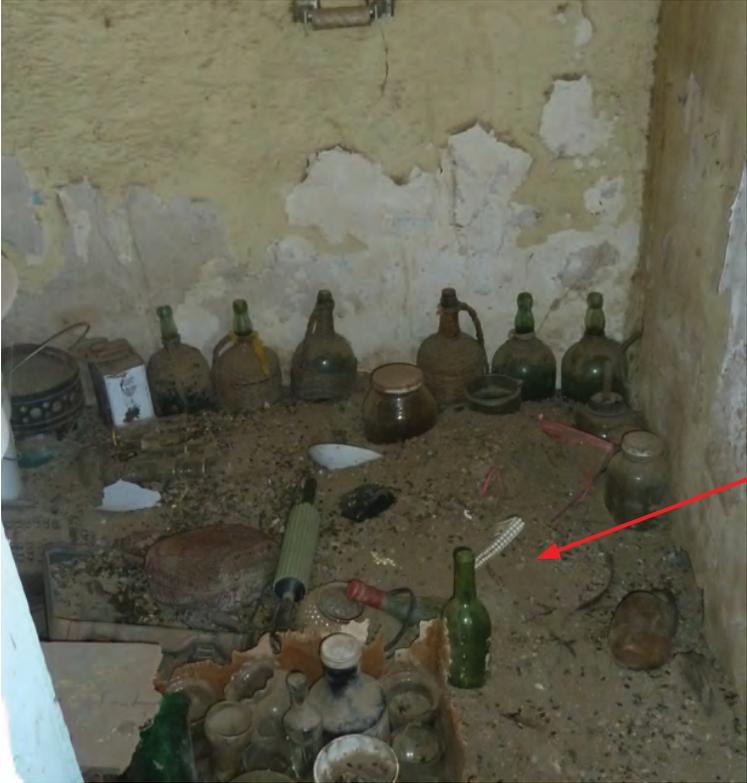
Floors / Walls: Dirt and stored items. Possible rodent activity.

Remove dirt, debris and stored items to reduce places for rodents to live.

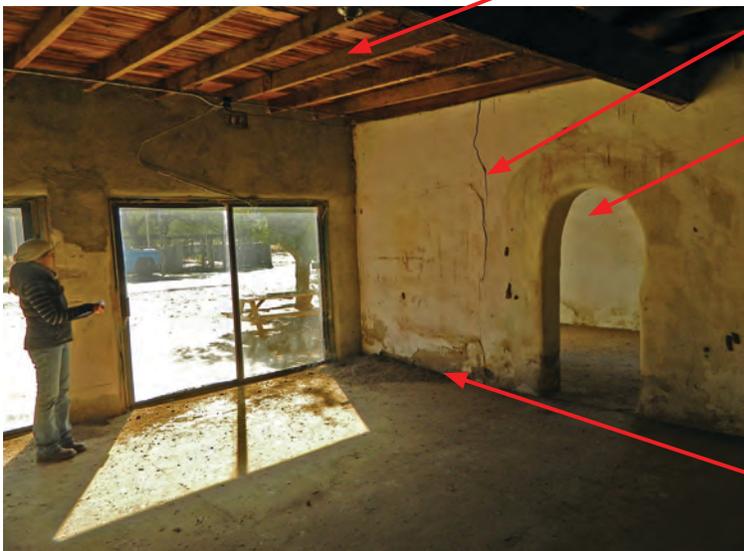
Fig 4.08: Southwest Corner of the Classroom / Western Movies Room

Wall: Crack in wall

Floors / Walls: Pile of dirt, appears to be rodent activity.

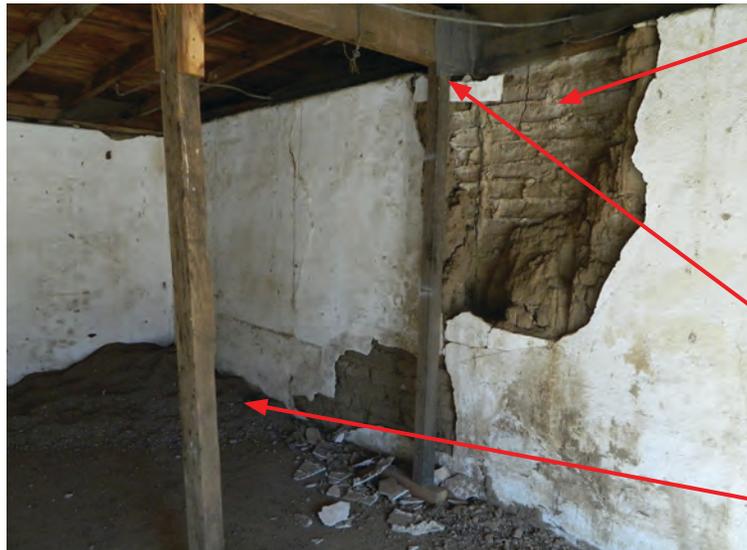
Fig 4.10: Northeast Corner of Classroom / Western Movies Room

Walls: Adobe deteriorated from earlier roof leak. Roof leak appears to be fixed. Stucco finish from other side still standing.

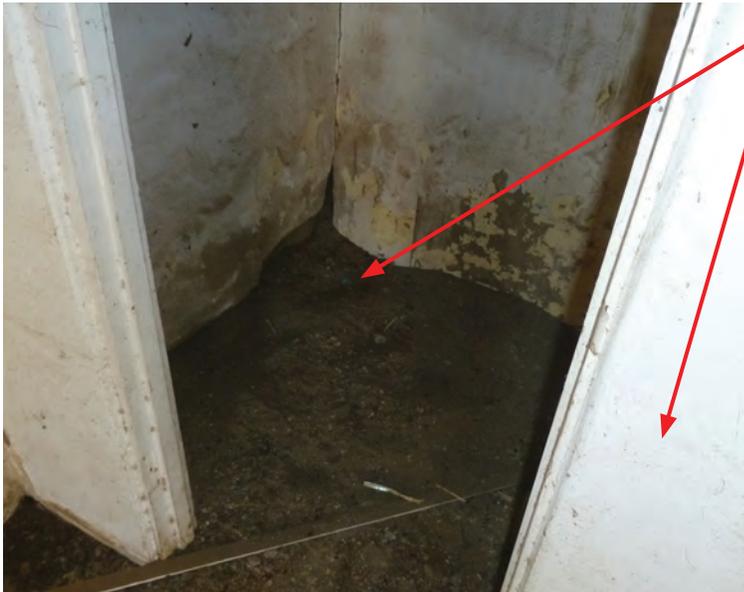
Walls / Floor: Closet in the Entry / Exhibits Room is full of dirt. Appears to be same activity from Northeast corner of Classroom / Western Movies Room.

Refer to recommendations in Fig. 4.10.

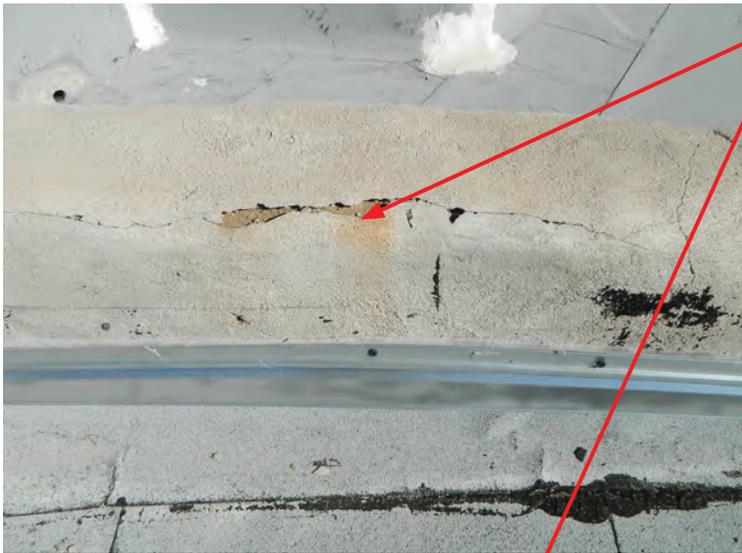
Wall: Stucco on top of parapet is cracking. Water is penetrating into adobe wall.

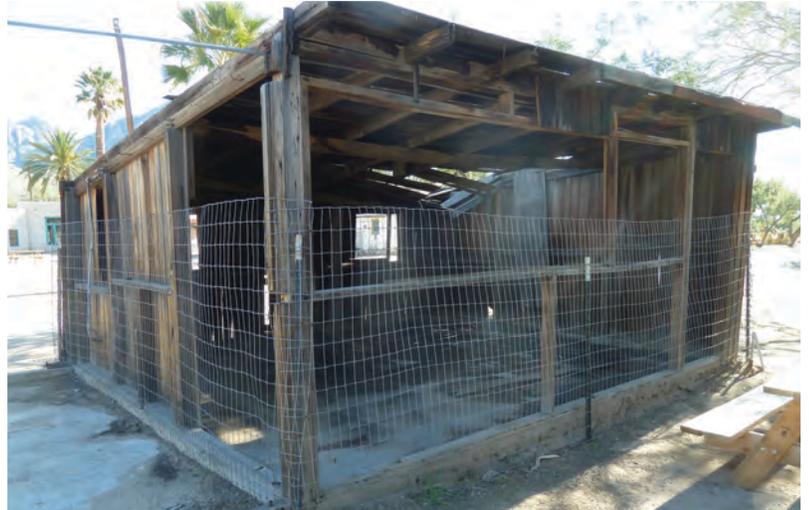
Fig. 7.04: Northeast Corner of Hatchery

The wood hatchery, is structurally unsound and in poor condition. The roof is partially collapsed and the interior supports have fallen.
