# PROCTER LEIBER RESIDENCE: CONDITION ASSESSMENT

10901 N Oracle Rd, Oro Valley, AZ 85737

Poster Mirto McDonald has been hired to produce an updated condition assessment report for the Procter Leiber building at the Steam Pump Ranch.

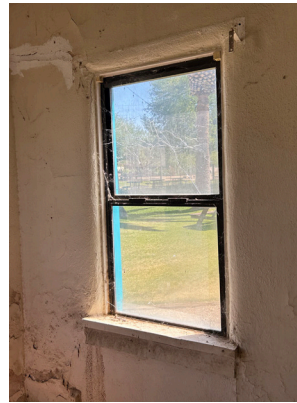
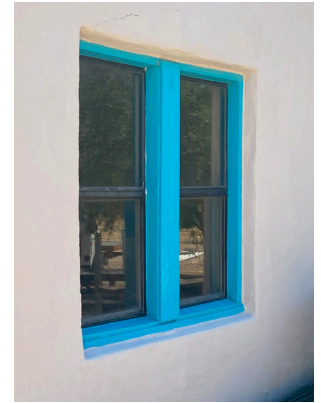
#### A.01 Exterior windows: Condition - Good

Typical aluminum frame single-hung window in single and pair arrangement. Likely originally matched wood frame single-hung windows elsewhere in the building but were replaced sometime in the 1970s or 1980s during a renovation.

Rehabilitate wood subframes, replacing worn components in kind. Remove any existing sealant and reseal full perimeter interior and exterior. Remove aluminum windows and replace with new double pane, clear glass fixed aluminum windows.

Recommend replacement with wood single-hung windows to match original construction.

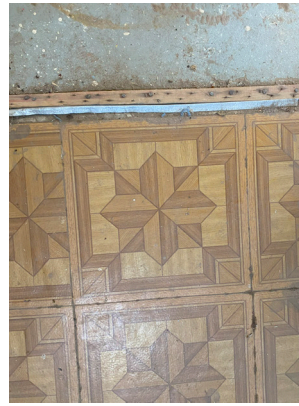
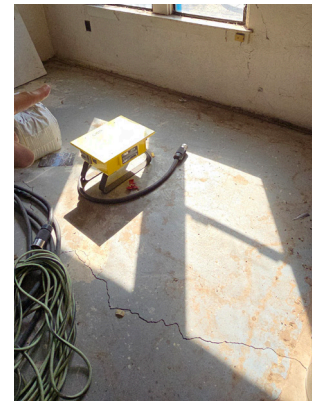
##### **Flooring: Condition - Fair**

Typical integral color concrete slab, portion of which is covered by laminate tile in poor condition. Concrete slab has visible cracking.

Remove laminate flooring and any related transitions. Reference Appendix 03 for recommendations for abatement of possible hazardous materials.

Remove laminate completely to assess condition of concrete slab below. Perform recommended structural upgrades.

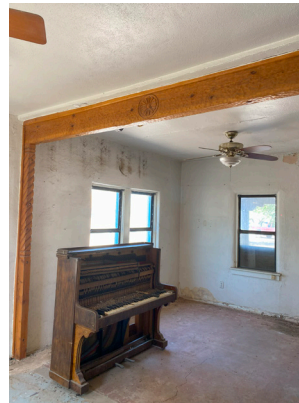
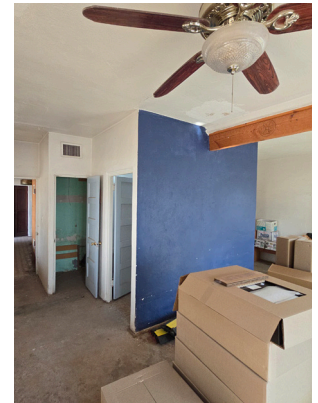
#### A.05

##### **Interior wall / plaster: Condition - Fair**

Adobe and wood frame walls with interior plaster finish. Exterior walls have cracking that requires patching.

See Appendix 01: Plaster and Adobe General Notes for recommendations in plaster patching.

Demolish and remove interior bathroom and closet walls completely. Layout does not serve programmatic needs of future building use. Complete any structural recommendations. Patch any cracking plaster or areas where damage has occurred according to Appendix 01.

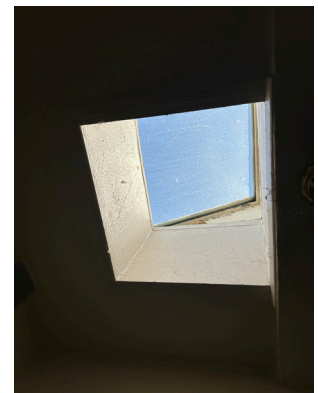
#### A.06

##### **Skylight: Condition - Fair**

Replace with new insulated glazing shed roof skylight. New product should be weather tight (no louvers).

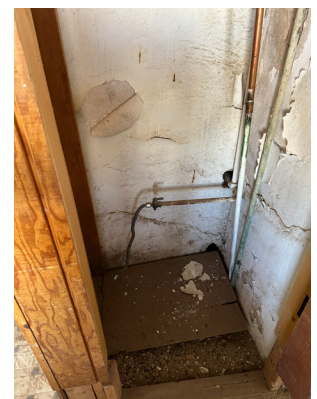
### B.03 T1-11 Closet : Condition - Very poor

T1-11 framed water heater closet with louvered door missing hardware in poor condition. No water heater currently present in closet.

Demolish closet entirely and cap any existing plumbing. WH closet does not serve programmatic needs of future building use. Clean and sanitize area.

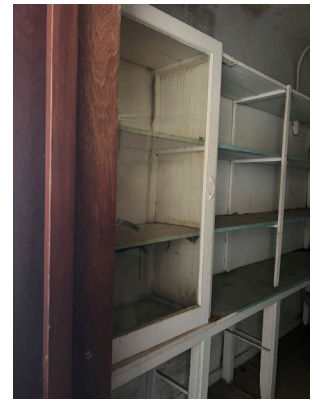
#### B.04

##### **Pantry Closet: Condition - Fair**

Remove all shelving, doors, and lighting completely. Provide new hollow metal door to serve future building use.

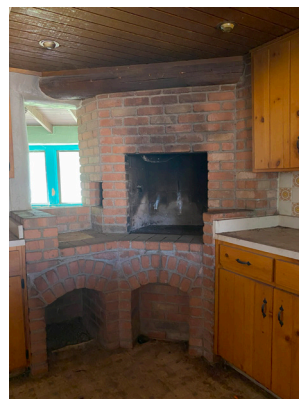
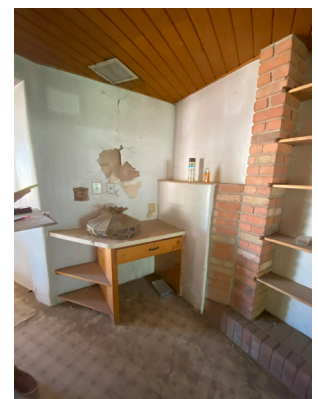
### C.02 Red brick: Condition - Good

Red brick infill in window and around wood-burning fireplace and shelving.

Thoroughly clean with low pressure, soap and water wash with a soft bristle brush.

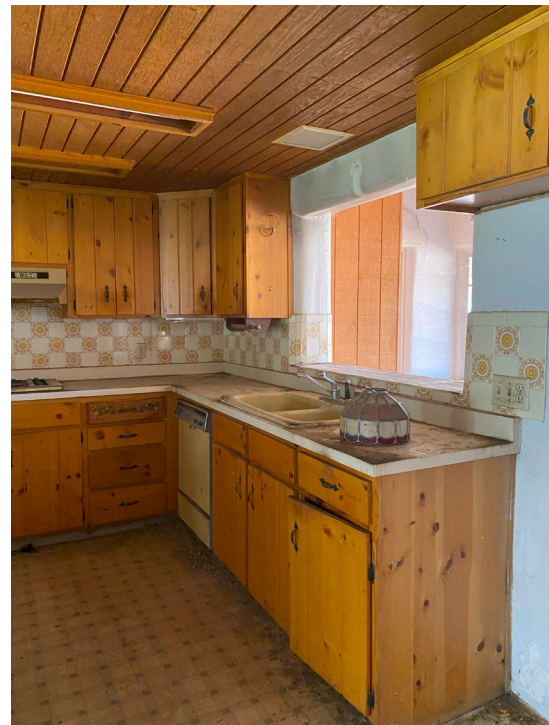
#### C.04

##### **Cabinets: Condition - Fair**

Clean and sanitize all outside and inside surfaces of cabinets. This should be done by a contractor specializing in hazardous cleaning using cleaning materials which will sterilize and deodorize. Any components which are compromised due to rodent chewing or excessive soiling should be replaced in kind. As a further recommendation, rodent waste is possible or likely to be found in the inaccessible area of the toe kick of the cabinets, and possibly between the wall and the base cabinets. This material, if left in place may continue to smell once the building is brought into service. It is our recommendation that the cabinets should be removed such that this area can be accessed and sanitized and then reinstalled. The countertop is soiled and should be removed and replaced as part of this operation.

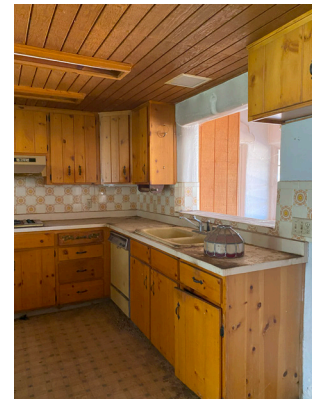
#### C.05

##### **Ceiling and lighting: Condition - Good**

The ceiling is in good condition. The wood paneling should be thoroughly cleaned. The existing lighting is fluorescent tube fixtures, the function of which could not be assessed. Regardless of function, the fixtures should be replaced with new LED fixtures. Seal any ceiling openings to prevent further rodent activity.

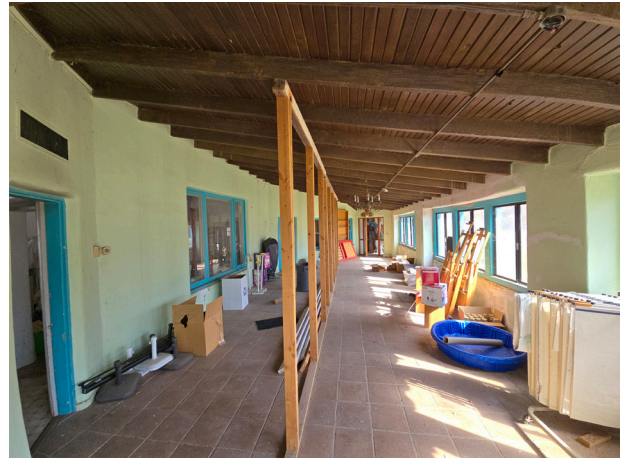
### D.01 Roof Structure: Condition - Requires attention

Exposed rough-sawn 2x6 beams. The roof is exhibiting signs of significant deflection and has been temporarily shored. Reference structural report for additional information. Above the joists is a tongue and groove bead board deck. This material appears to be in generally good condition.

Complete recommended structural upgrades. Paint existing and new structural members and deck.

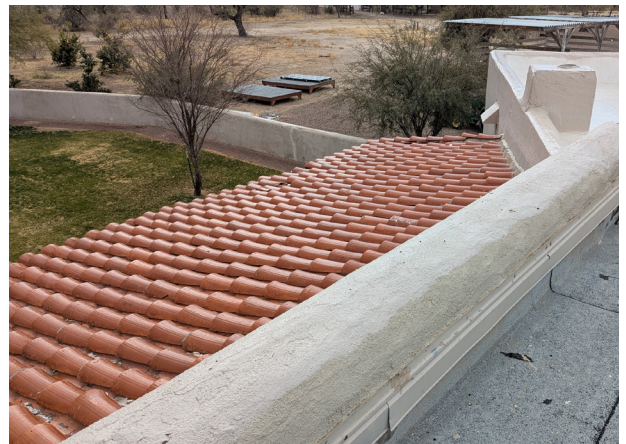
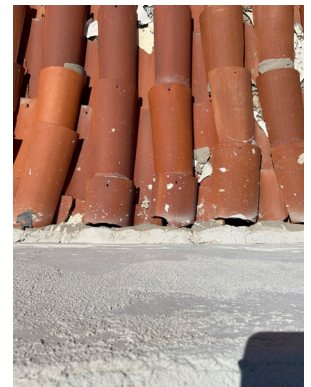
### D.02 Tile Roof: Condition - Requires replacement

Clay tile roof and related assembly. The date of the last replacement of the weather resistive membrane beneath the tile is unknown, but is assumed to be well past its service life. As reported above, the roof members are significantly deflected. It is likely that this movement has created issues at the margins of the system, at flashings and eaves.

Following completion of structural upgrades to supporting structure of roof, and of lintels at windows. Remove and salvage all tile material for re-installation. Remove and discard existing WRB down to deck, and remove all flashings and trim. Install new weather resistive barrier on top of existing decking. Install new flashings and reinstall clay roof tile. It should be assumed that it will be necessary to source matching material to account for breakage in salvage and installation process.

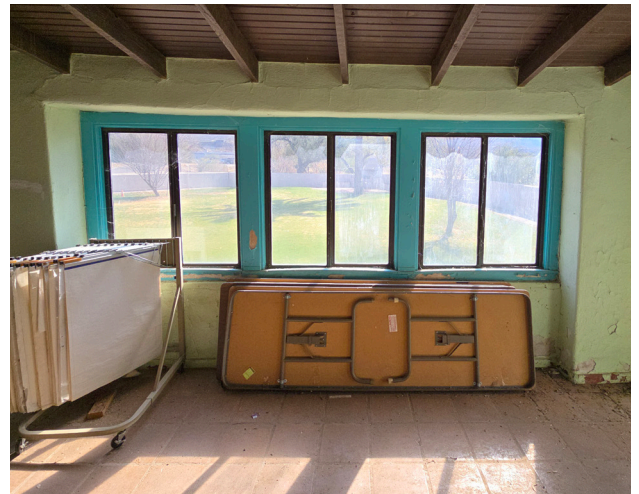
### D.03

#### **Exterior Window: Condition - Requires replacement**

Historic photos indicate that the windows were likely large plate glass panels. At present, large built-up painted verticals separate each bay into 3 segments, each with a sliding aluminum window. These windows are inexpensive modern replacements and should be replaced. Reference structural report for work to lintel above each bay of windows.

Remove and discard existing aluminum windows and intermediate built-up wood verticals and associated wood trim. This will restore the bays to their original configuration. Provide (2) equal new custom insulated glazing panels in each of (3) bays. Trim these glazing units with custom wood trim, full perimeter inside and out. Provide continuous sealant both sides of window system.

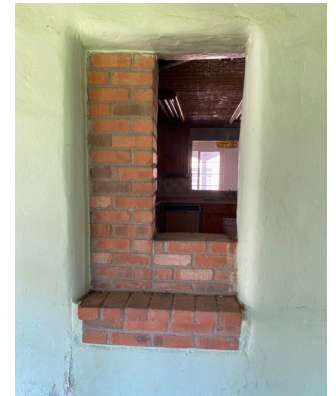
### D.04

#### **Interior Windows: Condition - Good**

The interior single hung wood windows of the Arizona room were once the exterior windows of the building, but have always been under deep cove, protected from rain and sun. They are in good condition.

Provide new wood single-hung window to match existing at location where window was removed as part of later kitchen remodeling.

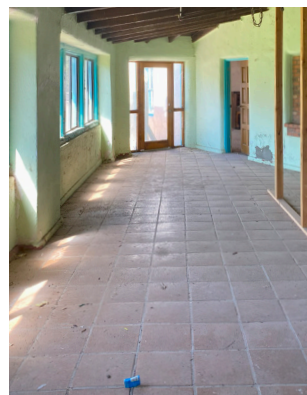
### D.04

#### **Flooring: Condition - Requires attention**

The Arizona room features 12x12 Mexican tile flooring with wide grout joints. This material is in good condition but the slab below has noticable depressions at the exterior wall.

Remove and discard tile. Demo slab (typ of building) and repour integral color concrete to match previous.

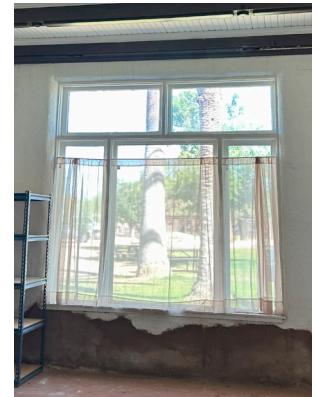
### E.02 Exterior Windows: Condition - Good

Wood frame operable casement window with double awning lites above. Window and glass appears to be in good condition.

Clean, adjust, and paint.

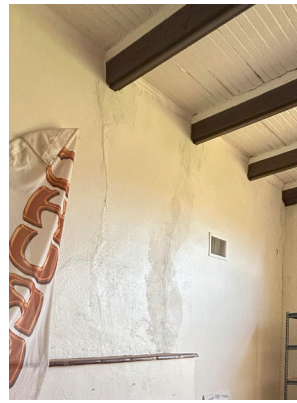
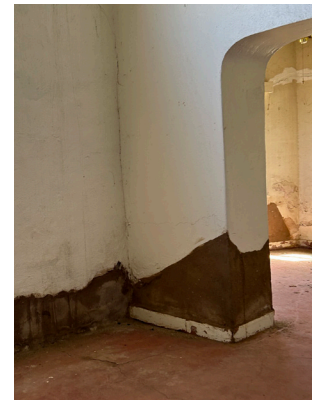
**E.04 Interior Plaster: Condition - Requires Attention**

Previously repaired interior plaster requires additional coat to match texture of existing. Cracking throughout requires patching.

See general plaster notes for areas with non-conforming plaster texture. Complete recommended structural upgrades to address cracking. Remove plaster in 12" around cracking. Float plaster patch material over entire area, feathering 12" over perimeter to meet existing material. Texture to match existing.

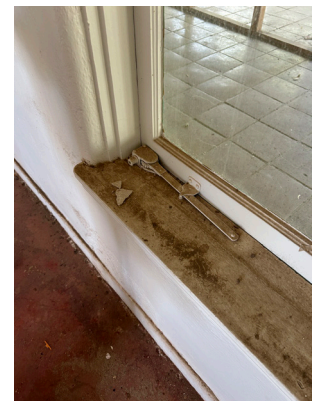
**E.05 Interior window: Condition - Good**

Interior wood casement window were once exterior windows of the building, but have always been under a deep cover, protected from rain and sun. Window is in good working condition.

Clean and adjust window and hardware. Paint frame.

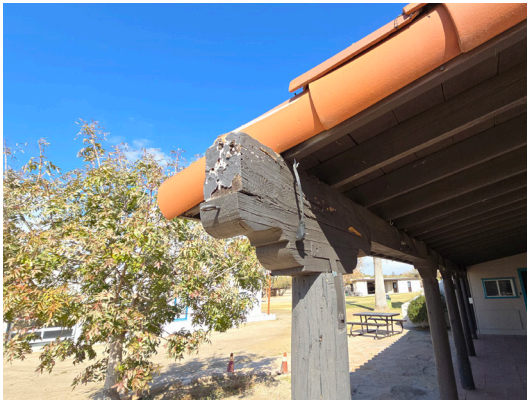
Porch beam with visible wood rot

Failed decking replaced with T1-11 siding

Rebuild porch completely from scratch with new beam, joists, decking, and weather resistive barrier. Materials that may be salvageable for future use include: telephone pole columns, decorative capitols, clay roof tile, and red clay floor tile. Any re-used material to be cleaned and painted, if applicable.

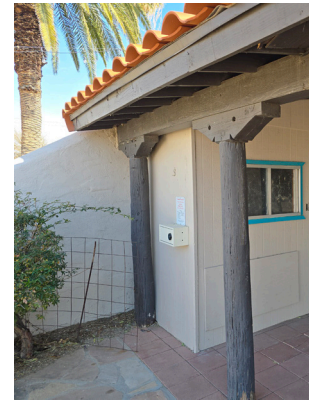
Telephone poll columns and capitols

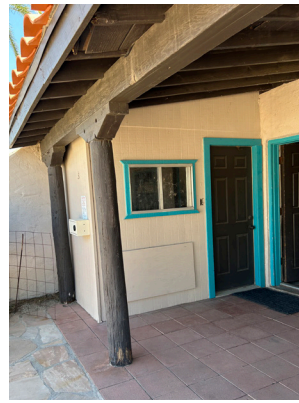
Exterior T1-11 storage room to be demolished

Demolish exterior storage room T1-11 siding walls, floor, and interior finishes completely. Clean and sanitize both rooms in accordance with Appendix 02: Best Practice for Cleanup of Rodent Infestation. Patch stucco on adobe stair wall to match existing. Clean, paint, and replace hardware on existing original five panel wood door.

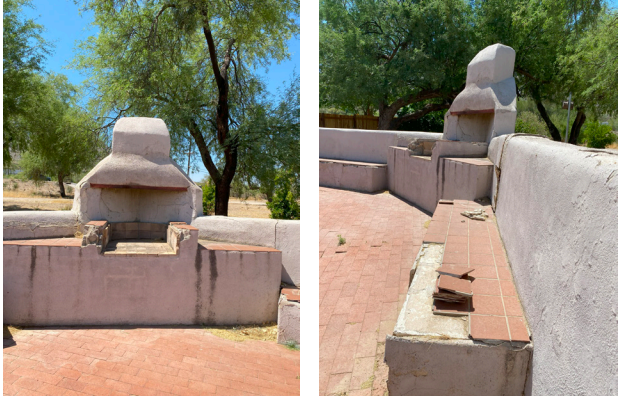
- L.02 Outdoor barbecue: Condition - Poor**  
Non-functional outdoor barbecue. Adobe construction with stucco and tile finish.  
**Stabilization recommendation:**  
Complete recommended structural upgrades. Reconstruct decorative barbecue and surrounding tile top benches with CMU and light sand stucco finish. Barbecue is not required to be functional for future building programmatic needs.

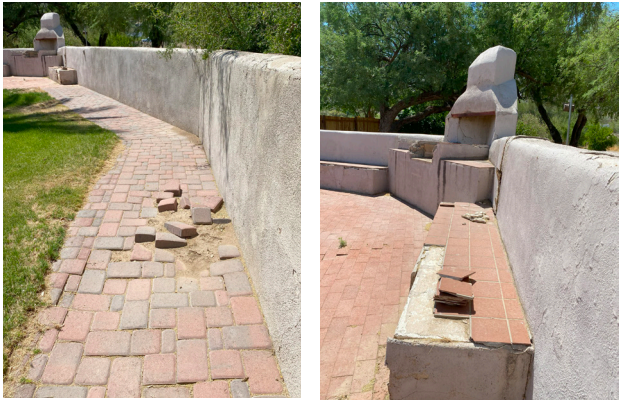
- L.03 Paved path along site wall: Condition - Poor**  
Concrete paver border along site wall path and red brick paving at barbecue area. Path is in poor condition with unlevelled surface and many pavers pulled up.

**Stabilization recommendation:**  
Complete recommended grading work. Remove red brick, reset sand base, set back red brick material.
-

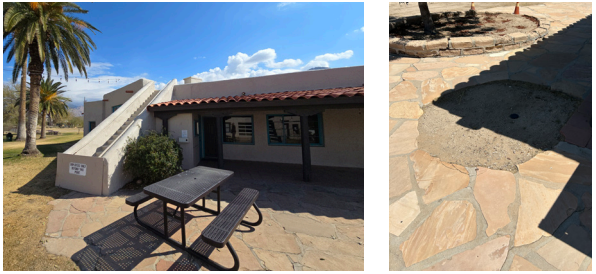
- L.04 Flagstone: Condition - Fair**  
Flagstone set in mortar on North West Porch. Uneven in some places and poses potential tripping hazards.

**Stabilization recommendation:**  
Complete recommended grading work. Remove flagstone completely and replace with decomposed granite.
-

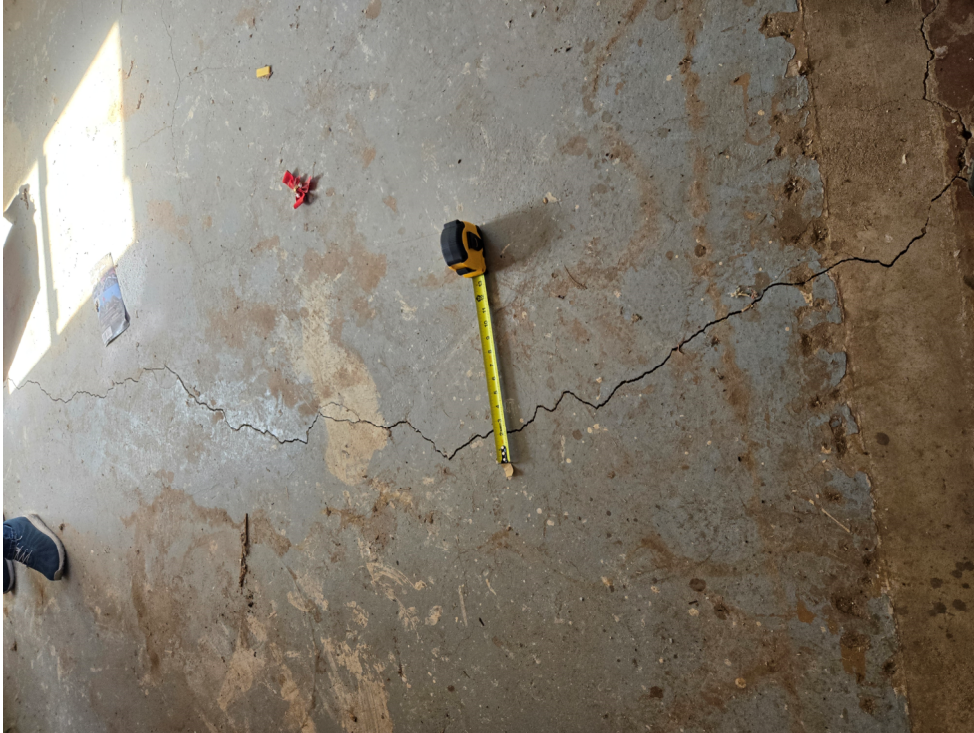
**Photo 1: Typical cracking at slab on grade (note lack of joints)**

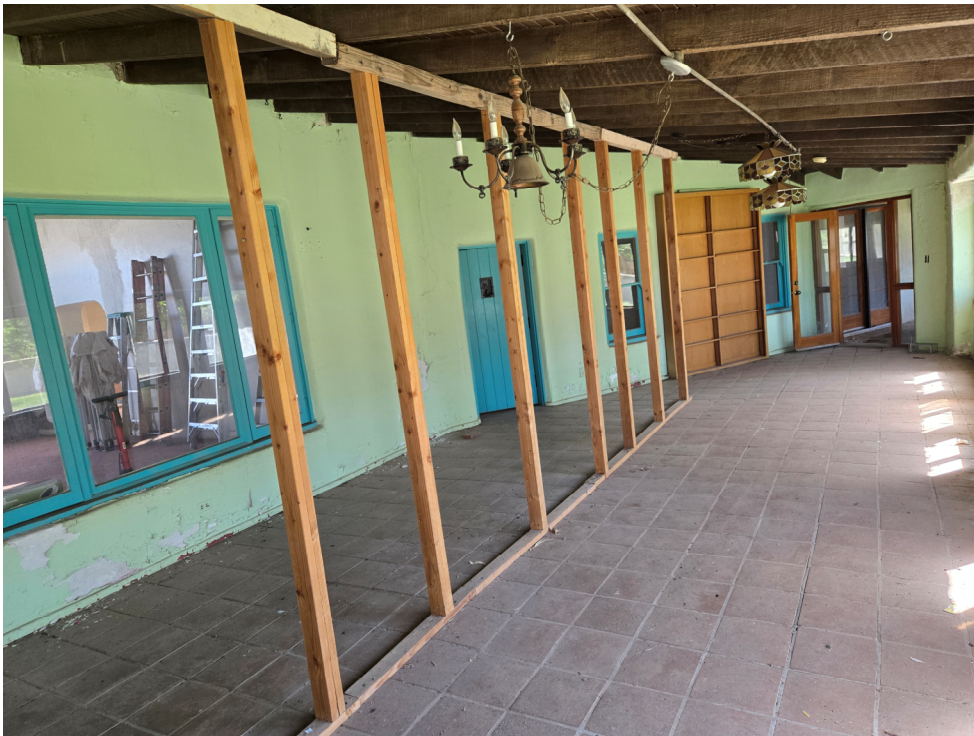
**Photo 2: Shored deflected roof joists at Arizona room**

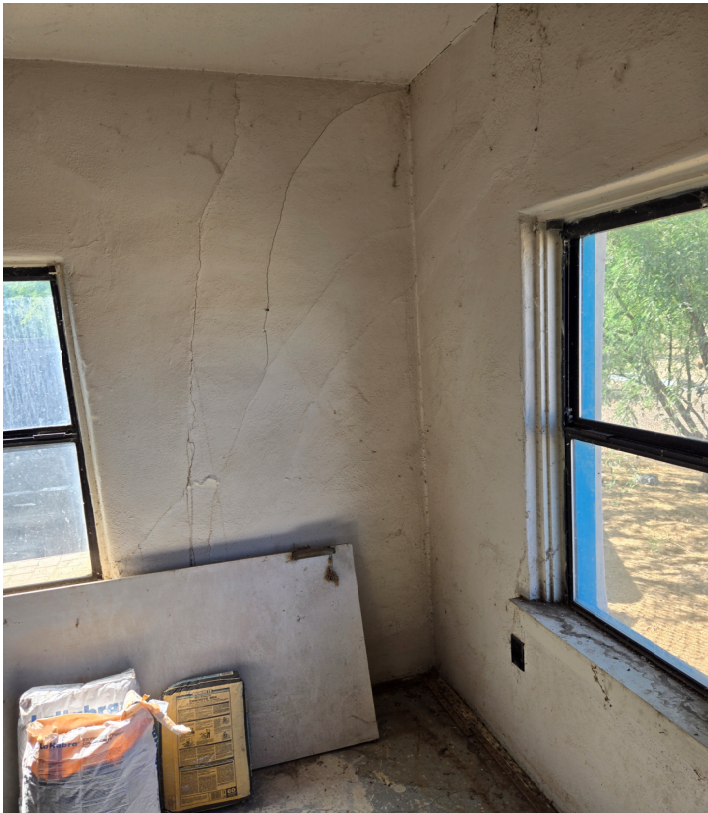
**Photo 4: Typical cracked plaster at interior of existing adobe wall**

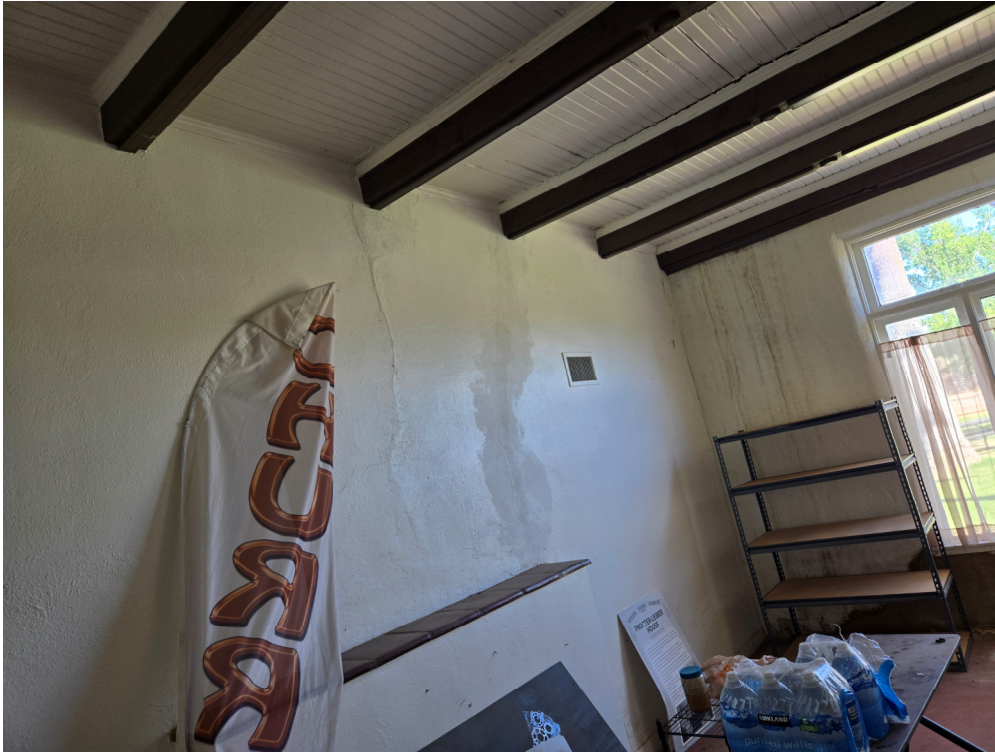
**Photo 5: Water intrusion and plaster cracks at adobe walls**

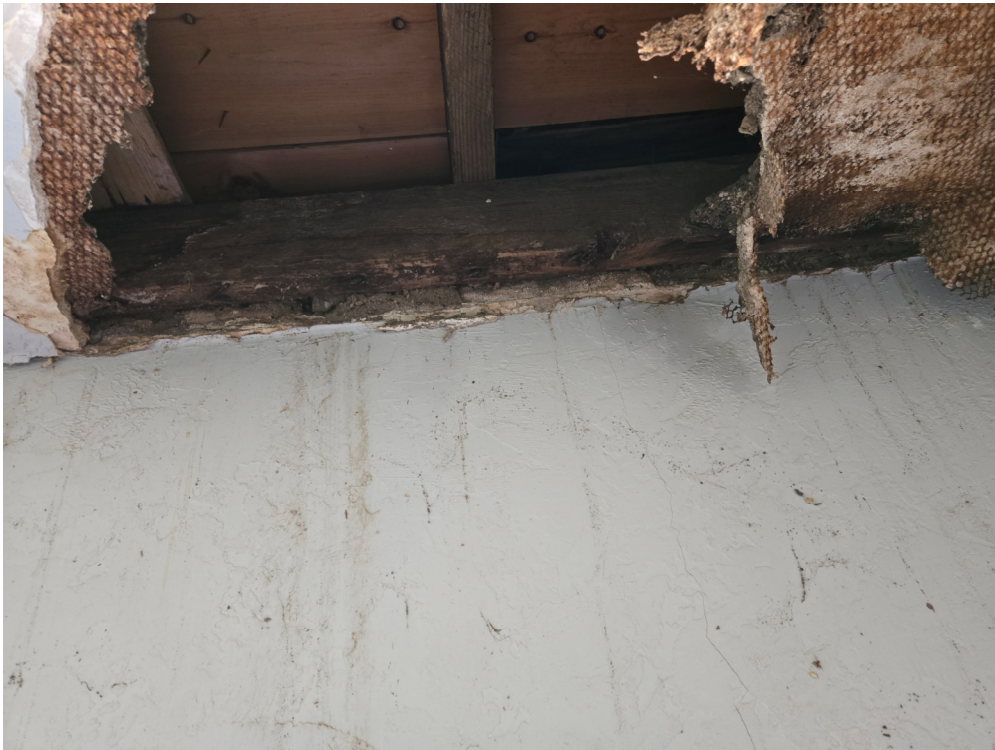
**Photo 6: Water intrusion and water damaged wood framing**

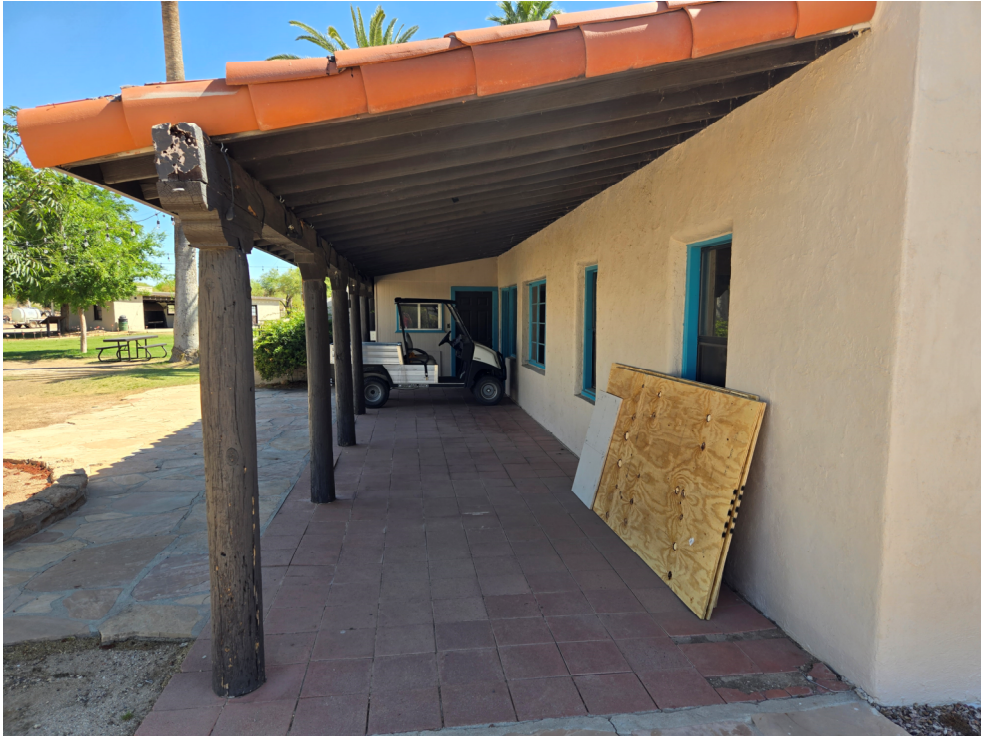
**Photo 7: Wood rot at entry porch**

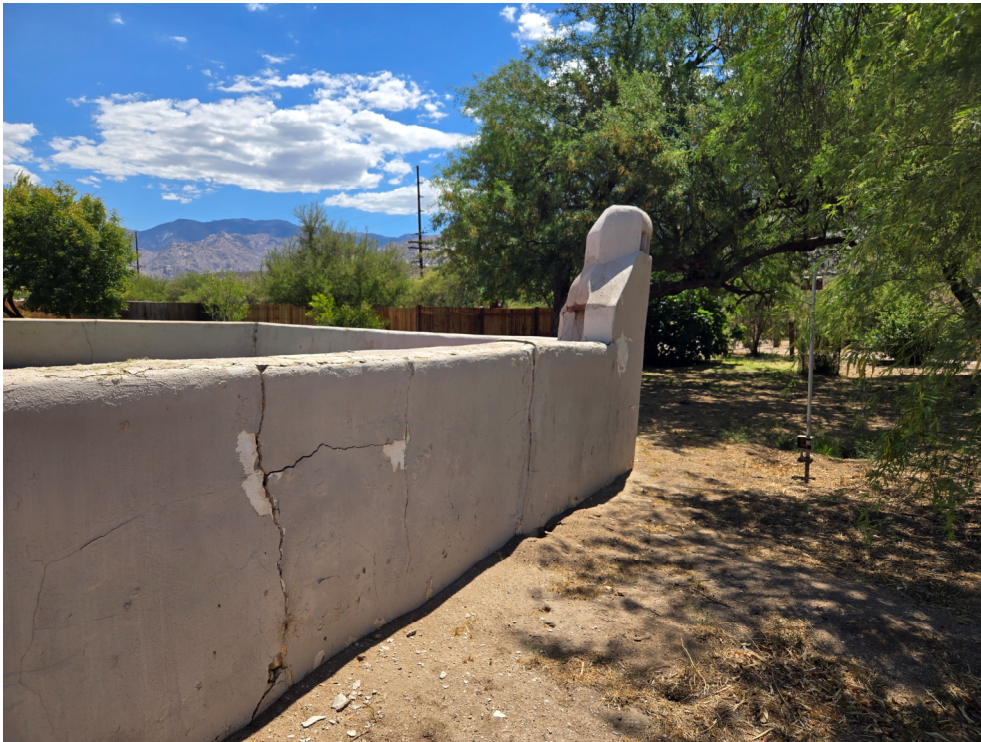
**Photo 8: Deterioration of existing site wall and barbecue**
