Steam Pump Ranch Condition Assessment Report

for the Town of Oro Valley
December, 19 2014

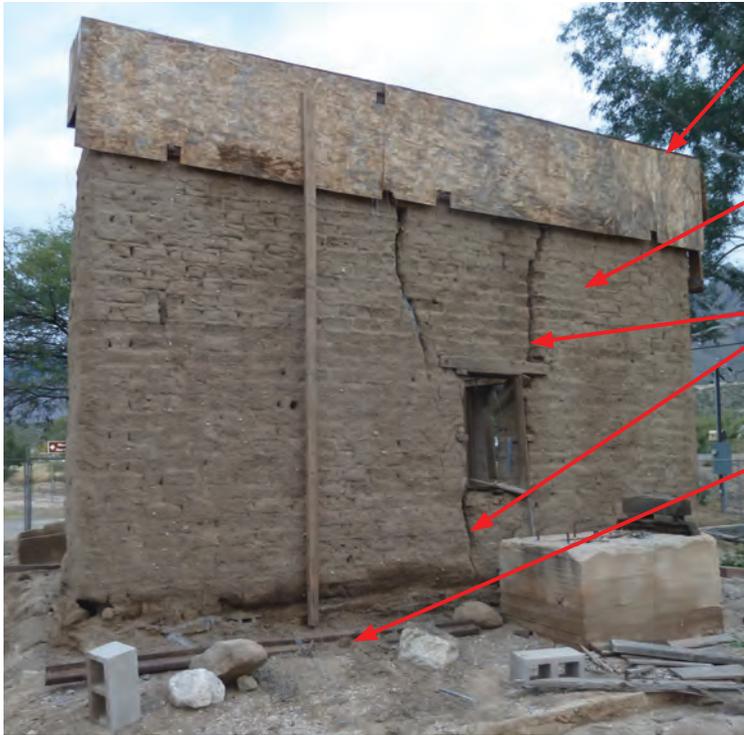
Wall: Plywood cap at top of adobe wall appears to be protecting the top of the adobe.

Continue to cover the top of the wall with tarp to help keep water out.

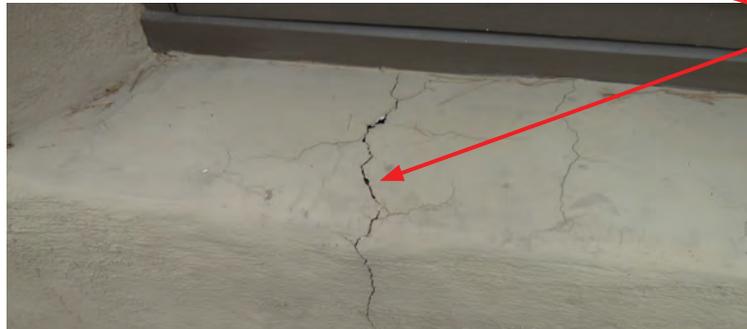
Fig 2.04: South Window at Research Library

Window/Wall: Crack in wall at window allowing water to enter adobe.

Seal any cracks around the window and patch stucco to prevent water from entering.

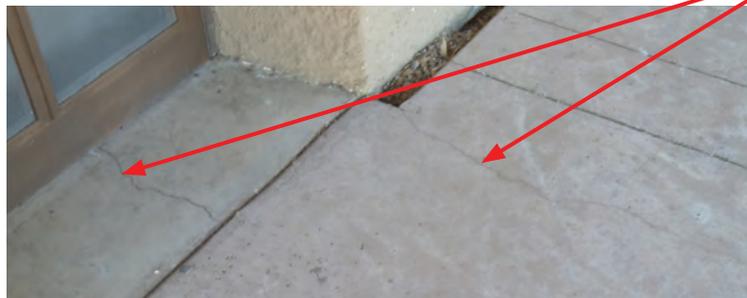
Fig 2.05: East Open Porch

Floor: Minor cracks in concrete floor.

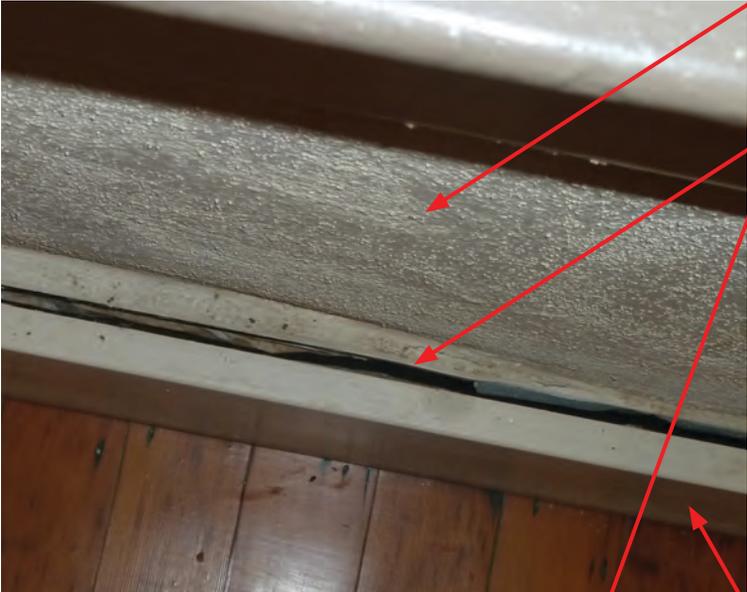
Fig 2.14: Baseboard at Wall in the Pusch / Ranching Exhibits

Wall: Baseboard is separating along the north wall in the Meeting Room and the Pusch Family and Ranching Exhibit room. Possibly due to settlement occurring or rodent activity along that wall. Current separation of baseboard appears minor.

Not a critical repair at this time.

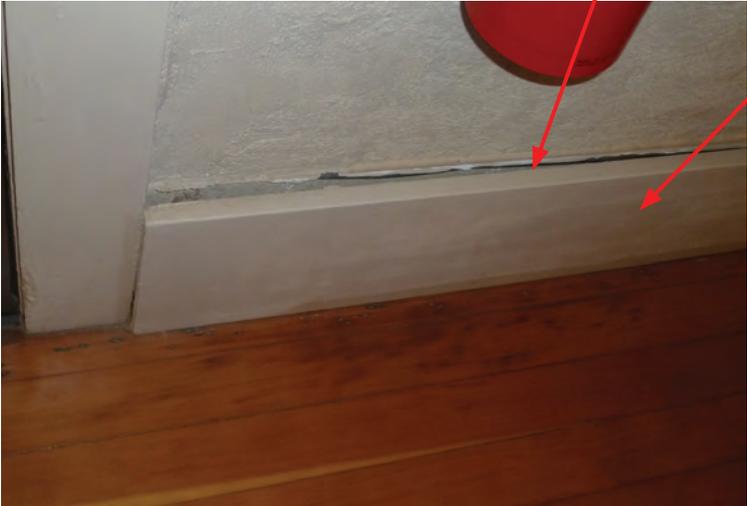
Fig 2.15: Baseboard at Wall in the Meeting Room

Wall: Baseboard

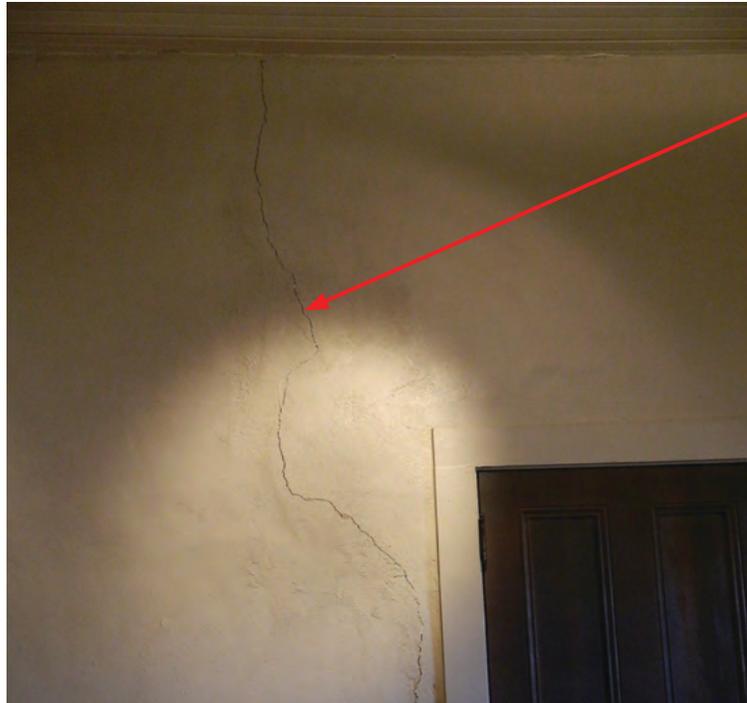
Fig 2.16: East Wall in the Pusch / Ranching Exhibits

Wall: Crack along east wall near fire-place.

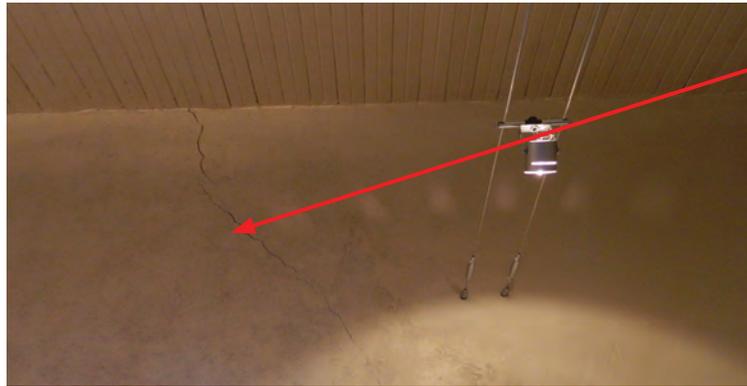
Fig 2.17: South Wall in the Meeting Room

Crack on the South wall above the door

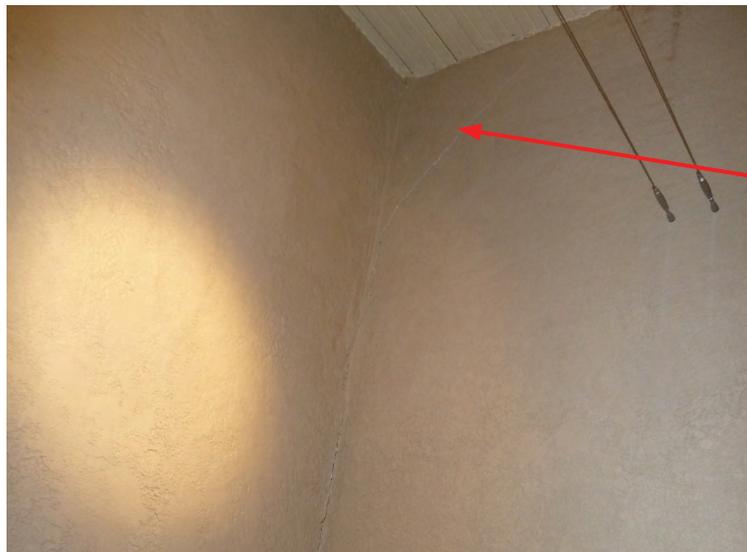
Fig 2.18: Southeast Corner in the Research Library

Wall: Crack on south wall in the Research Library.

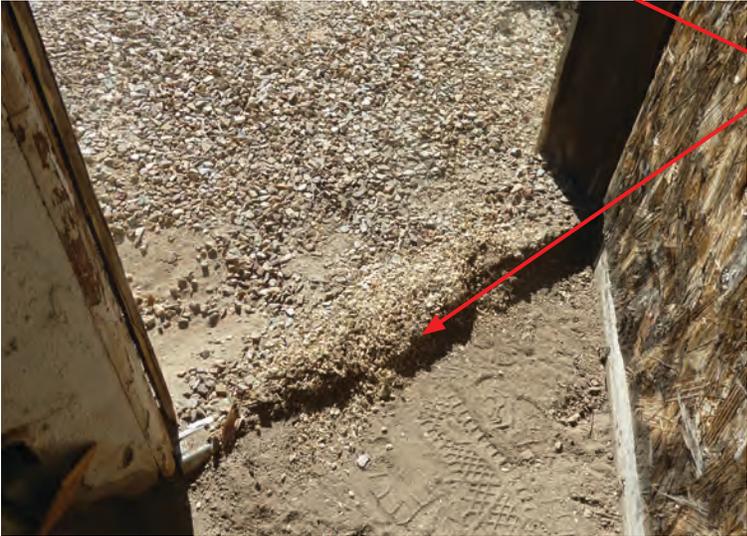
Fig 3.09: Bunk House A at South Elevation Door, View from Inside Looking Out

Grading: Grade around both Bunk Houses is higher than the interior finish floors.

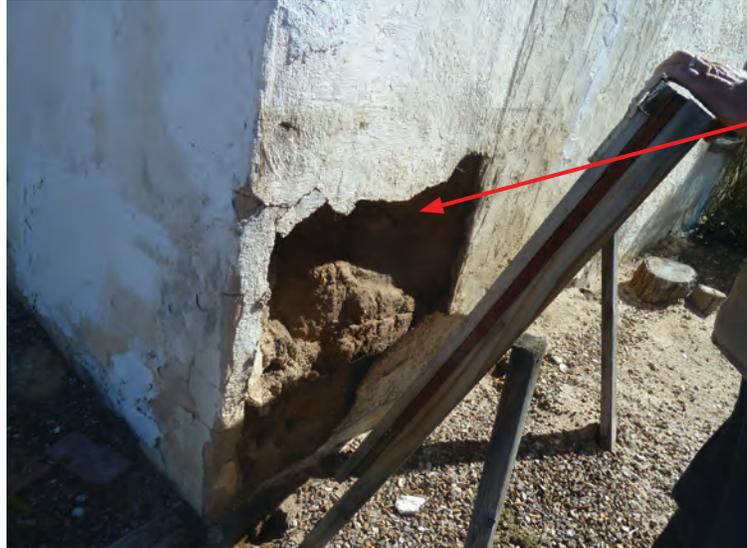
Fig 3.11: Bunk House A, Northwest Corner

Walls: Damaged adobe. Same location as Fig. 3.11.

See recommendation in Fig. 3.07.

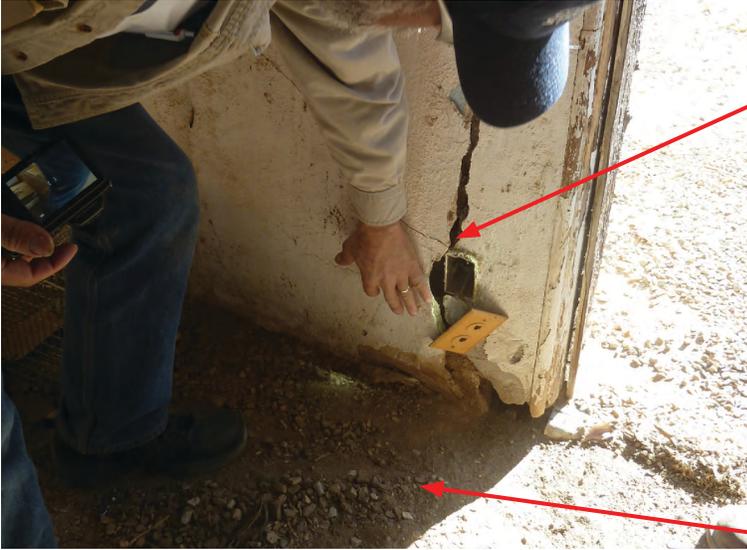
Fig 3.14: Bunk House A, South Elevation, Interior of Bunkroom

Walls: Crack by South window and crack by South door. Caused by water collecting at base of wall and/or water leaking from window

Refer to recommendation in Fig. 3.09. Remove debris and dirt from the interior.

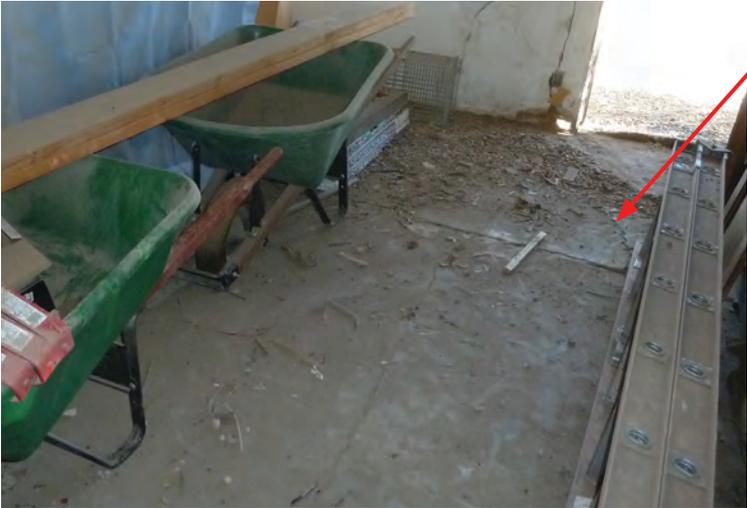
Fig 3.16: Bunk House A, Bunkroom Floor

Floor: Cracks in concrete floor.

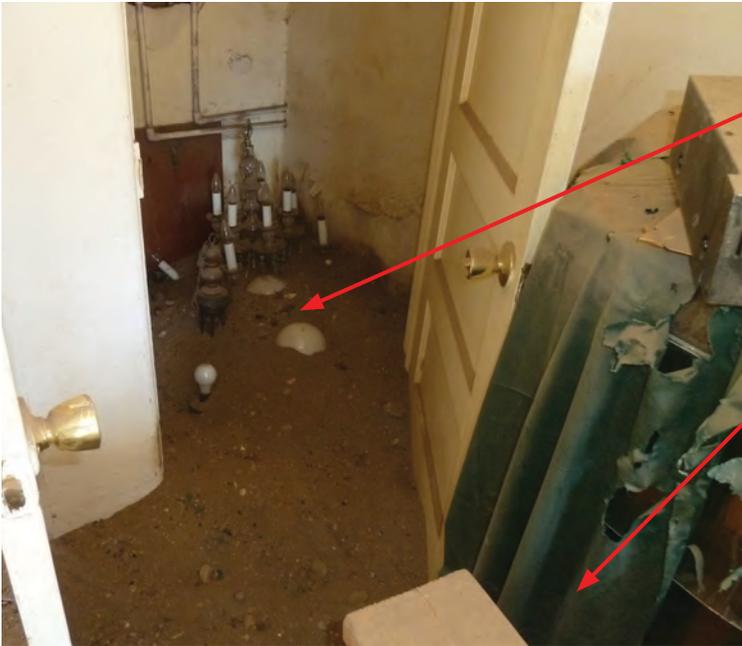
Fig 3.17: Bunk House A, Closet and Bunkroom

Not critical to stabilization.

Refer to recommendations in Fig. 3.07 and 3.14.

Remove all unused items to allow space to be maintained.

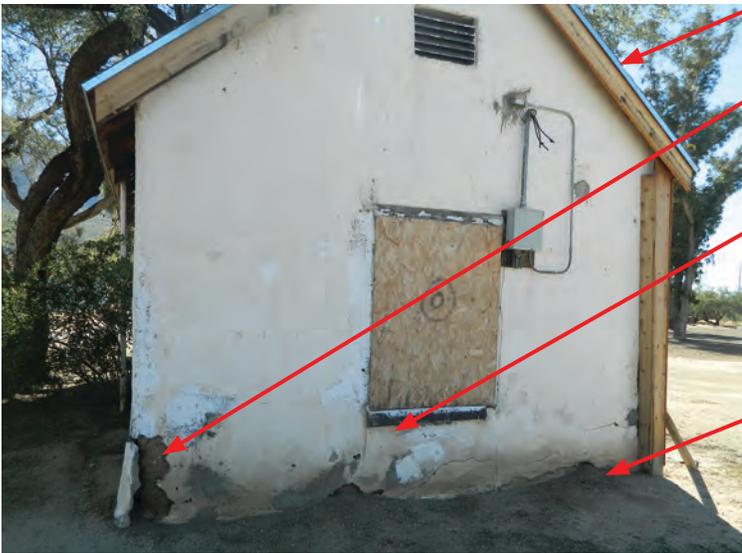
Fig 3.18: Bunk House B, North Elevation

Roof: New roof.

Walls: Erosion at corner from water damage.

Windows / Walls: Possible water damage to adobe under window from water getting in around window frame.

Walls: Possible rodent damage. Dirt is located higher than floor interior.

Refer to Fig. 3.06 for recommendations.

Refer to Fig. 3.05 for recommendations.

Refer to Fig. 3.07, 3.08 and 3.09 for recommendations.

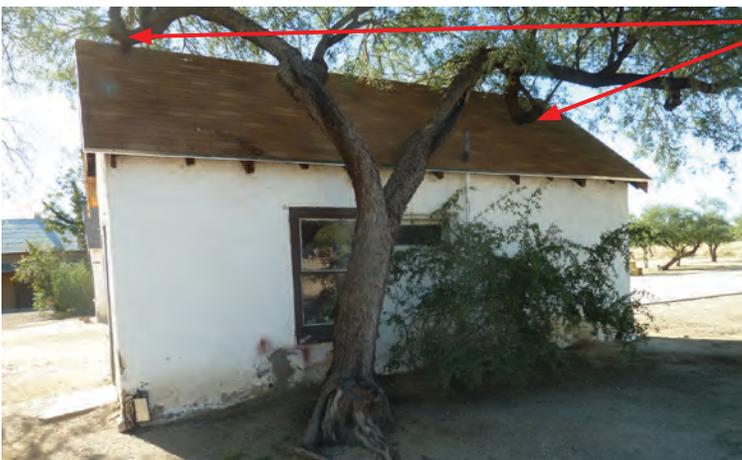
Fig 3.19: Bunk House B, East Elevation

Roof: Mesquite tree can hit roof during wind storms.

Trim lower tree branches so no branches within 2' to 3' of the roof.

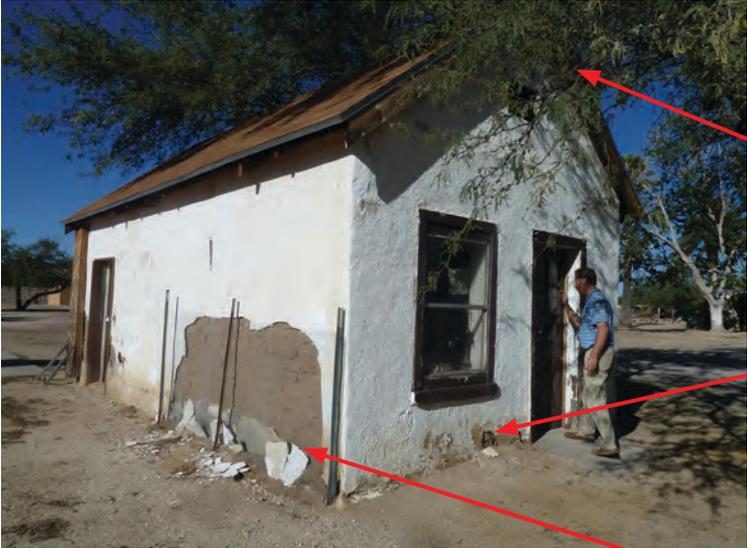
Fig 3.20: Bunk House B, Southwest Corner

Walls: Stucco falling off due to water leaking around windows.

For recommendations refer to Fig. 3.04.

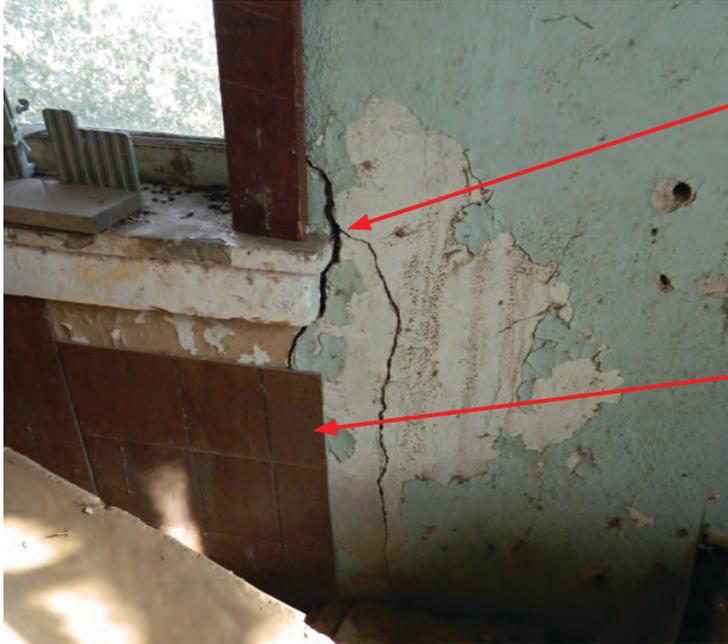
Fig 3.17: Bunk House B, South Bunkroom Window on East wall

Walls / Windows: Cracks due to water infiltrating around window.

Refer to recommendation in Fig. 3.05 and 3.14.

Remove to ensure there is no damage to adobe under covering.

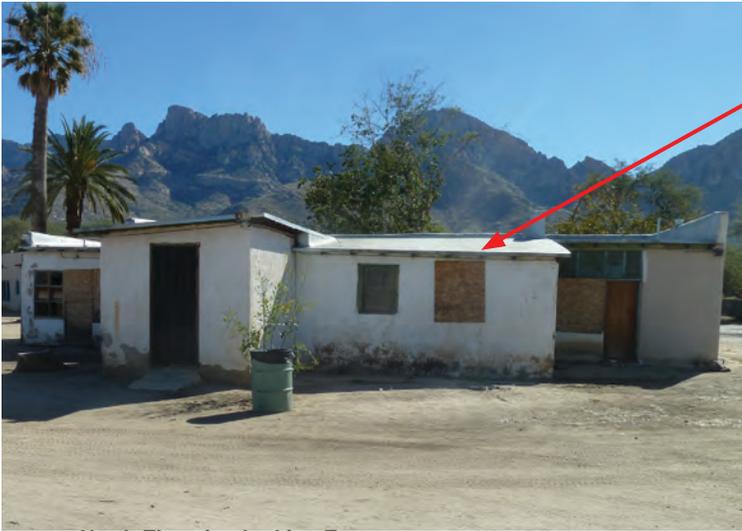
Fig 4.03: North Elevation looking East

Majority of the North elevation will be demolished in the future.

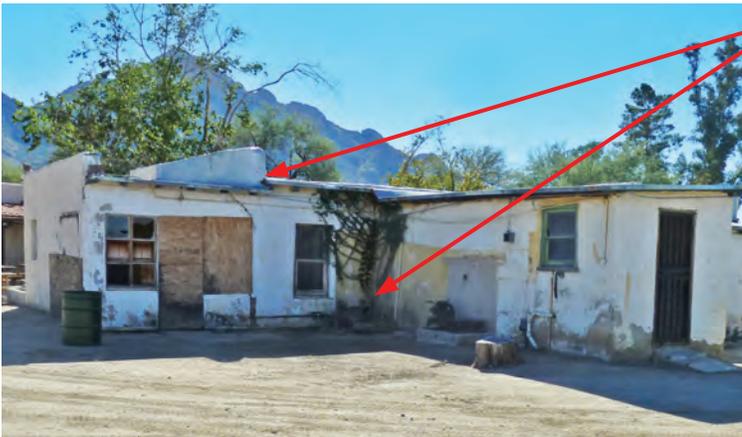
Fig 4.04: Northeast Elevation

Location of building that will be preserved. Interior is in fair condition.

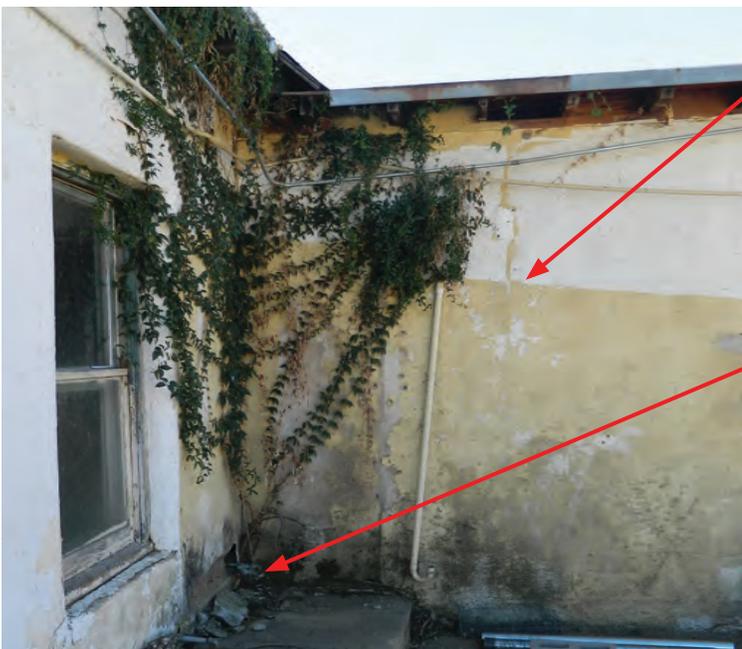
Fig 4.05: North Elevation by Restroom / Storage, looking West

Portion of building that will be demolished in the future.

Walls: Water collecting in the corner and eroding base of wall. Possible rodent activity, see Fig. 4.11 for view of this location at the interior.

- ii. Water appears to be collecting along the North exterior wall of the Restroom / Storage. Provide a thin lime plaster, 1/8" to 1/4" thick on exposed adobe. Make patch obvious to indicate where the temporary repair has occurred and that future repair is required in that location.

- iii. Direct water away from the corner by the Restroom / Storage and the Site Storage by adding gutters and downspouts to the roof around the portion of the building to be kept. Locate downspouts to direct water away from the building. Remove vine growing in that corner.

Place thin lime plaster, 1/8" to 1/4" thick over missing stucco. Add gutters to roof line above the area of the building that will be restored and locate downspouts to flow away from building. Remove vine.

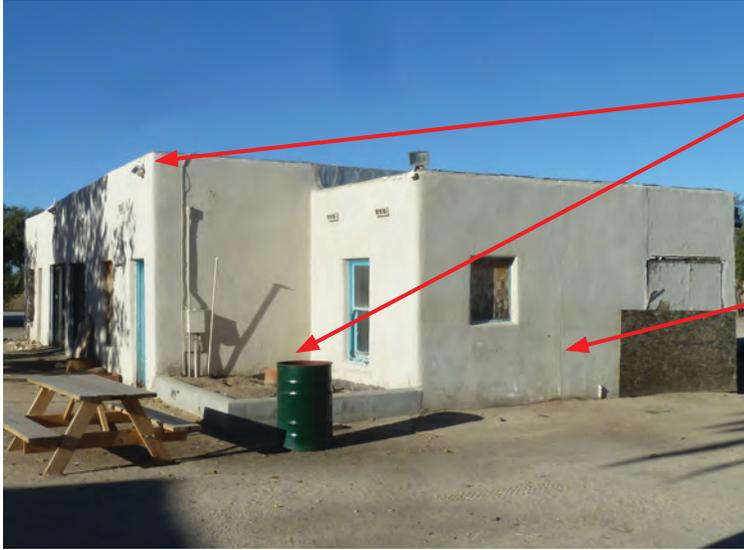
Fig 4.06: South and East Elevations, looking Northwest

Portion of building to be preserved. In fair condition.

Lower building will be demolished in the future.

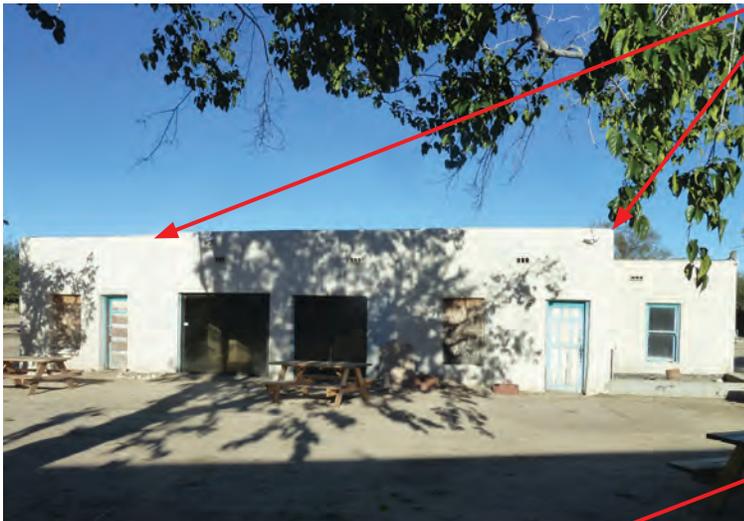
Fig 4.07: South Elevation

Portion of building to be preserved. This portion appears structurally stable.

Roof: Roof in good condition.

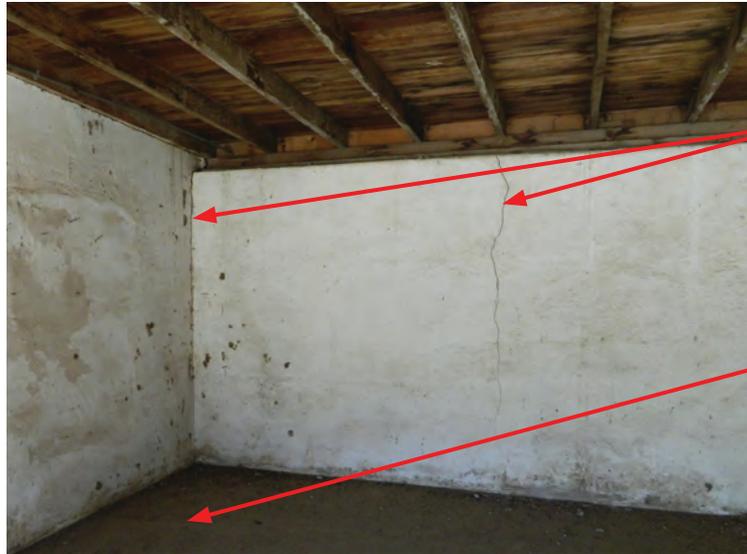
Fig 4.09: Northwest Corner of Classroom / Western Movies Room

Walls: Cracks in at corner and on the North wall of Classroom / Western Movies Room.

Not critical to repair at this time.

Floor: Cracks in concrete floor.

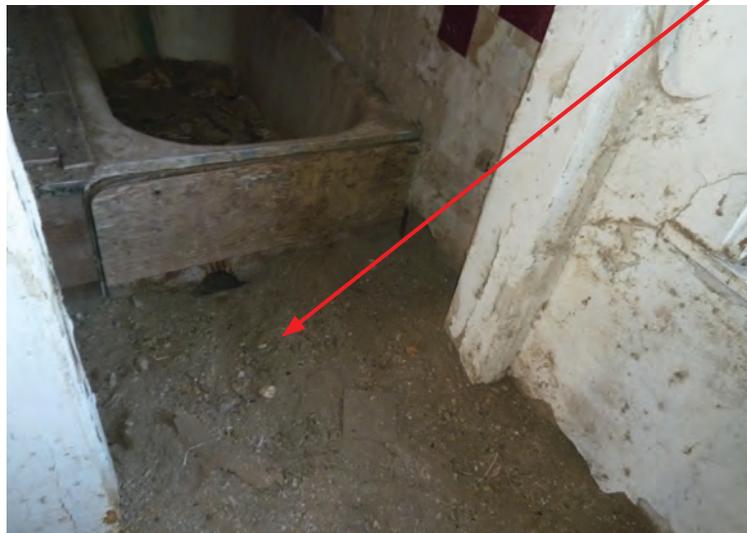
Fig 4.11: Bathtub in Restroom / Storage

Floor / Walls: Large amount of dirt, possibly due to rodent activity.

Remove dirt and inspect adobe to ensure that large portions of adobe wall aren't missing. Repair as needed and close rodent holes if any.

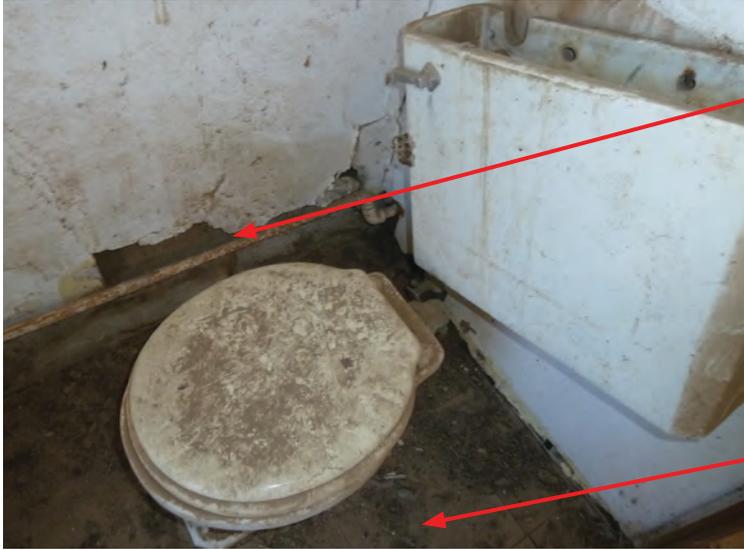
Wall: Wall is damaged near base. Possibly from water infiltrating from exterior or rodent activity.

Refer to recommendation in Fig. 4.05.

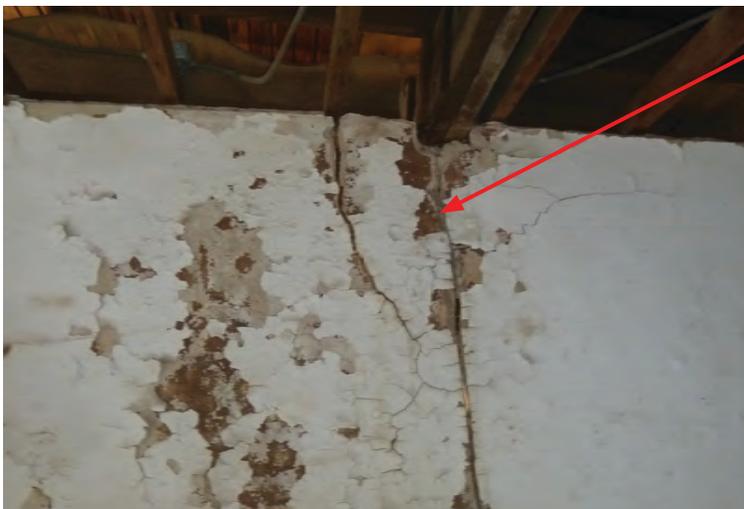
Fig 4.14: Center of West Wall of Entry / Exhibit Room

Walls: Damage to wall from water leak. Same wall as the East wall of the Classroom / Western Movies Room in Fig. 4.10.

Refer to recommendation in Fig. 4.10.

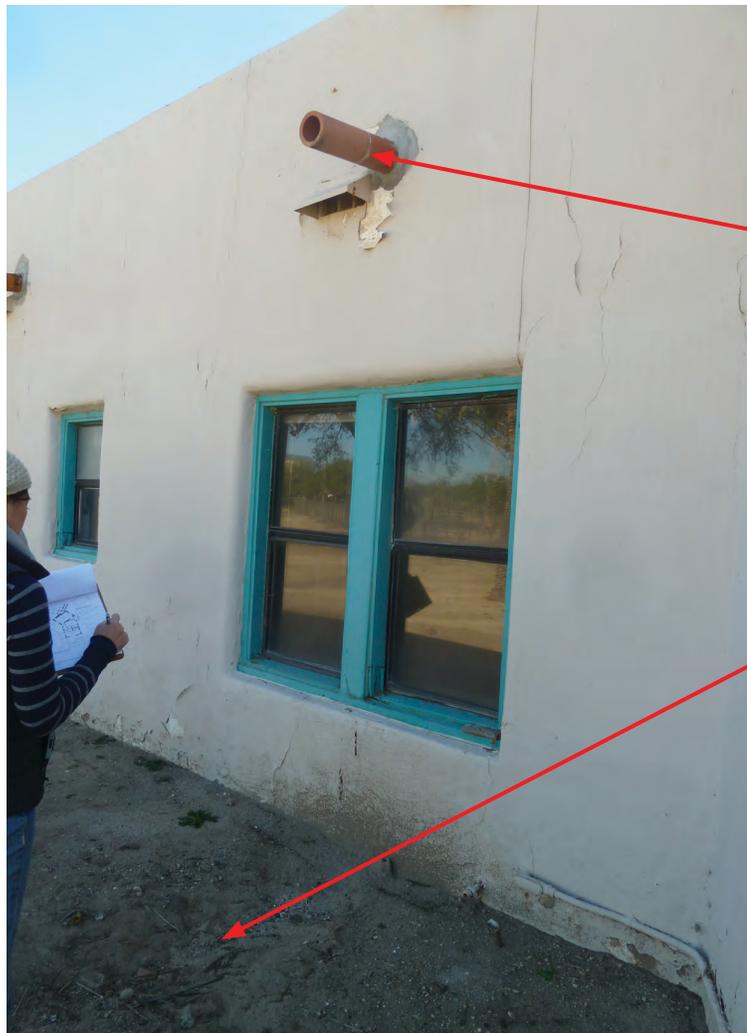
Fig 5.07: North Elevation, at Exhibit Room

Wall: Canales along the North wall of the Exhibit Room and Office / Archive have been extended.

Install wire hardware cloth along the perimeter of the building if rodent activity begins to create significant damage around the perimeter of the building. We would recommend the same solution described in the Pusch Ranch House if that appears to work. In addition to the hardware cloth we would recommend installing rodent traps in or around the building.

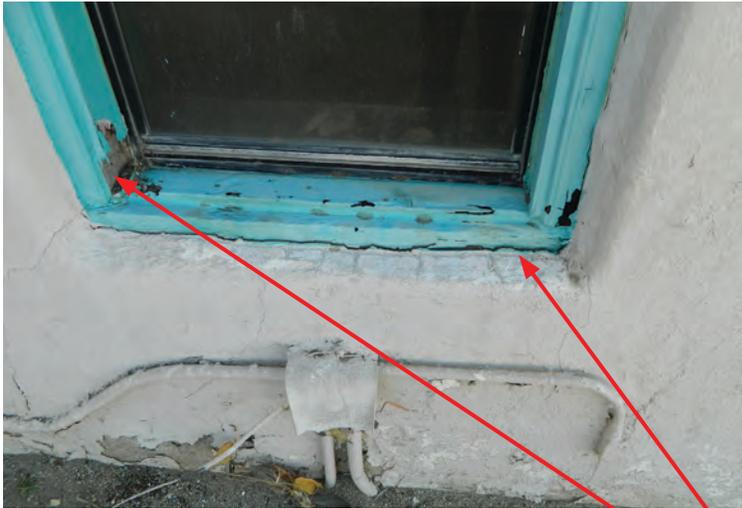
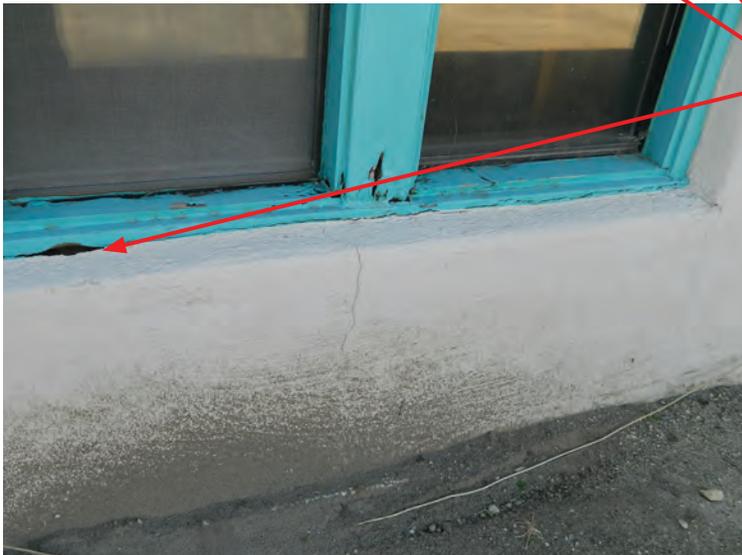
Fig 5.09: North Window in Office / Archive Room

Windows: Wood framed windows have deteriorated allowing for water to penetrate and compromise the adobe wall. This promotes additional problems with termites and rodents.

Seal cracks around the window and frames to make the windows water tight. This is typical for all windows in the Sitting Room, Exhibit Room and Office / Archive. This is a critical repair and should be done as soon as possible. If budget allows, treat for termites.

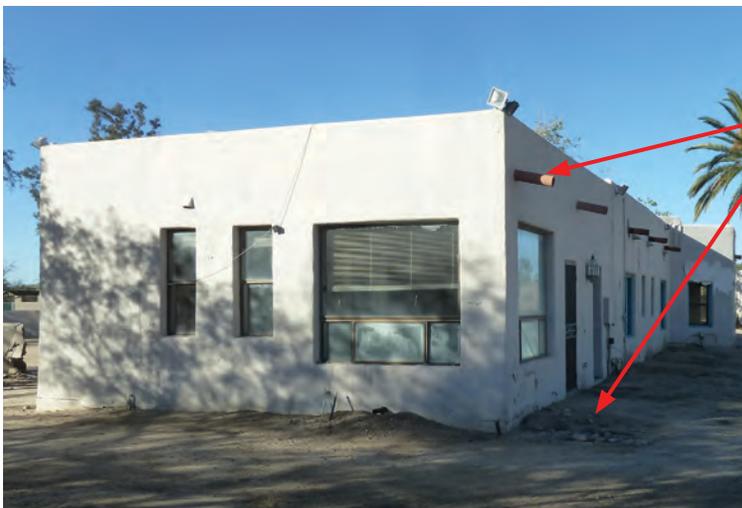
Fig 5.10: Northeast Corner

Wall: Canales have been extended. When water falls from canales, a depression in the dirt is created, allowing the water to be collected near the base of the building.

Refer to Fig. 5.07 for recommendations.

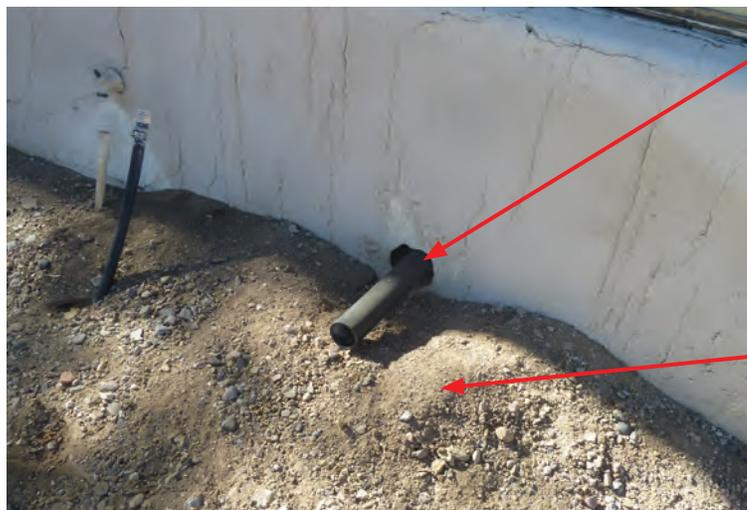
Fig 5.12: East Elevation at East Addition Bathroom

Wall: Hole in wall allows animals to enter. Pipe from bathtub.

Site: Dirt is above finished floor

Regrade dirt so it is below finish floor.

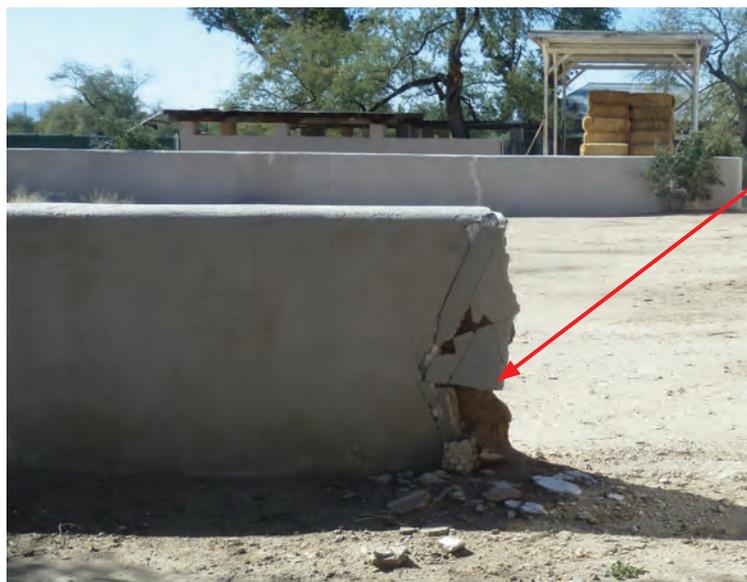
Fig 5.13: Site Wall to the South of the Porch Addition

Wall: Edge of wall is damaged.

Repair adobe site wall and re-stucco to prevent additional deterioration. Wrap adobe with tarp until able to repair wall to prevent further deterioration of adobe wall.

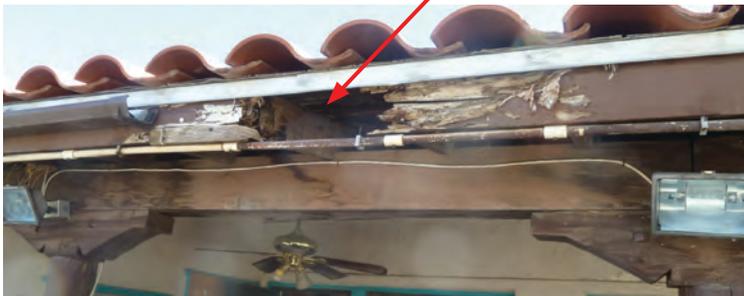
Fig 5.17: Open Porch, Near Front Door

Roof: Structural damage to porch.

Repair / replace damaged wood and fix clay tiles above.

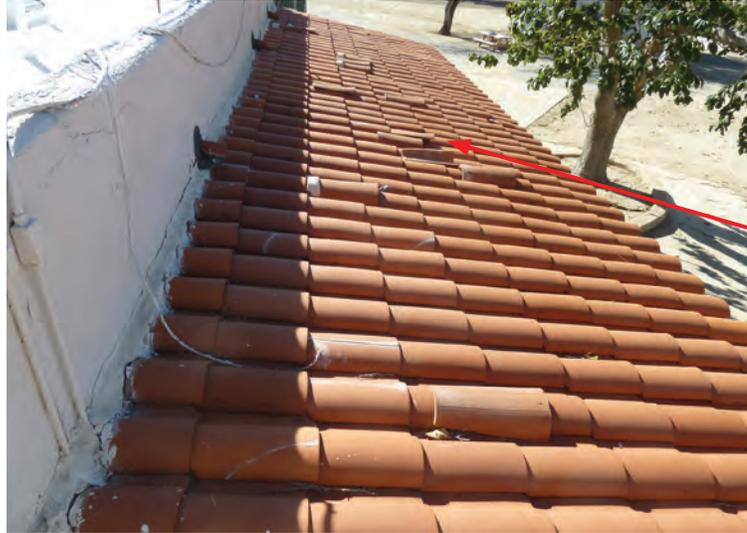
Fig 5.18: Roof at Open Porch

Roof: Debris on roof.

Clean debris on roof so water is able to flow off of roof.

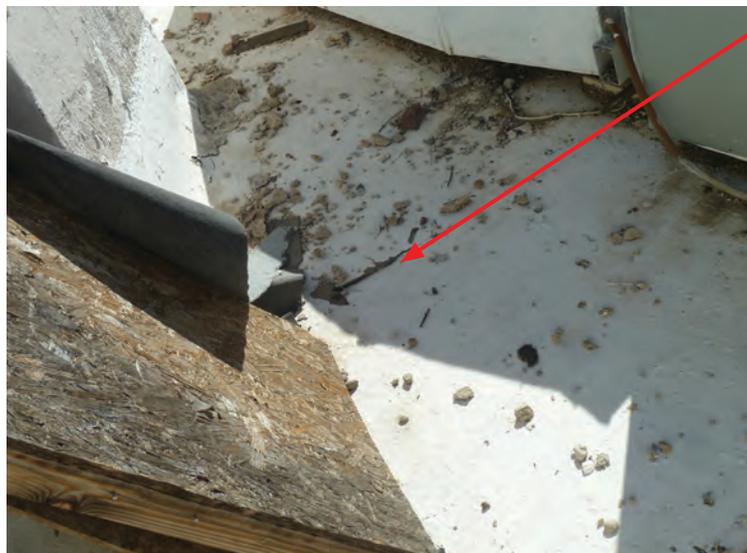
Fig 5.20: Roof above Food Service Room

Roof: Crack in roof.

Repair roof leak,
refer to Fig. 5.20.

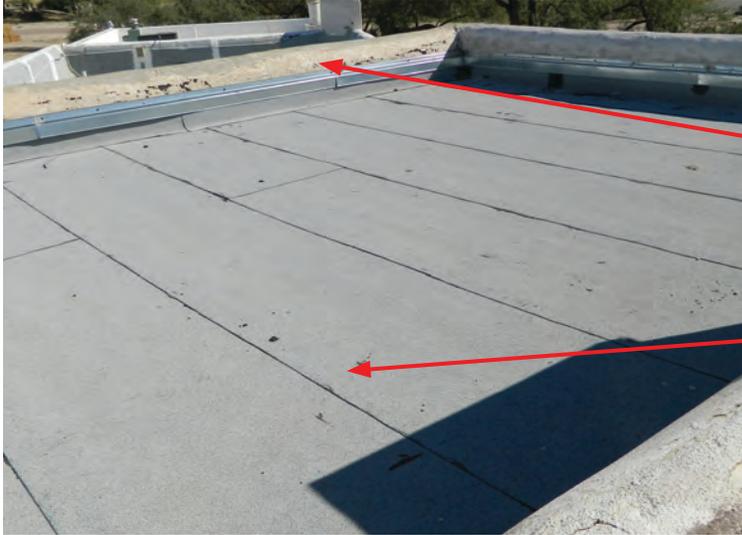
Fig 5.22: Parapet Wall at Procter Displays

Wall: Stucco on parapets is failing. Refer to the images below.

Roof: Roll roofing above appears to be in good condition.

It is critical to repair any cracked stucco on the top of any of the parapet walls to prevent water entering the wall which will cause deterioration of the adobe wall. Most of the damage appears to be on the Procter Displays Room parapets. Provide a thin lime stucco 1/8" to 1/4" over cracks to prevent water from entering as a temporary fix. Locate patches to be obvious so future long term stabilization will know to repair stucco.

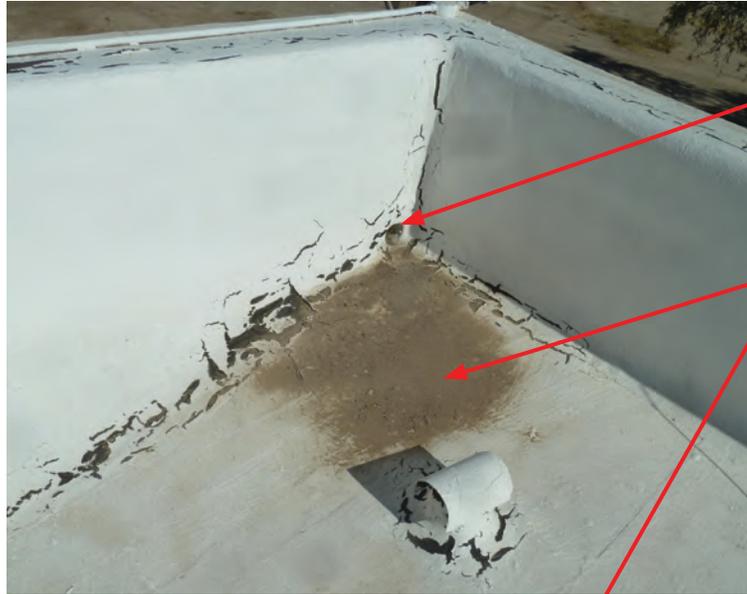
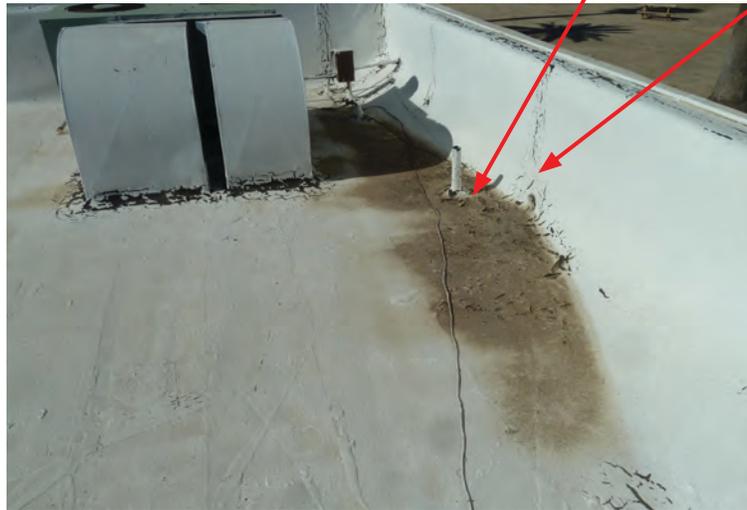
- ii. The roof over the East Addition needs to be built up more to allow water to flow out of the canales correctly. Currently the roof is lower than the canales, creating a ponding area and allowing water to leak into the sink in the Bathroom of the East Addition.

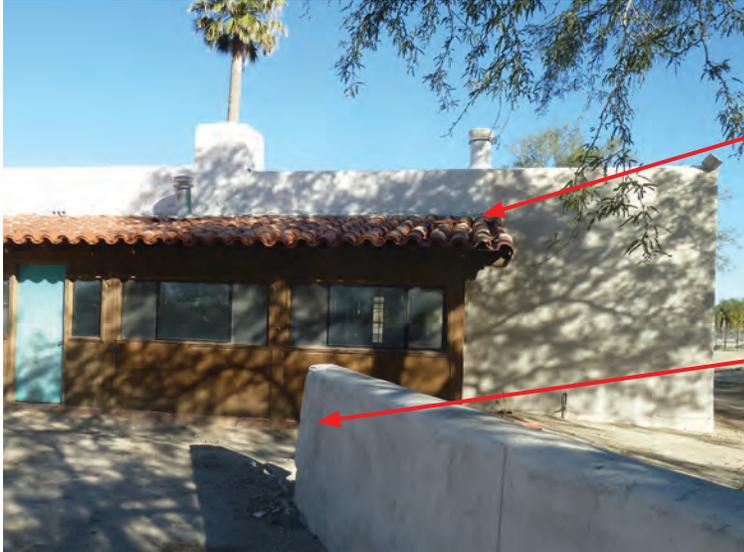
Fig 5.27: Porch Addition to Demo

Wall: Adobe site wall with damage at the edge.

Refer to Fig. 5.13 for recommendations.

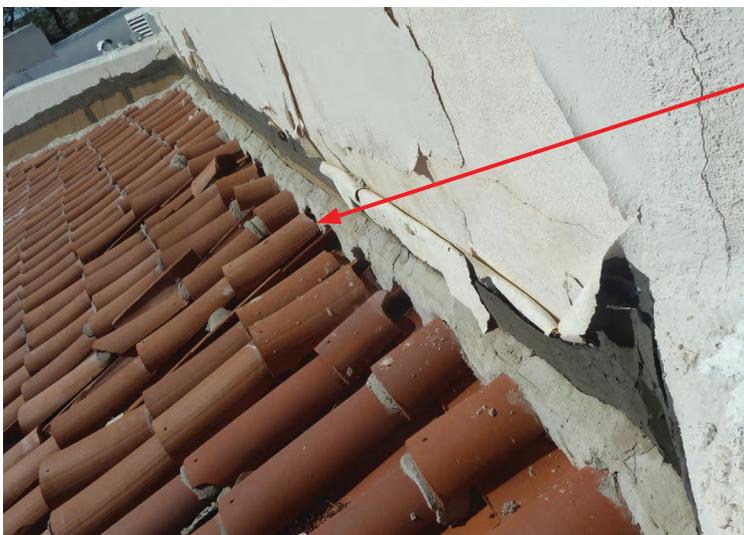
Fig 5.29: Roof at Sun Porch near Procter Displays Room Wall.

Roof: Clay tiles are starting to pull away from the wall.

Re-attach or replace clay tiles to prevent water from leaking through.

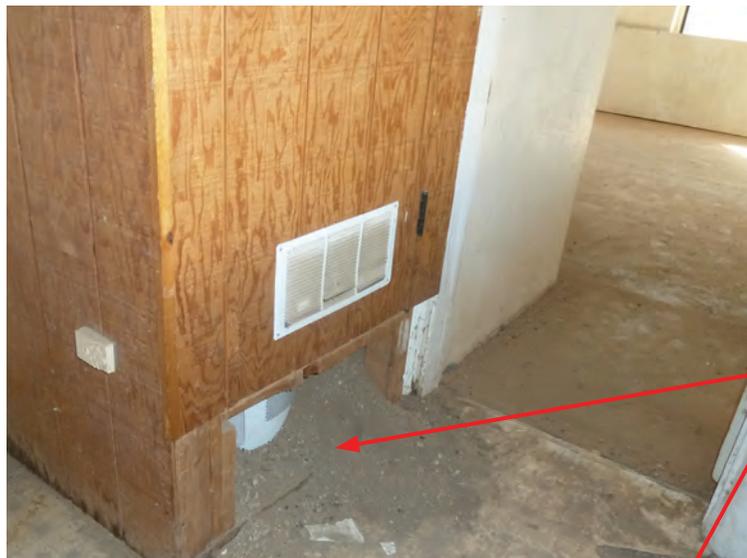
Fig 5.31: Water Heater Closet in Entry Porch

Walls: Rodent activ-
ity.

Clean up dirt to find
location of rodent
activity. Close any
holes.

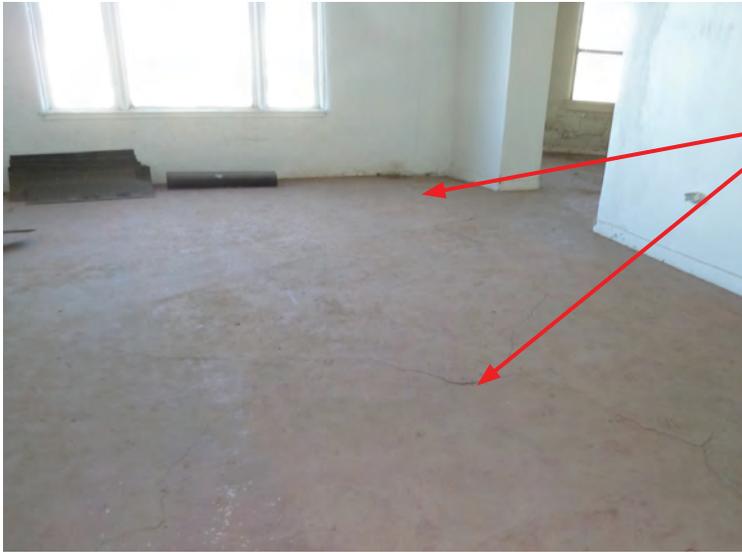
Fig 5.33: Procter Displays, Looking Northeast

Floor: Cracks in concrete floor.

Not critical to stability of structure.

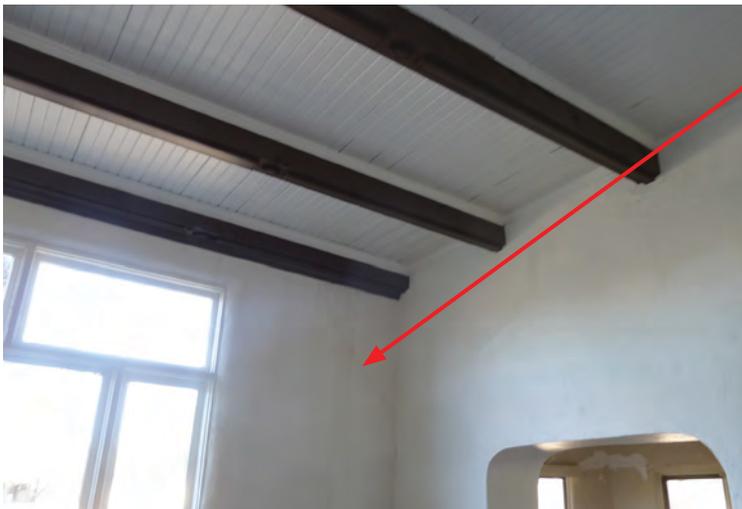
Fig 5.34: Procter Displays Room Looking Northeast at the Ceiling

Walls: Cracking in North wall of living room.

Refer to recommendation on Fig. 5.05.

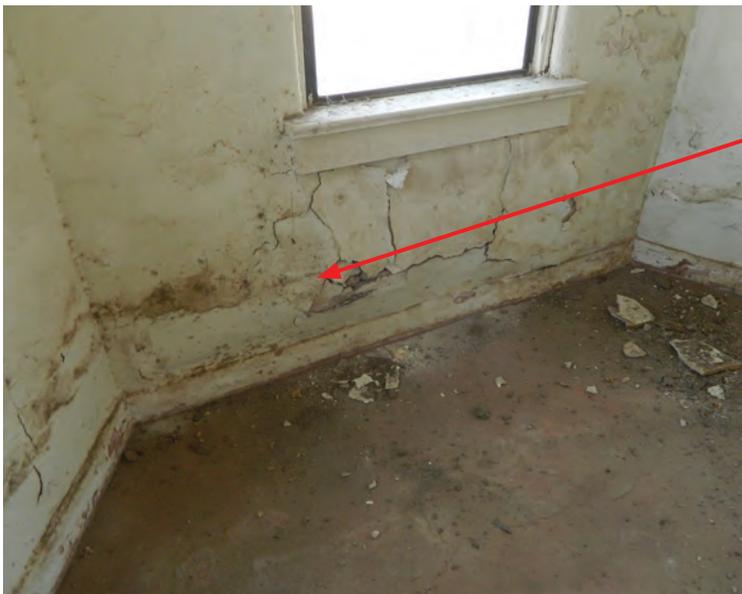
Fig 5.35: North Window in Sitting Room

Wall: Wall deteriorating under window due to water coming in from window no longer being water tight and possibly from ponding at the exterior. Some damage due to earlier leak in the roof that has since been repaired.

Refer to recommendations in Fig. 5.05 and 5.08.

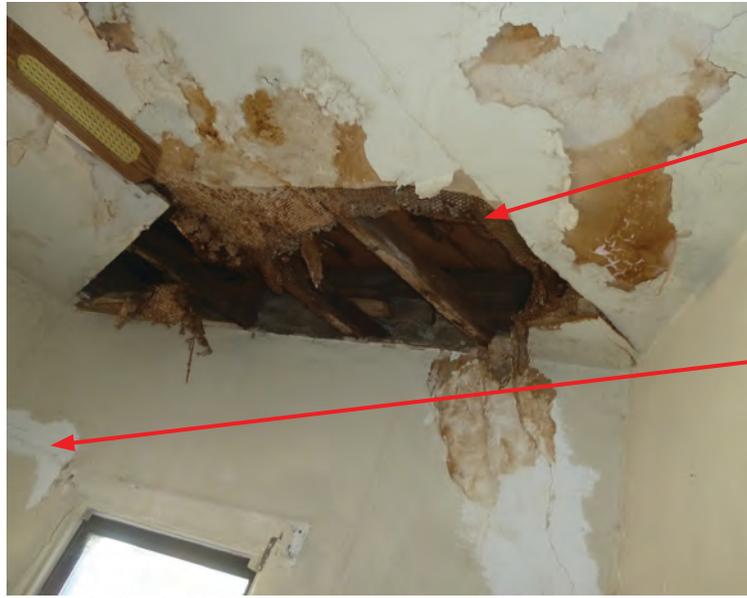
Fig 5.36: Ceiling in Sitting Room above North Window

Roof / Ceiling:
Damage from Roof Leak.

Wall: Cracks in wall by window.

Roof leak appears to have been fixed.

Cracks from water leaking around window. Make windows and parapets watertight. Refer to recommendation in Fig. 5.08 and 5.09.

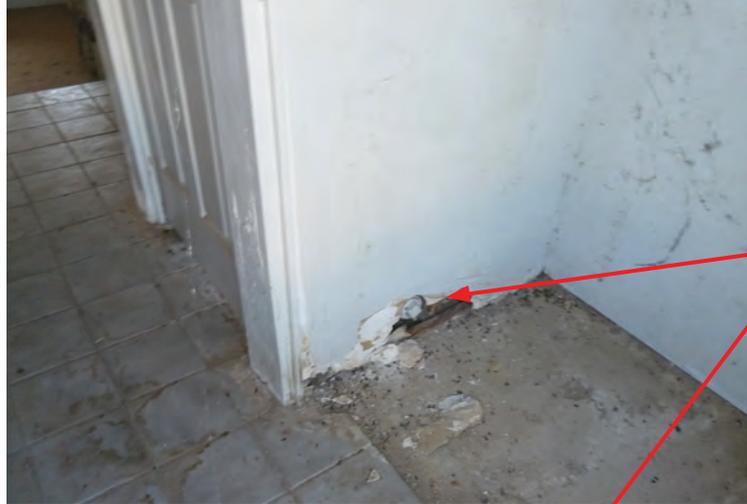
Fig 5.37: East Addition Power Room

Walls: Rodent damage.

Close holes and set traps.

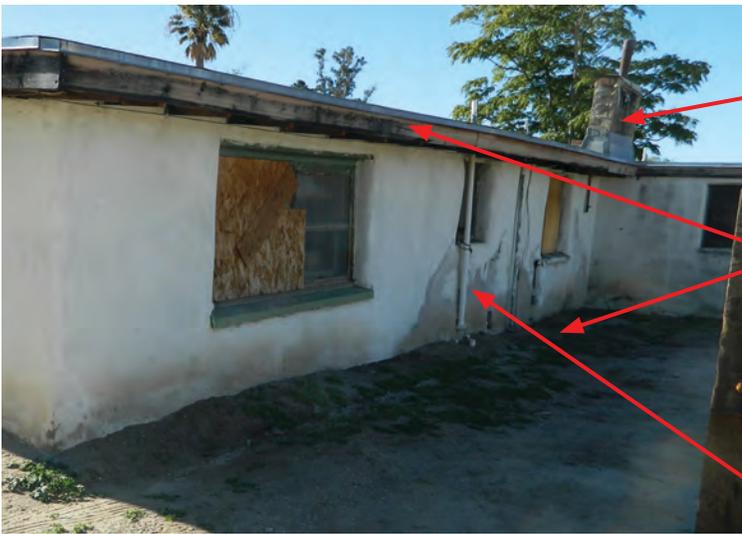
Fig 6.04: North Elevation of Portion to be preserved

Windows: Water might be leaking along window and creating erosion under the window. This is typical at all windows along the North Elevation.

Seal around the window frame to prevent water from entering. This is typical for all windows on the North Elevation.

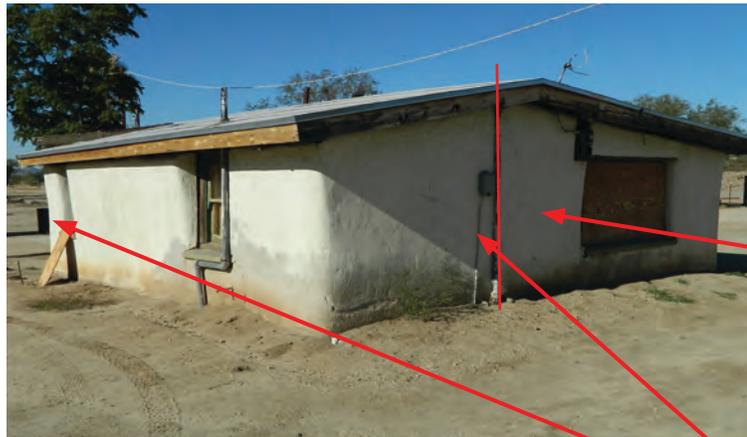
Fig 6.05: Southeast Corner

Walls: Full length of wall is adobe.

This portion will not be preserved per the 2008 Master Plan.

Study this portion of building to determine if this section is part of the early adobe construction and should be preserved.

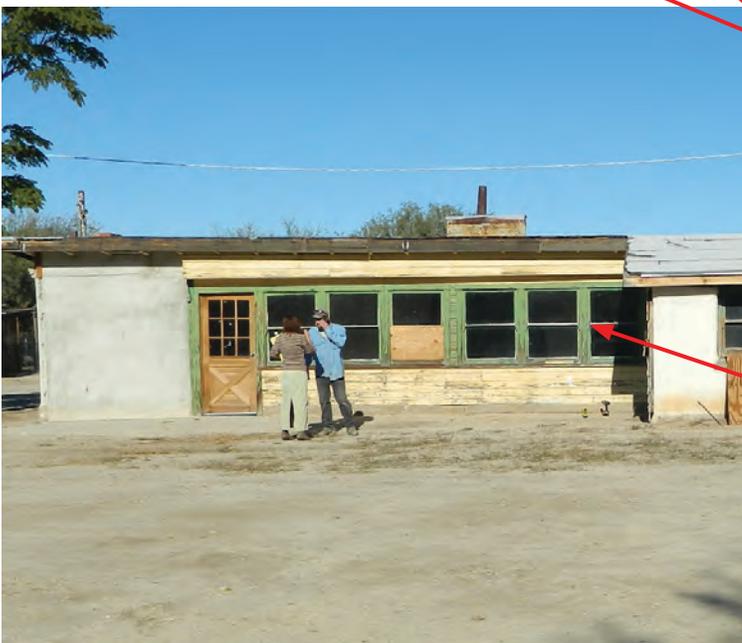
Fig 6.06: South Elevation at the Barbecue

Windows: Windows to be removed and salvaged at a later date.
