Steam Pump Ranch Condition Assessment Report

for the Town of Oro Valley
December, 19 2014

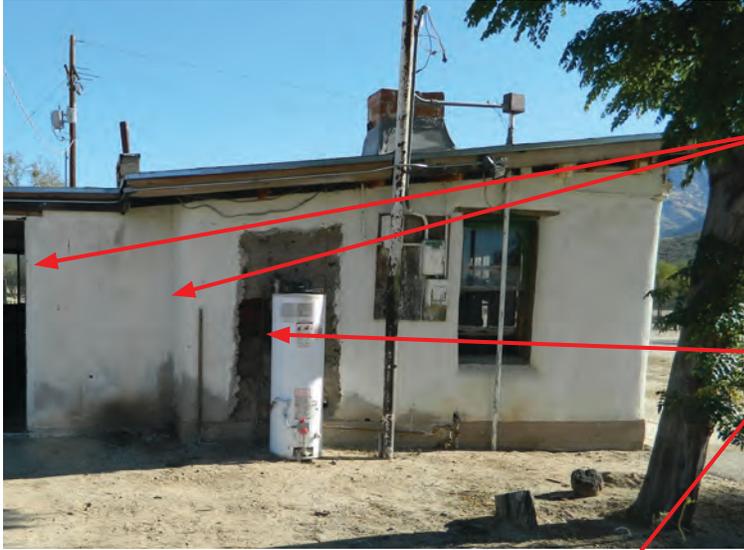
Fig 6.07: West Elevation

Walls: Large hole in adobe and stucco has been removed.

Close openings in adobe wall with exterior rated plywood. Apply a thin lime plaster 1/8" to 1/4" thick to exposed adobe.

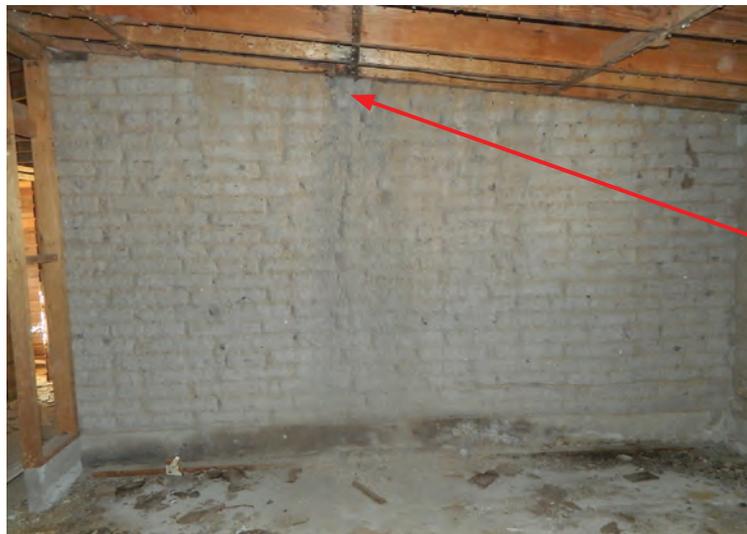
Fig 6.12: West Wall in Restroom

Walls / Windows:
Deterioration of
adobe walls under
windows.

Roof / Wall: Pos-
sible leak in roof.

Fix leak in roof if not
yet repaired.

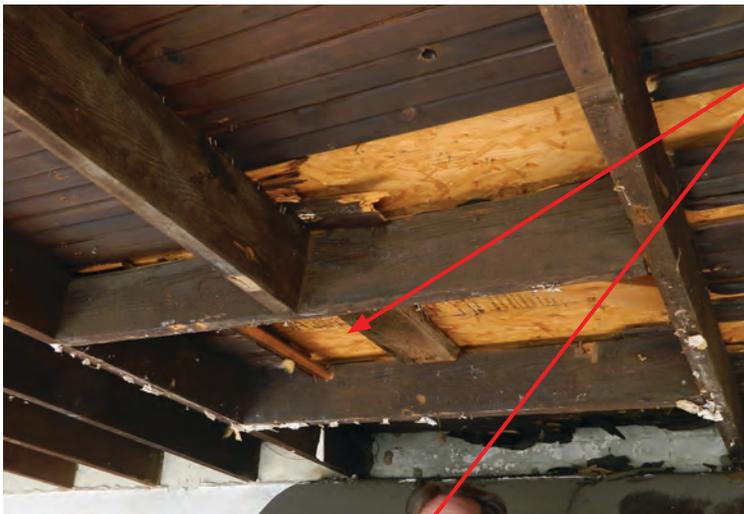
Fig 6.14: Above Barbecue

Ceiling / Roof:
Joists missing above barbecue

Floor: Large cracks in concrete floor.

Not a critical repair at this time.

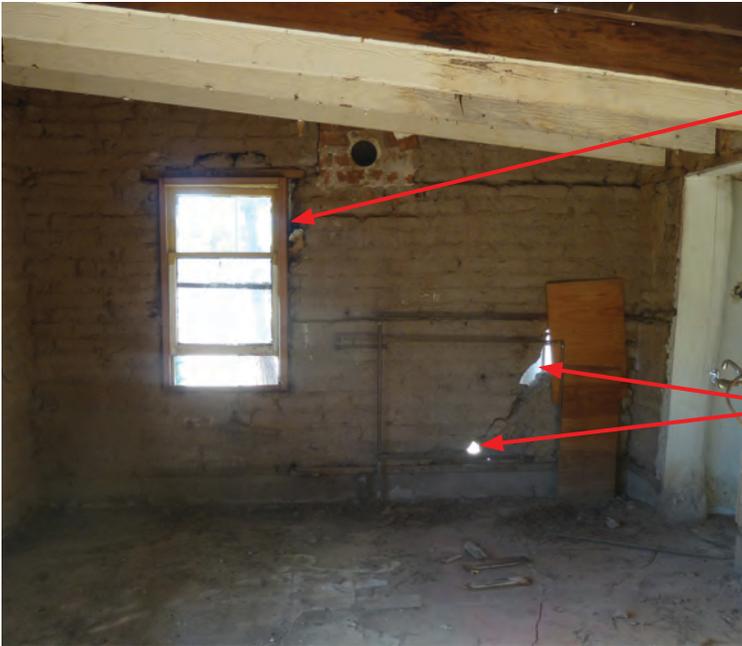
Fig 6.16: West Wall of Barbecue / Gathering Space

Window: Gaps around window.

Walls: Hole in wall near water heater. Refer to Fig. 6.07 and 6.08.

Seal gaps to make window water tight and to prevent damage to the adobe around the window. Keep windows securely closed.

Refer to recommendations in Fig. 6.07 and 6.08.

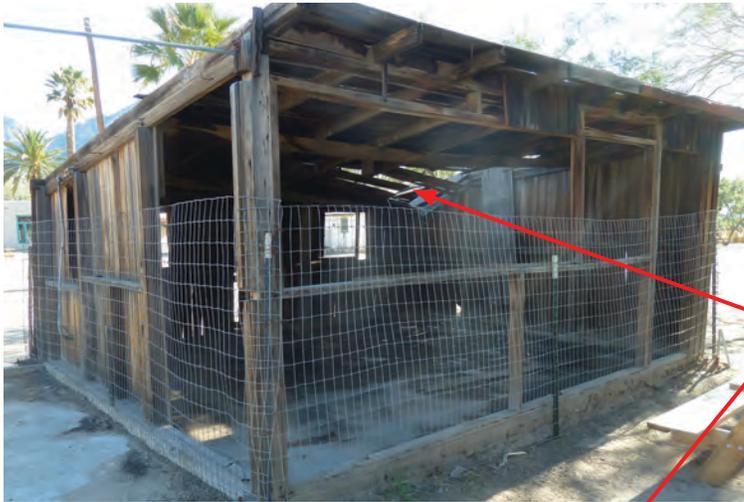
Fig 7.05: Northeast Corner of Hatchery

Roof: Partial collapse of wood roof structure and deck with portions of corrugated metal roof missing. Center wood support is failing.

See recommendations above. Prop up with posts portions of roof starting to collapse.

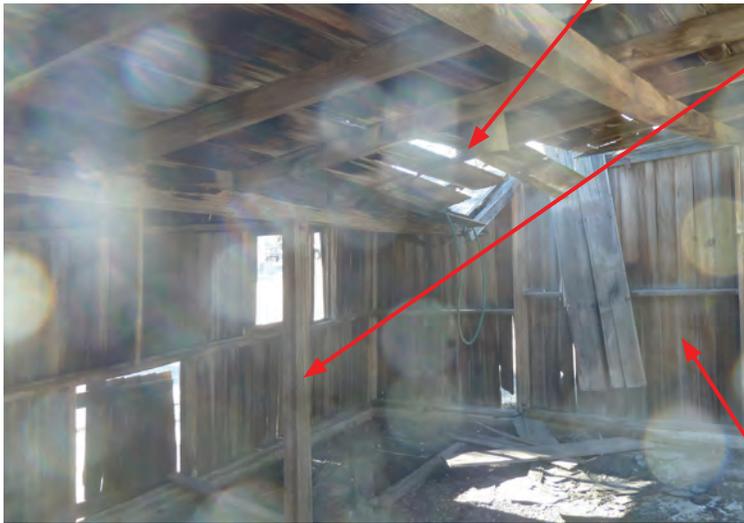
Fig 7.06: Southwest Interior Corner of the Hatchery

Structure: Building structure is composed of dimensional lumber. Lumber appears to be in poor condition.

Walls: Wood boards are in fair condition.

See recommendations above.

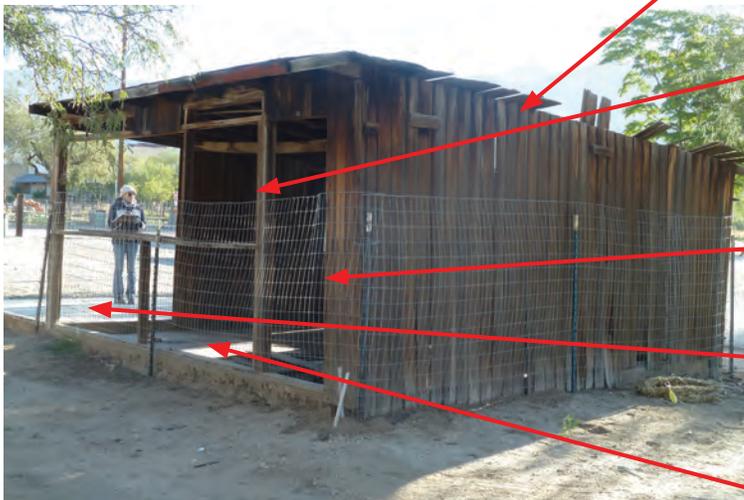
Fig 7.07: Northwest Corner of Hatchery

Walls: Wall boards in this area are missing or may have been connected with chicken wire.

Door: Door is missing from this location.

Floor: Possibly existing hatchery floor with concrete stem walls.

Floor: Concrete floor is in fair condition

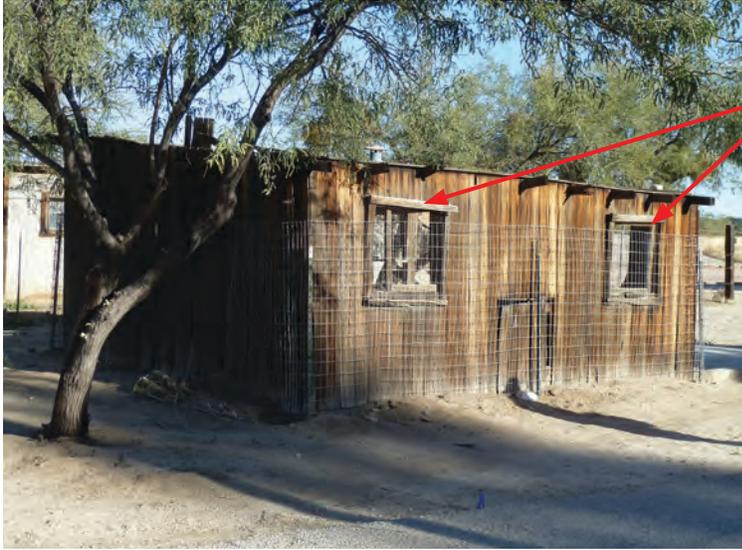
Fig 7.08: Southwest Corner of Hatchery

Windows: Window frames are in poor condition.

No repair, not critical to structural stability.

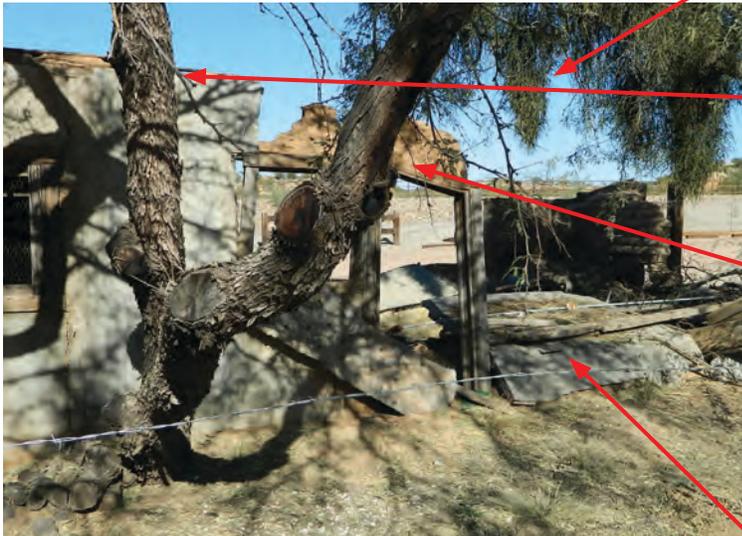
Fig 7.09: East End of Chicken Coops Looking North

Roof: roof is completely missing in this area

Doors: Exposed adobe at failed lintel where door frames have twisted and are about to fall.

Cover adobe with tarp and support / brace lintel to prevent additional movement of lintel or remove adobe as it is a potential safety hazard.

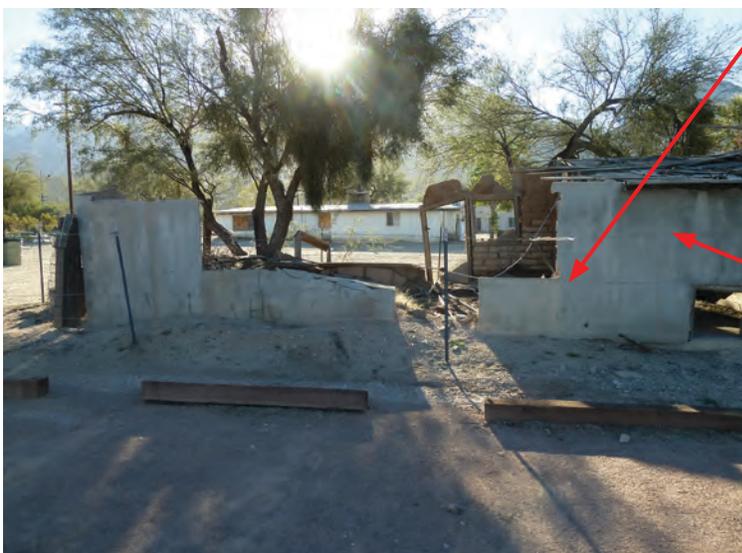
Fig 7.10: East End of Chicken Coops Looking South

Walls: East end has collapsed. Only portions of adobe wall remaining.

Walls: The grey colored stucco appears to be a cement based stucco on a large portion of the interior and exterior, which is not ideal for adobe walls.

Cover tops of walls where there is no roof with tarp. Ensure that the top of the walls do not get wet and that moisture can still escape from the tarps.

The concrete stucco can remain as a temporary finish, for long-term stabilization the cement stucco should be removed and replaced with a lime based stucco.

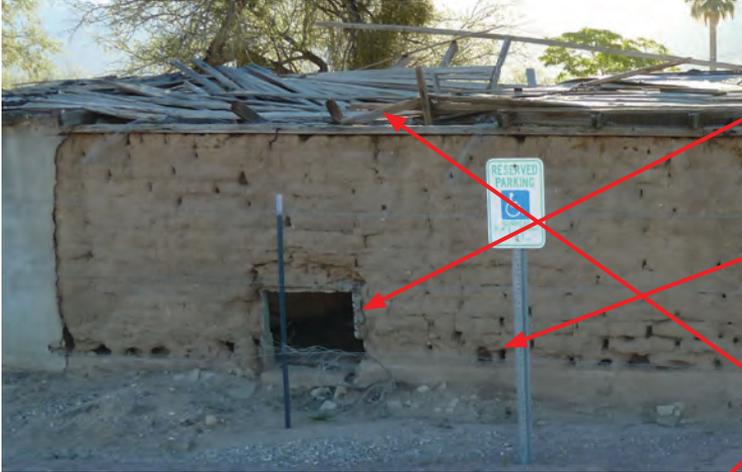
Fig 7.11: North Elevation, Center of Coops

Walls: Wood frame at chicken door missing.

See recommendations below.

Option 1: Leave roof structure as is.

Option 2: Prop up roof areas that are collapsing.

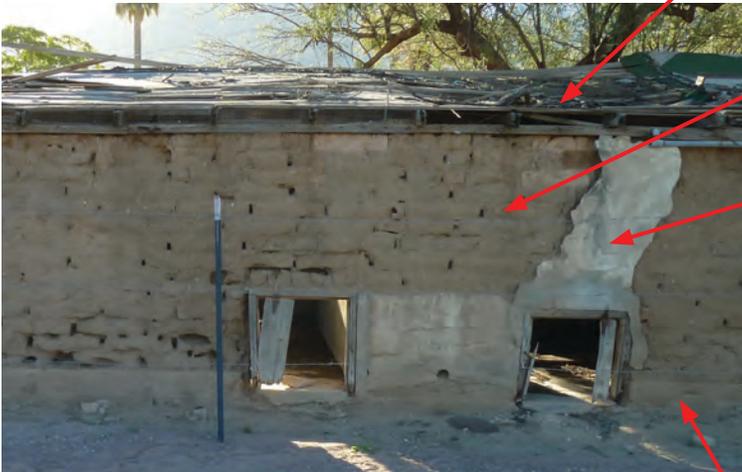
Fig 7.12: North Elevation, Center of Coops Adjacent to Image Above

Walls: Adobe walls are exposed and starting to erode.

Walls: The grey colored stucco appears to be a cement based stucco.

Option 2: Carefully cover and secure tarp over exposed adobe walls. Ensure the tops of exposed adobe walls are covered to help prevent water from deteriorating adobe. Avoid covering roof with tarp.

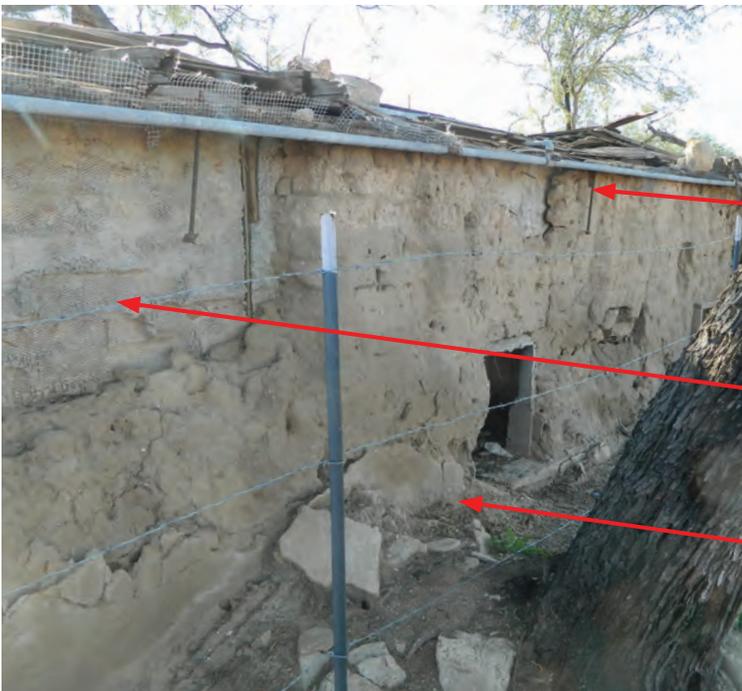
Fig 7.13: North Elevation, near West End of Coops

Walls: Concrete stem wall in good condition.

Wall: Large, historic mesquite to be preserved. Roots of tree appear to be pushing wall up.

Trim branches where hitting the structure.

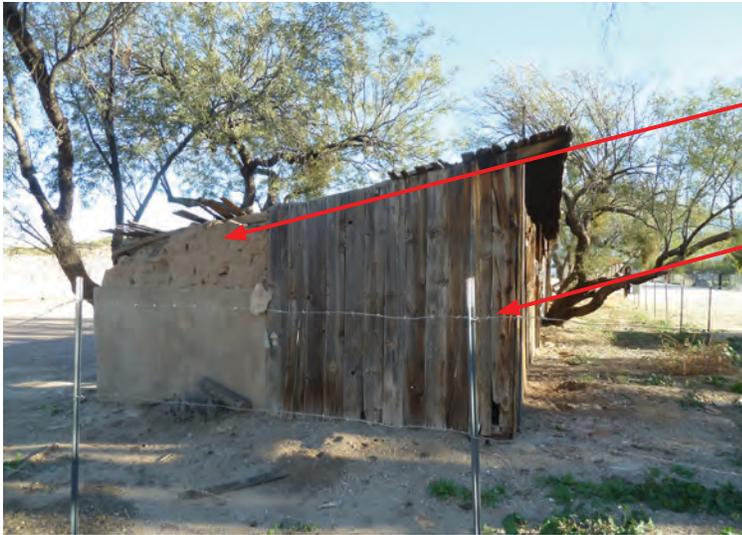
Fig 7.14: West Elevation

- Wall:** Portions of stucco have fallen off.
- Wall:** Wall boards are in fair condition

See recommendations in Fig. 7.12.

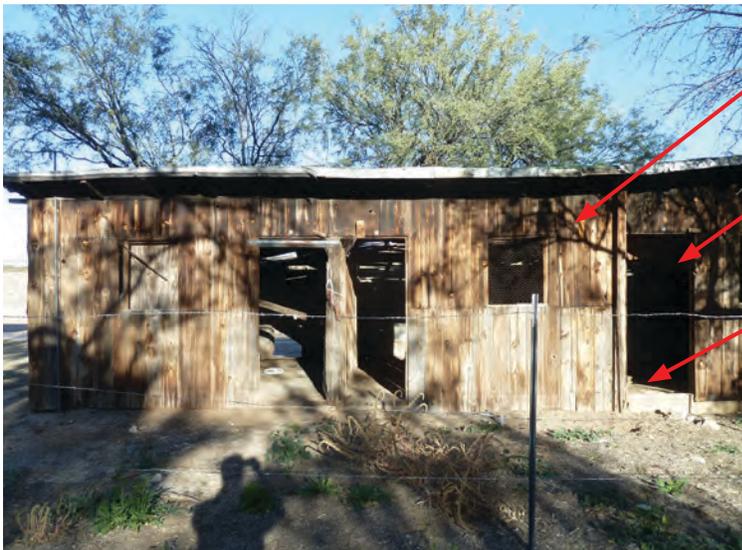
Fig 7.15: South Elevation at West end

- Walls:** Wood boards are in good condition.
- Openings:** Windows and doors are missing or boarded.
- Floor:** Concrete floor in good condition.

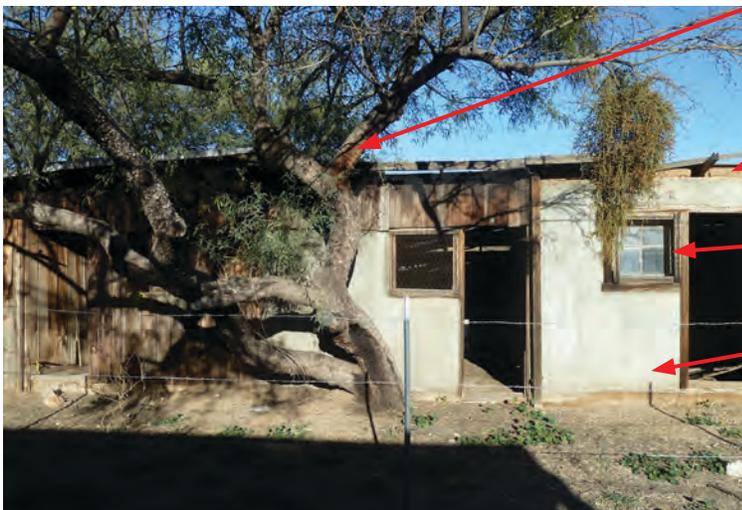
Fig 7.16: South Elevation near the West end

- Tree is hitting structure.
- Wall:** Portions of stucco have fallen off.
- Openings:** Glass window and frame in place.
- Walls:** The grey colored stucco appears to be a cement based stucco.

See recommendations in Fig. 7.12.

See recommendations in Fig. 7.10.

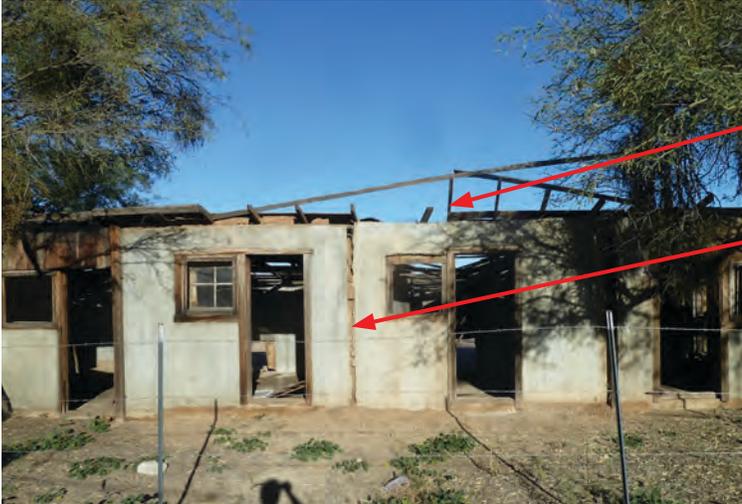
Fig 7.17: South Elevation in the Center of the Coops

Wall: Stucco missing.

See recommendations in Fig. 7.12.

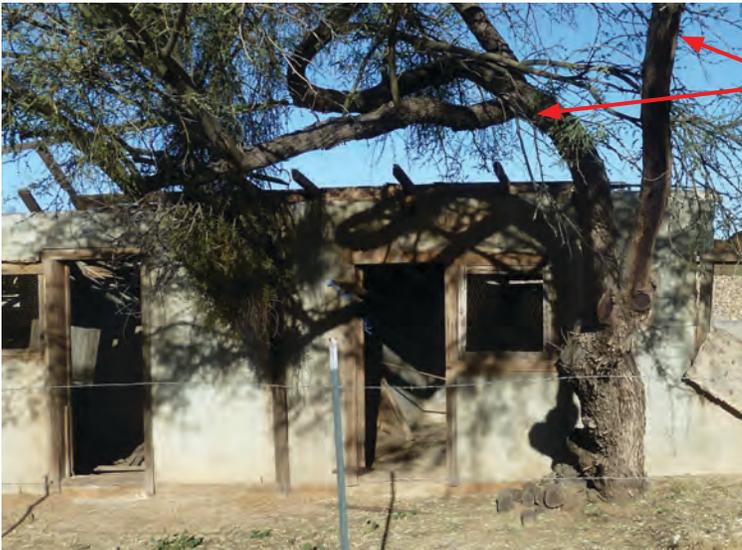
Fig 7.18: South Elevation near East End

Trees are hitting structure.

Trim trees, remove dead branches and mistletoe.

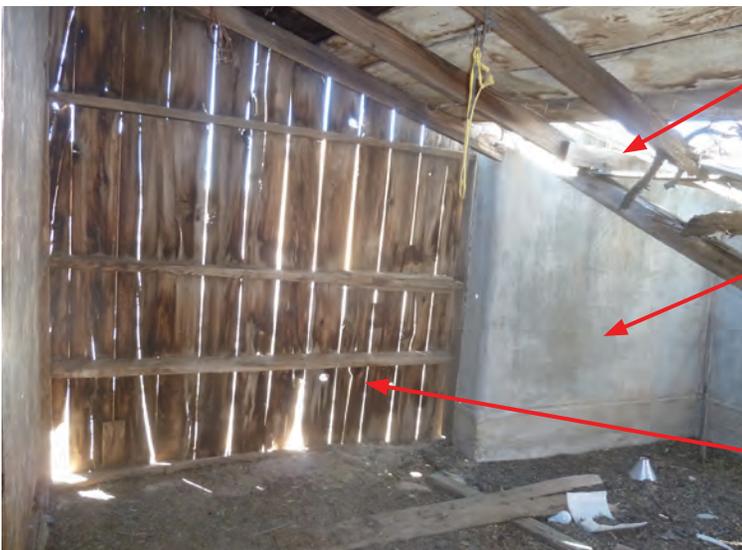
Fig 7.19: Chicken Coop at East End

Roof: Wood roof has collapsed.

Wall: Interior of adobe wall appears to be a good condition. Stucco might be concrete based stucco.

Wall: Wall boards are in fair condition. Interior view from Fig. 7.14.

Remove fallen branches on top of roof structure. See recommendations in Fig. 7.12.

See recommendation in Fig. 7.10.

No temporary structural stability required due to short height of boards.

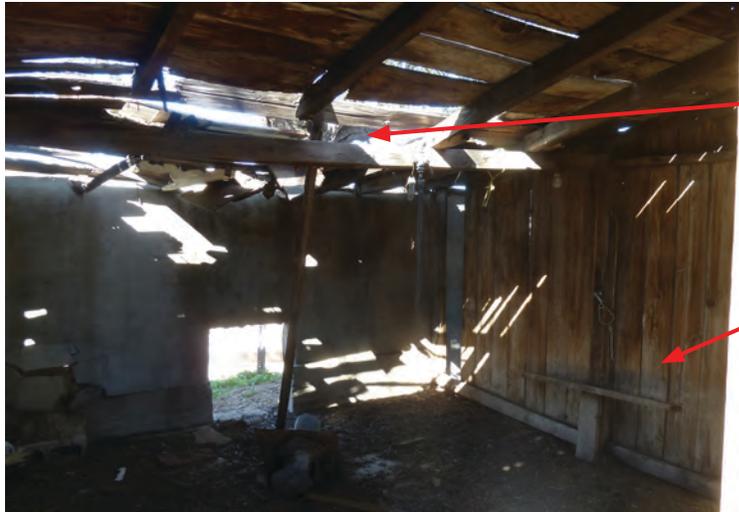
Fig 7.20: Interior of Chicken Coop near West End by Large Mesquite

Wall: Wood wall in fair condition.

Remove debris on roof and trim dead branches off of mesquite tree. See recommendations in Fig. 7.12.

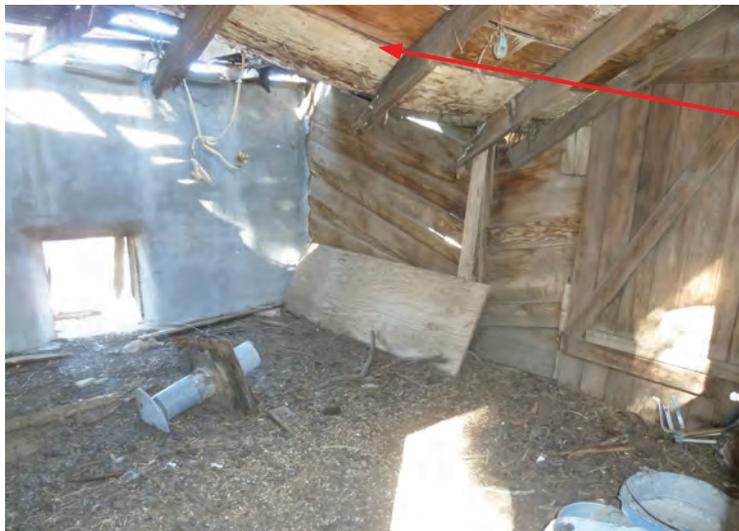
Fig 7.21: Interior of Chicken Coop near Center of Coops

Wall: Wood wall and roof collapsing.

See recommendations in Fig. 7.12.

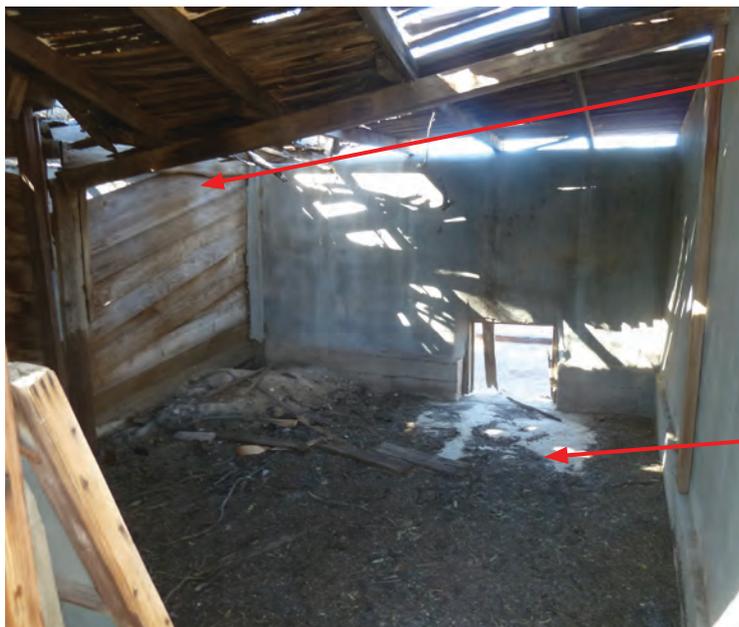
Fig 7.22: Interior of Coop Near Center of Chicken Coops

Roof: Roof collapsing, coop is adjacent to coop in image above.

Floor: Concrete floor in good condition.

See recommendations in Fig. 7.12.
