# PROCTER LEIBER RESIDENCE: CONDITION ASSESSMENT

10901 N Oracle Rd, Oro Valley, AZ 85737

Poster Mirto McDonald has been hired to produce an updated condition assessment report for the Procter Leiber building at the Steam Pump Ranch.

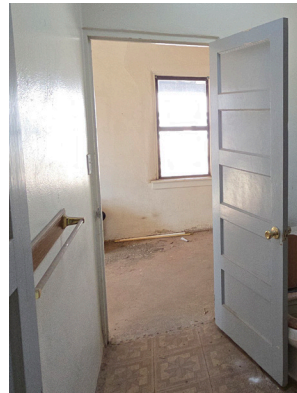
#### A.03 Interior doors: Condition - Good

Interior panelized door likely added during renovation, not original to building construction.

Remove and discard door and frame. Passage door not required in this location for proposed scope of work.

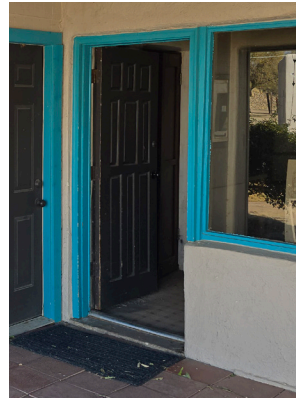
#### B.05

##### **Exterior doors: Condition - Good**

Exterior panelized wood door. This door is not original and likely replaced during a previous renovation. Door is suited to a residential use.

Replace door weather stripping, clean, and adjust door and frame.

Remove and discard door and all associated hardware. Re-use existing door frame. Provide new hollow metal door to serve future building use.

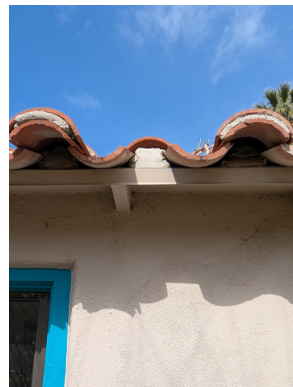
### D.02 Tile Roof: Condition - Requires replacement

Clay tile roof and related assembly. The date of the last replacement of the weather resistive membrane beneath the tile is unknown, but is assumed to be well past its service life. As reported above, the roof members are significantly deflected. It is likely that this movement has created issues at the margins of the system, at flashings and eaves.

Following completion of structural upgrades to supporting structure of roof, and of lintels at windows. Remove and salvage all tile material for re-installation. Remove and discard existing WRB down to deck, and remove all flashings and trim. Install new weather resistive barrier on top of existing decking. Install new flashings and reinstall clay roof tile. It should be assumed that it will be necessary to source matching material to account for breakage in salvage and installation process.

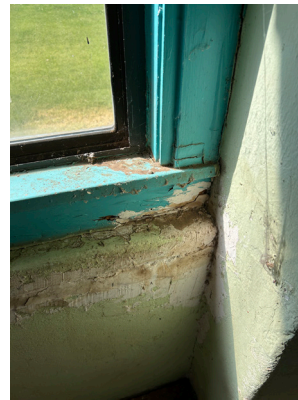
### D.03

#### **Exterior Window: Condition - Requires replacement**

Historic photos indicate that the windows were likely large plate glass panels. At present, large built-up painted verticals separate each bay into 3 segments, each with a sliding aluminum window. These windows are inexpensive modern replacements and should be replaced. Reference structural report for work to lintel above each bay of windows.

Remove and discard existing aluminum windows and intermediate built-up wood verticals and associated wood trim. This will restore the bays to their original configuration. Provide (2) equal new custom insulated glazing panels in each of (3) bays. Trim these glazing units with custom wood trim, full perimeter inside and out. Provide continuous sealant both sides of window system.

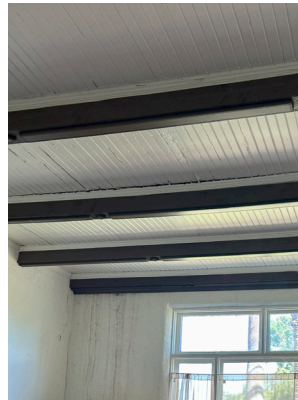
### E.01 Roof Structure: Condition - Requires attention

Rough-sawn 4x8 material with applied decorative elements. Above the joists is a painted tongue and groove bead board deck in generally good condition.

Complete recommended structural upgrades. Salvage all decorative material for reuse on structural members. Paint new / existing structural members and deck.

Complete recommended structural add alt upgrades to increase load bearing capacity of roof structure for use as an occupied roof deck.

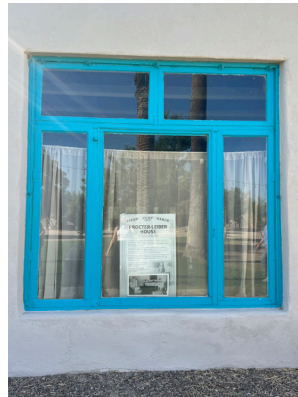
### E.02 Exterior Windows: Condition - Good

Wood frame operable casement window with double awning lites above. Window and glass appears to be in good condition.

Clean, adjust, and paint.

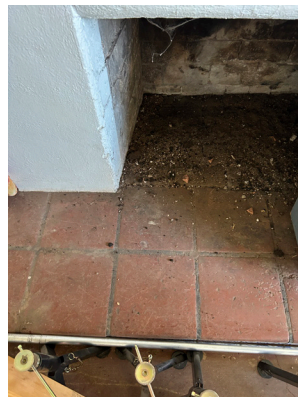
### E.03 Fireplace: Condition - Good

Plaster finish fireplace with Mexican clay tile mantel with wide grout lines and decorative painted tile at base. Chimney is capped at roof and assumed non operational. Material is considered historic and serviceable.

Clean existing grout and repoint where degraded. Provide new penetrating sealer to tile and grout.

Remove wire penetrations to plaster face and patch according to general notes for plaster repair.

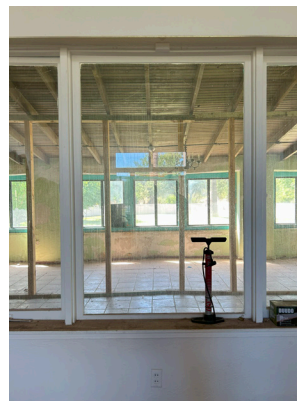
**E.05 Interior window: Condition - Good**

Interior wood casement window were once exterior windows of the building, but have always been under a deep cover, protected from rain and sun. Window is in good working condition.

Clean and adjust window and hardware. Paint frame.

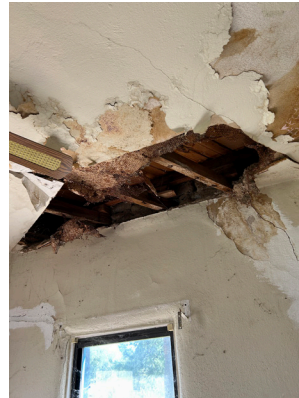
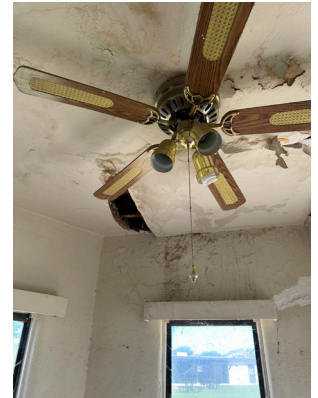
### F.01 Ceiling + Lighting: Condition - Poor

Plaster ceiling has been damaged by water intrusion and requires full replacement. Ceiling fan is not in working condition and does not meet programmatic needs of future building use.

Complete recommended structural upgrades to mitigate cracking. Replace plaster ceiling with like.

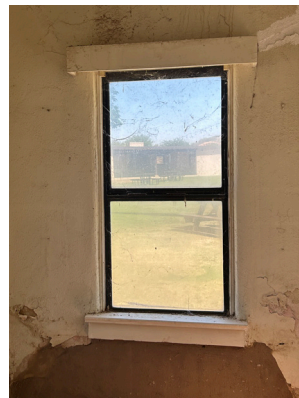
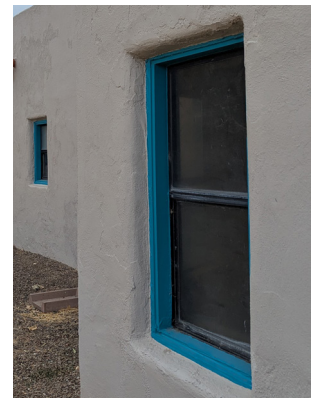
### F.02 Exterior Windows: Condition - Functional but recommend replacement

Likely originally wood single hung windows as seen elsewhere in building.

Rehabilitate wood subframes, replacing worn components in kind. Remove any existing sealant and reseal full perimeter interior and exterior. Remove aluminum windows and replace with new double pane, clear glass fixed aluminum windows.

**New work recommendation:** Rehabilitate wood subframes, replacing worn components in kind. Remove any existing sealant and reseal full perimeter interior and exterior. Remove aluminum windows and replace widow unit with a custom, faithful replica of existing single hung wood window as found in Arizona Room.

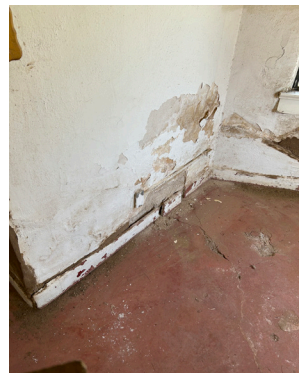
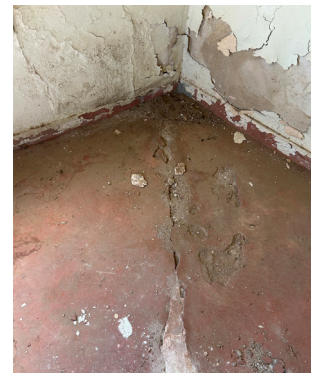
### F.03 Floor + Base: Condition - Poor

Cast-in-place integral color concrete slab and base shows signs of differential settlement and water intrusion.

Complete recommended structural upgrades. New concrete slab and cast wall base to be integral color to match previous.

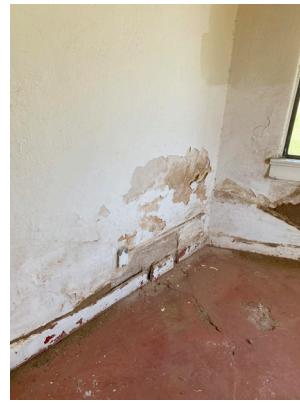
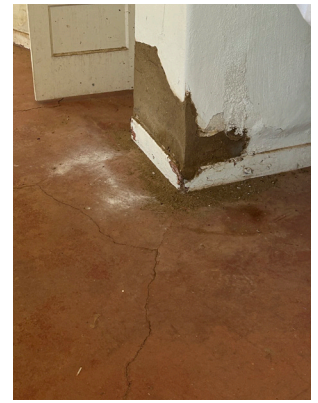
**F.04****Interior Plaster: Condition - Poor**

Interior plaster is in failing condition and requires replacement throughout room.

**Stabilization recommendation:**

Plaster requires replacement throughout room. Follow Appendix 01 for general requirements in plaster repair. Plaster with previous repair to be textured to match.

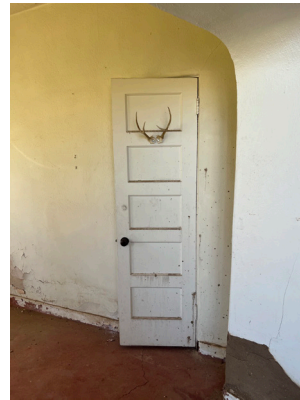
**F.04****Interior Door: Condition - Good**

Existing five panel wood door.

**New work proposal:**

Existing door to remain in place. Replace door hinges and hardware if required by new building programmatic requirement.

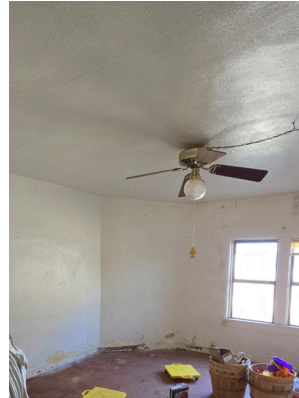
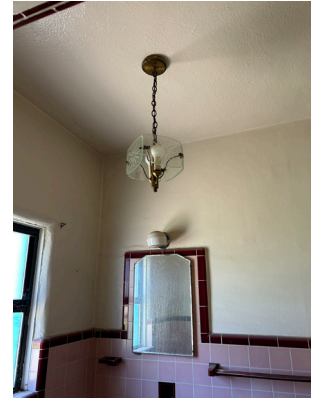
### G.01 Ceiling + Lighting: Condition - Good

Plaster ceiling in good condition. Existing light fixtures do not meet programmatic needs of new building use.

#### **Stabilization recommendation:**

Complete recommended structural upgrades. Ceiling likely to incur damage through course of construction. Patch and/or replace plaster ceiling per Appendix 01: Plaster Repair General Notes.

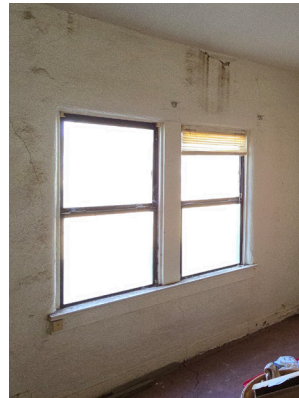
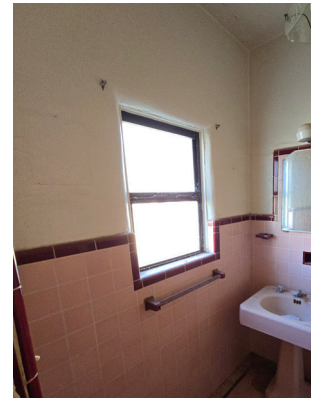
### G.02 Exterior Windows: Condition - Functional but recommend replacement

Likely would have been wood single hung windows as seen elsewhere in building.

#### **Stabilization recommendation:**

Rehabilitate wood subframes, replacing worn components in kind. Remove any existing sealant and reseal full perimeter interior and exterior. Remove aluminum windows and replace with new double pane, clear glass windows.

**New work recommendation:** Rehabilitate wood subframes, replacing worn components in kind. Remove any existing sealant and reseal full perimeter interior and exterior. Remove aluminum windows and replace widow unit with a custom, faithful replica of existing single hung wood window as found in Arizona Room.

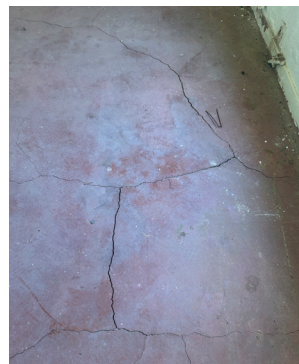
### G.03 Floor + Base: Condition - Poor

Cast-in-place integral color concrete slab and base shows signs of differential settlement and water intrusion.

#### **Stabilization recommendation:**

Complete recommended structural upgrades. New concrete slab and cast wall base to be integral color to match previous.

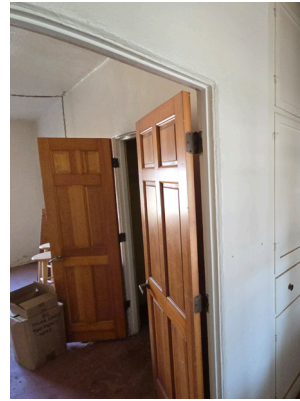
#### G.04

##### **Interior Doors: Condition - Functional but recommend replacement**

Panelized wood door likely replaced during concurrent renovations sometime in the 70s - 80s.

##### **New work recommendation:**

Recommend demo of all interior walls in this portion of the building completely, including doors.

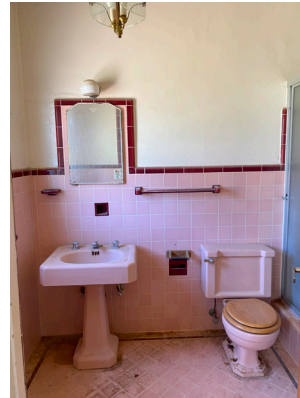
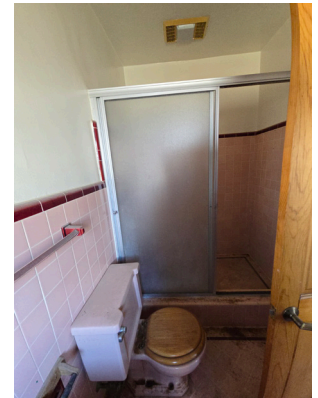
#### G.05

##### **Bathroom: Condition - Poor**

##### **New work recommendation:**

Demo restroom and closet interior walls, finishes, and fixtures entirely to better serve programmatic needs of building.

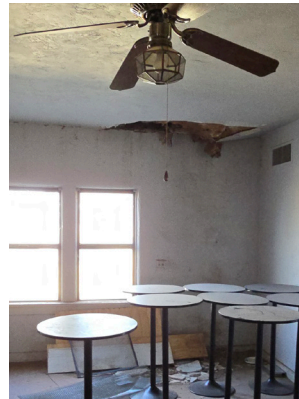
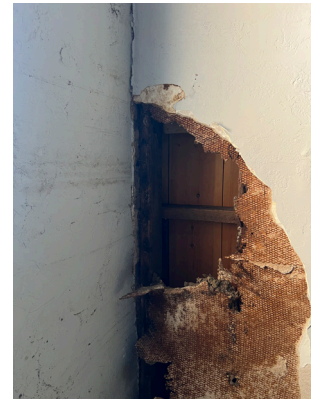
### H.01 Ceiling + Roof Structure: Condition - Poor

Plaster shows evidence of water intrusion and has significant damage on north side where roof structure is visible above.

#### **Stabilization recommendation:**

Complete recommended structural upgrades. Ceiling likely to incur damage through course of construction. Patch and/or replace plaster ceiling per Appendix 01: Plaster Repair General Notes.

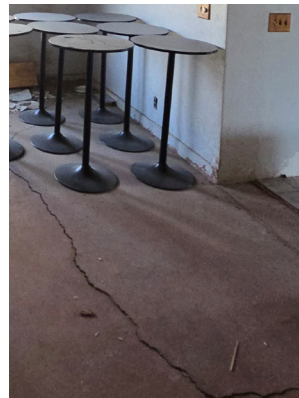
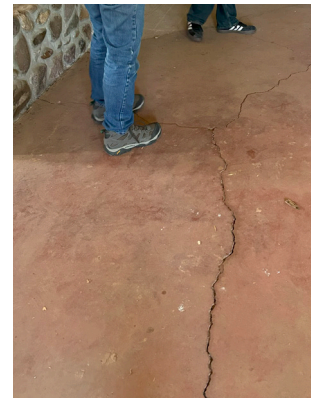
### H.02 Floor + Base: Condition - Poor

Cast-in-place integral color concrete slab and base shows signs of differential settlement and water intrusion. Large cracking present throughout.

#### **Stabilization recommendation:**

Complete recommended structural upgrades. New concrete slab and cast wall base to be integral color to match previous.

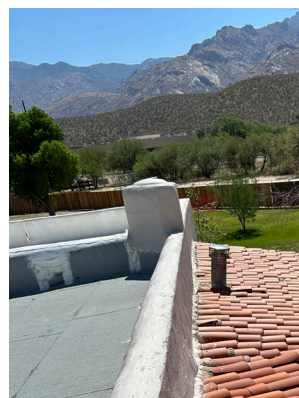
### H.03 Chimney: Condition - Good

Chimney structure above roof - likely for use of standalone fire place during residential use of building. The ceiling has been capped in this location and there is no evidence of issue with remaining as-is.

#### **Stabilization recommendation:**

See Appendix 04: Roof Work for required upgrades and stucco repair.

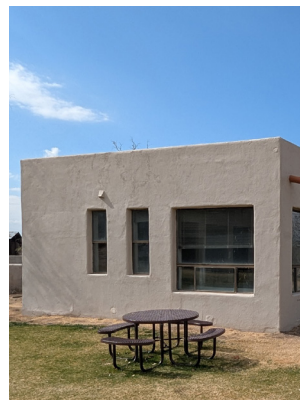
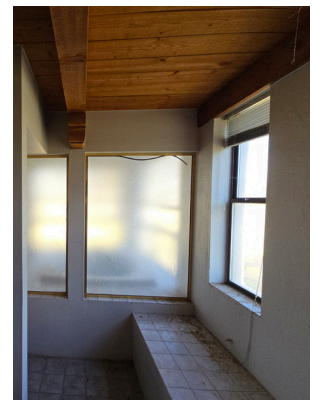
### I.01 Exterior Windows: Condition - Functional but recommend replacement

Windows throughout east wing are single pane aluminum fixed, single hung, or sliding contemporary to addition construction.

**Stabilization recommendation:**  
Remove any existing sealant and reseal full perimeter interior and exterior.

**New work recommendation:**  
Remove any existing sealant and reseal full perimeter interior and exterior. Remove aluminum windows and replace with new double pane, clear glass windows.

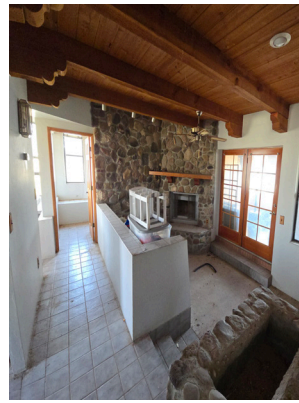
### **Ceiling + Roof Structure: Condition - Good**

#### **Stabilization recommendation:**

Beams and roof structure appear in good condition and require cleaning only.

#### **New work recommendation:**

Recommend removing decorative corbels to align with aesthetic intent of schematic work. Assess condition of beams / decking after removal of walls and river rock elements.

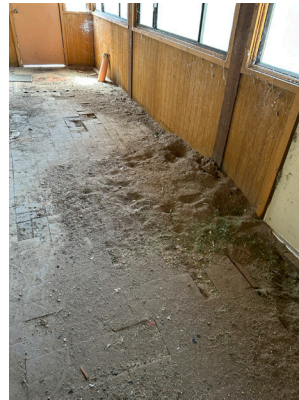
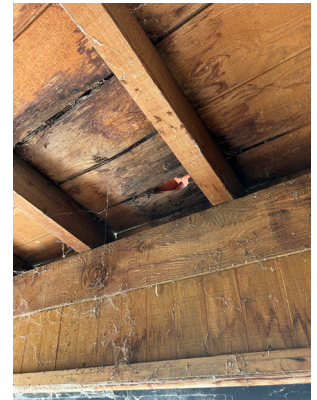
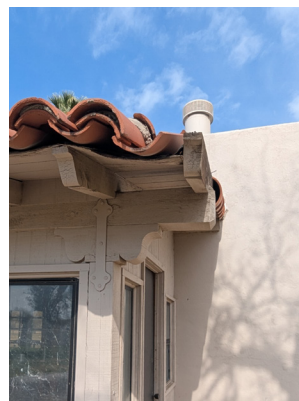
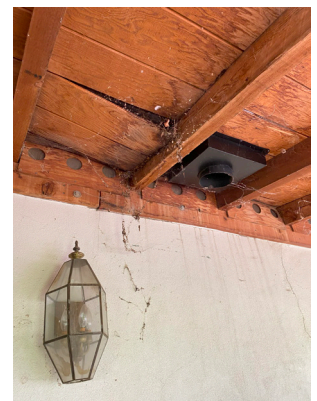
### **Porch Addition: Condition - Very Poor**

Wood framed porch addition attached to Arizona Room and East Addition. The clay tile roof, T1-11 siding, aluminum windows, wood structure, and brick floor are in poor condition.

#### **Stabilization recommendation:**

Regardless of whether the proposed Schematic work is undertaken, it is our recommendation to demolish this later addition entirely. This work will include patching the plaster and adobe at the points of connection and reworking the roof where this addition connected to the historic portion of the Arizona room.

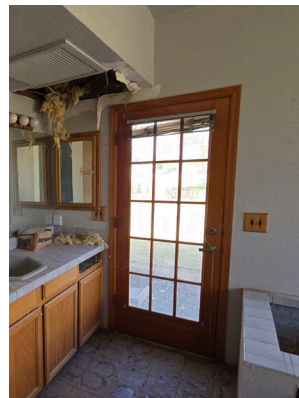
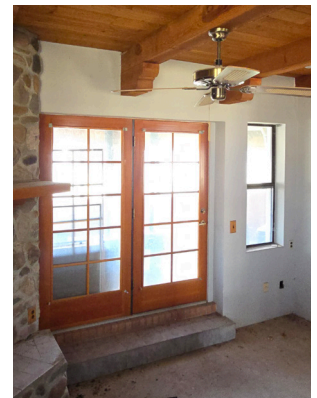
### **Exterior Doors: Condition - Functional but recommend replacement**

#### **New work recommendation:**

Remove any existing sealant and reseal full perimeter interior and exterior. Remove exiting door and frame / replace with new full-lite aluminum storefront door / frame.

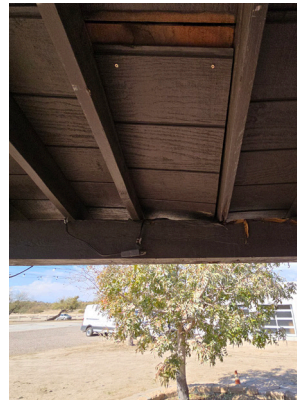
Failed decking replaced with T1-11 siding

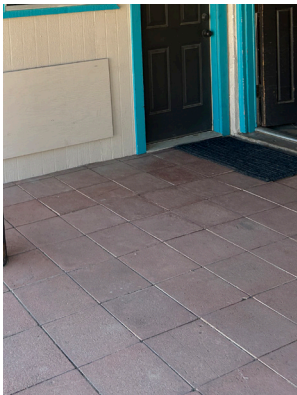
Floor tile to be salvaged

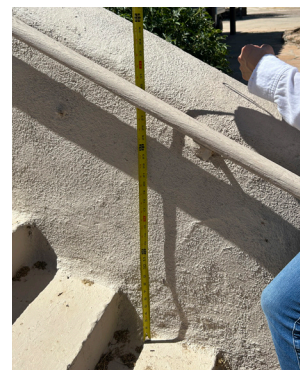
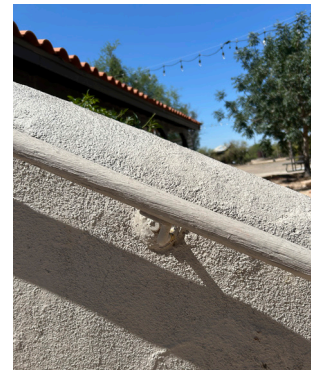
#### **K.02 Handrails:**

Existing handrails are mounted to adobe cheek walls and are installed approx. 24" above tread height, below code compliant height.

##### **Add alt recommendation:**

Remove and discard existing handrails and repair adobe at points of connection. Install new IBC compliant steel handrails and guardrails to the concrete stair treads between adobe cheek walls.

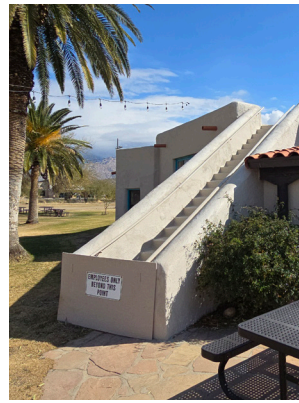
#### **Gate:**

#### **Add alt recommendation:**

Remove existing plywood barrier and discard. Install lockable metal gate at base of stairs to selectively restrict access.

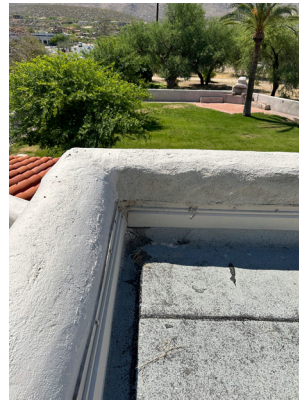
#### **Guardrail at roof:**

#### **Add alt recommendation:**

Install new guard rail at accessible portion of roof. Set guardrail back approx 5' from edge of roof to reduce visibility of the railing. Railing posts to be anchored down through roof and connected to top of the roof beams below using lag screws. Suggest keeping rail members small and painting them a dark color in contrast to the light building in order to reduce visibility.

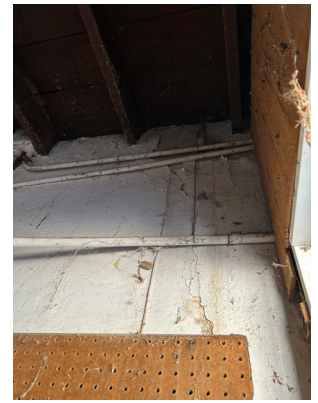
Underside of stair structure - new T1-11 storage wall room on the right

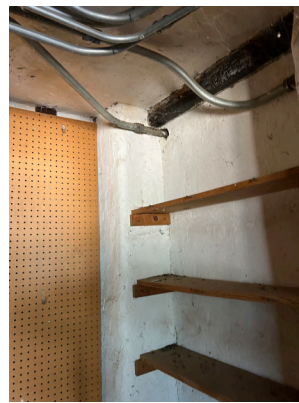
Interior of storage room to remain

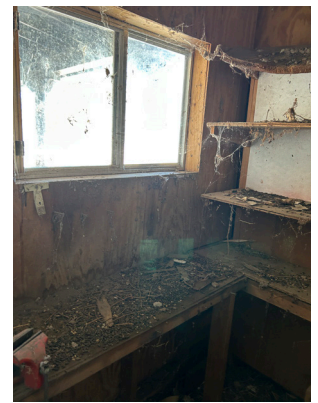
Interior of storage room to be demolished

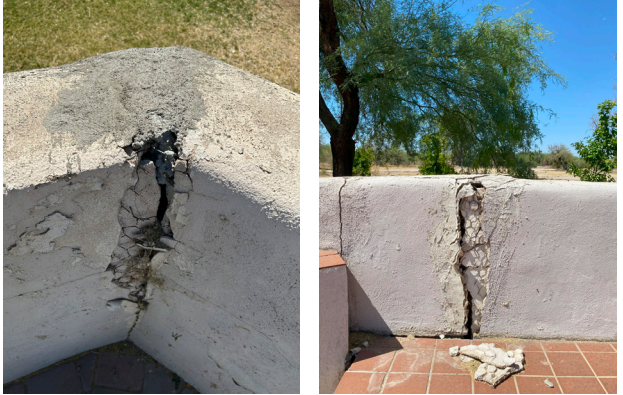
- L.01 South site wall: Condition - Poor**  
Adobe wall with stucco finish. Wall has deteriorated and requires replacement.  
**Stabilization recommendation:**  
Complete recommended structural upgrades. Remove existing adobe wall completely and rebuild with CMU. Wall profile, height, and stucco finish to match previous.

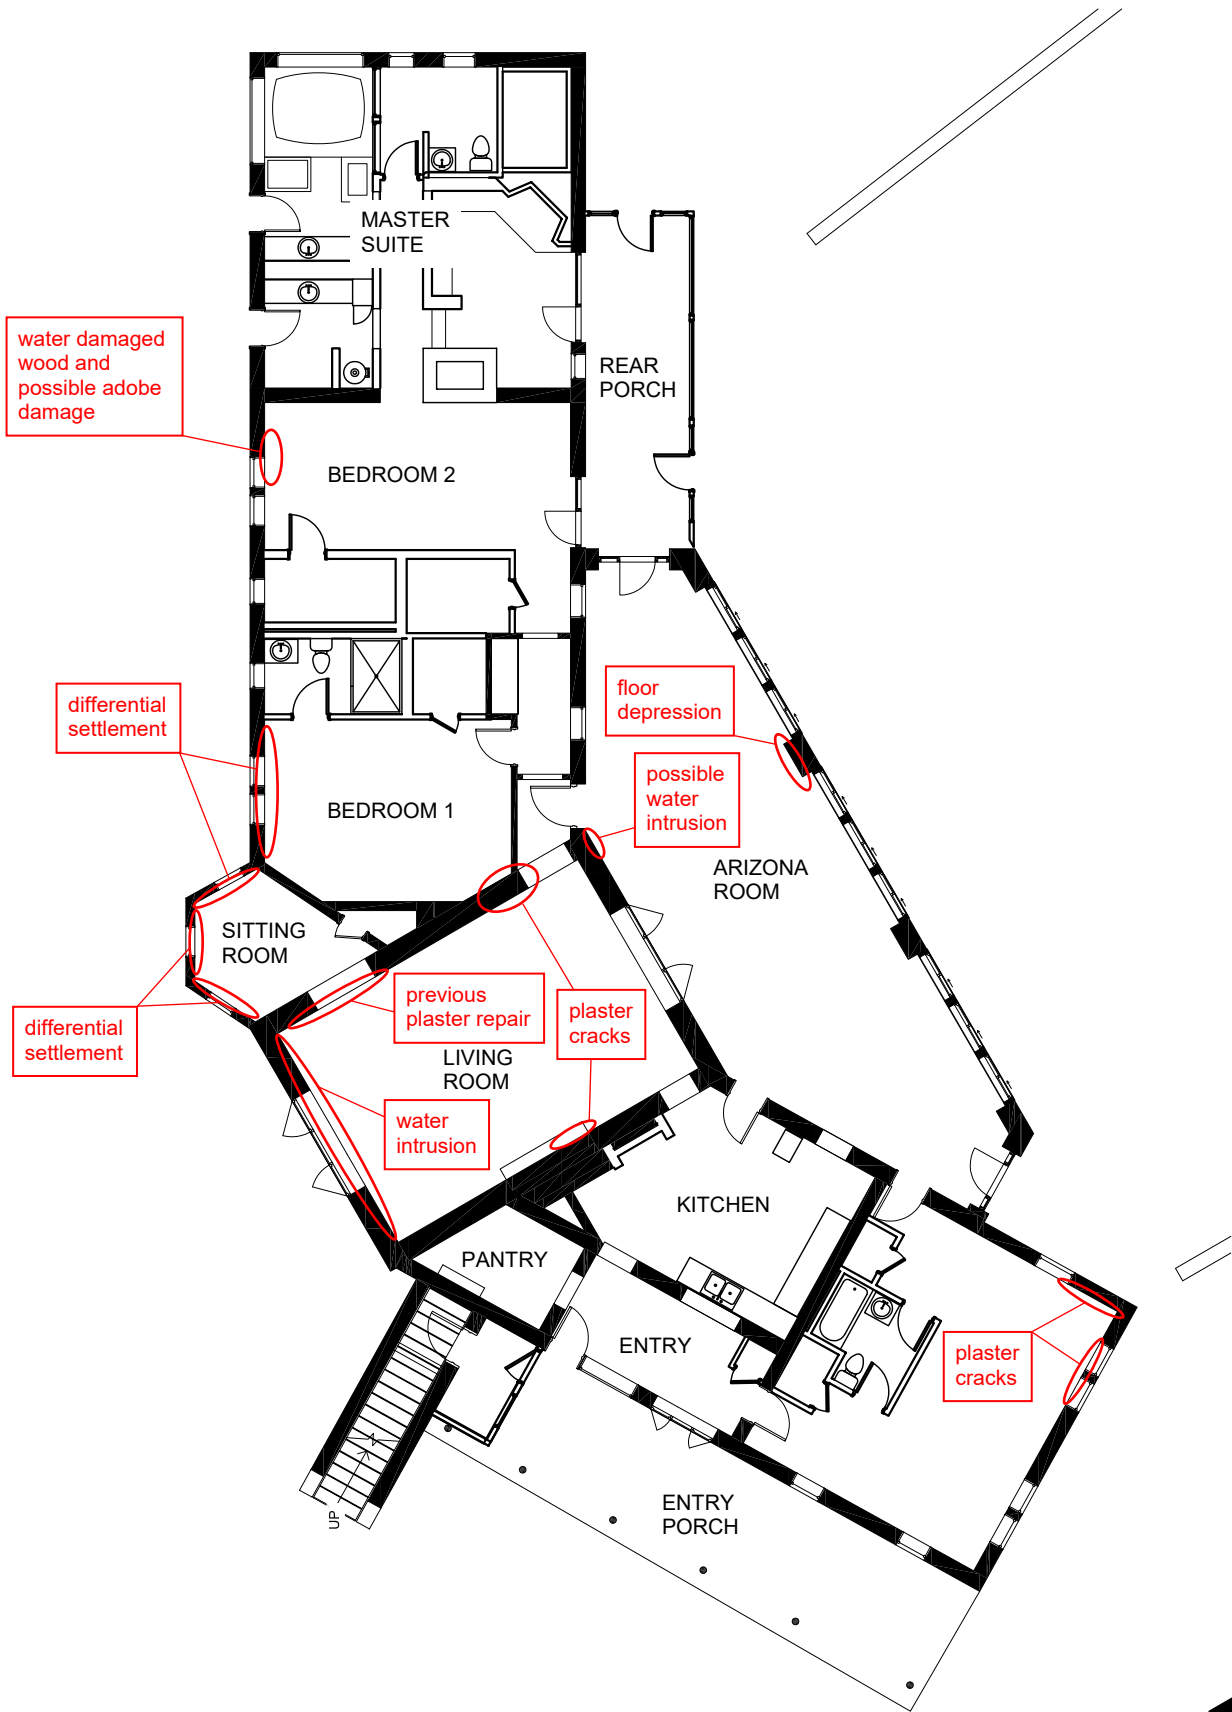
# REFERENCE PLAN:

(remove plaster finish in areas noted to assess condition of existing adobe)

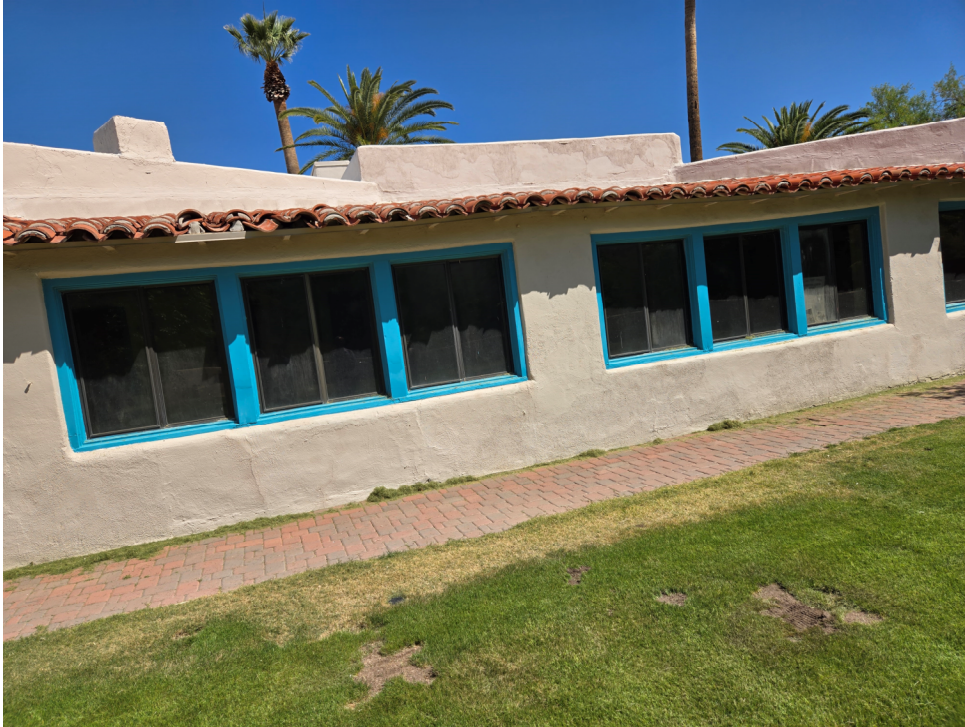
- The headers above the exterior windows at the Arizona room exhibit visible deflection and plaster cracks (see photo 3, page 6). We recommend removing the existing finish from the headers so that the size and condition of the existing headers can be evaluated.

**Photo 3: Deflected headers at Arizona room (note deflection in roof)**
