Town of Oro Valley
Water Utility

TOWN OF ORO VALLEY WATER UTILITY ANNUAL REPORT APRIL 2023

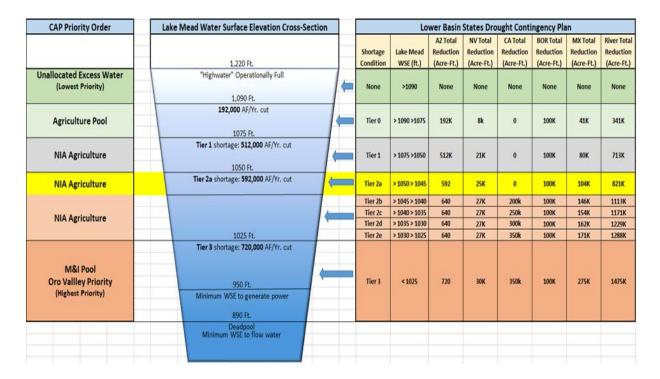
FIGURE 2

Figure 2 shows the relationship between the CAP priority order, Lake Mead water surface elevation and the LBDCP. The area highlighted in yellow represents the current Tier 2a water shortage.

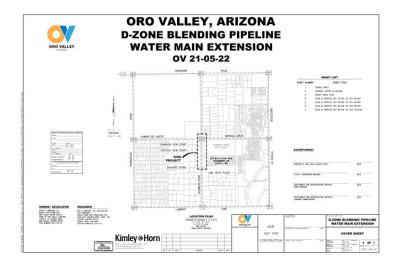
Northwest Recharge, Recovery and Delivery System (NWRRDS) Blending Waterline: This project is designed to blend "D" Zone water with our incoming NWRRDS Partnered water delivered from the Lower Santa Cruz Recharge Facility to the OVWU service area.

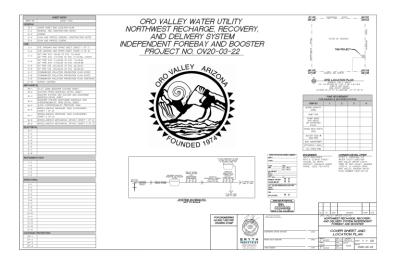
Northwest Recharge, Recovery and Delivery System (NWRRDS) Shannon Road Forebay: This project is designed as a forebay reservoir between the Lower Santa Cruz water recovery area and the Oro Valley service area. Once completed, this water infrastructure will allow the Utility to deliver up to an additional 4,000 acre feet of CAP water per year to the Oro Valley water customers.

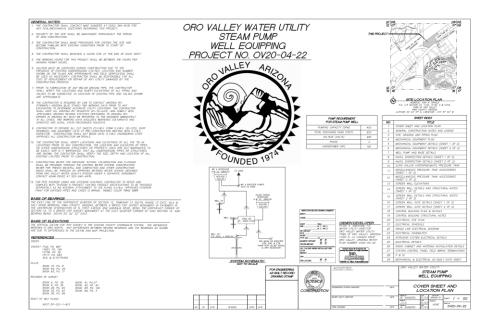
- Nakoma Sky Well Design and off-site electrical work: Nakoma Sky offsite electrical is currently in the planning stage with La Posada. Design of this well site facility is approaching 100 percent.
- > Steam Pump Well Design, Control Panel, and off-site electrical work: The Steam Pump Station Control Panel is 100% complete, electrical is currently in the design stage (60%). Design of well site facility is nearly complete. Construction is scheduled for FY 2023-2024.

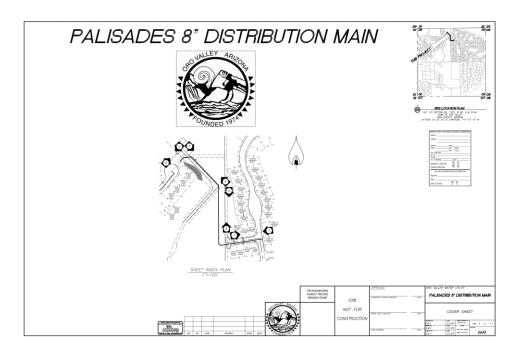
➤ Palisades Redundancy 8-inch water main: This project adds additional reliability to the Palisades service area. Design expected to be complete in FY 2022/23 with construction slated for FY 2023/24.

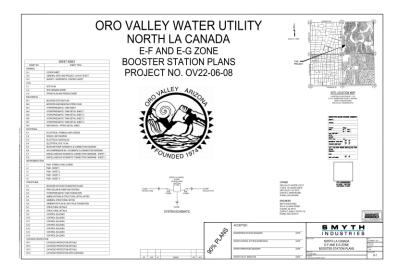
La Cañada design of "E" to "F" and "E" to "G" Zone Booster design: This project is the second of a multiyear design and construction project to equip the La Cañada Reservoir with two new booster stations. The first year of work included the design and construction of the electrical improvements necessary to power the future booster stations at La Cañada. This will ultimately help the Utility with moving water to "F" and "G" zones. Phase one of the work was completed in FY 2021/22. Design work for the booster station is is expected to be complete this fiscal year (FY 2022/23).

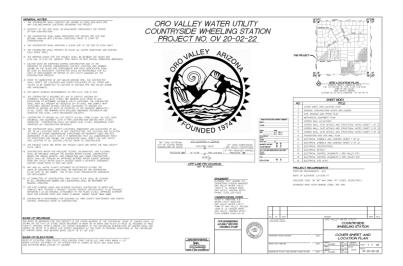
Countryside Wheeling Station Upgrade: This project will increase the wheeling capacity from Tucson Water to Oro Valley Water's remote water service area known as "Countryside". The site will be equipped with telemetry to monitor and control flows into Countryside to supplement our groundwater well production. An additional 200 gpm capacity will be added to the current 100 gpm capacity. Construction will include a security wall, telemetry for valve flow control and remote flow meter monitoring. Project is expected to be constructed in FY 2023/24.
