OV1215-14
MASTER RECREATION AREA PLAN
 FOR
ALTERRA AT VISTOSO TRAILS
 LOTS 1-150 AND COMMON AREAS "A" THROUGH "D"

BEING A PORTION OF SECTION 25
 TOWNSHIP 11 SOUTH, RANGE 13 EAST, G & S.R.M.
 TOWN OF ORO VALLEY, PIMA COUNTY, ARIZONA

AUGUST 2016
 WLB NO. 185050-MT03
 CONTOUR INTERVAL: 1'

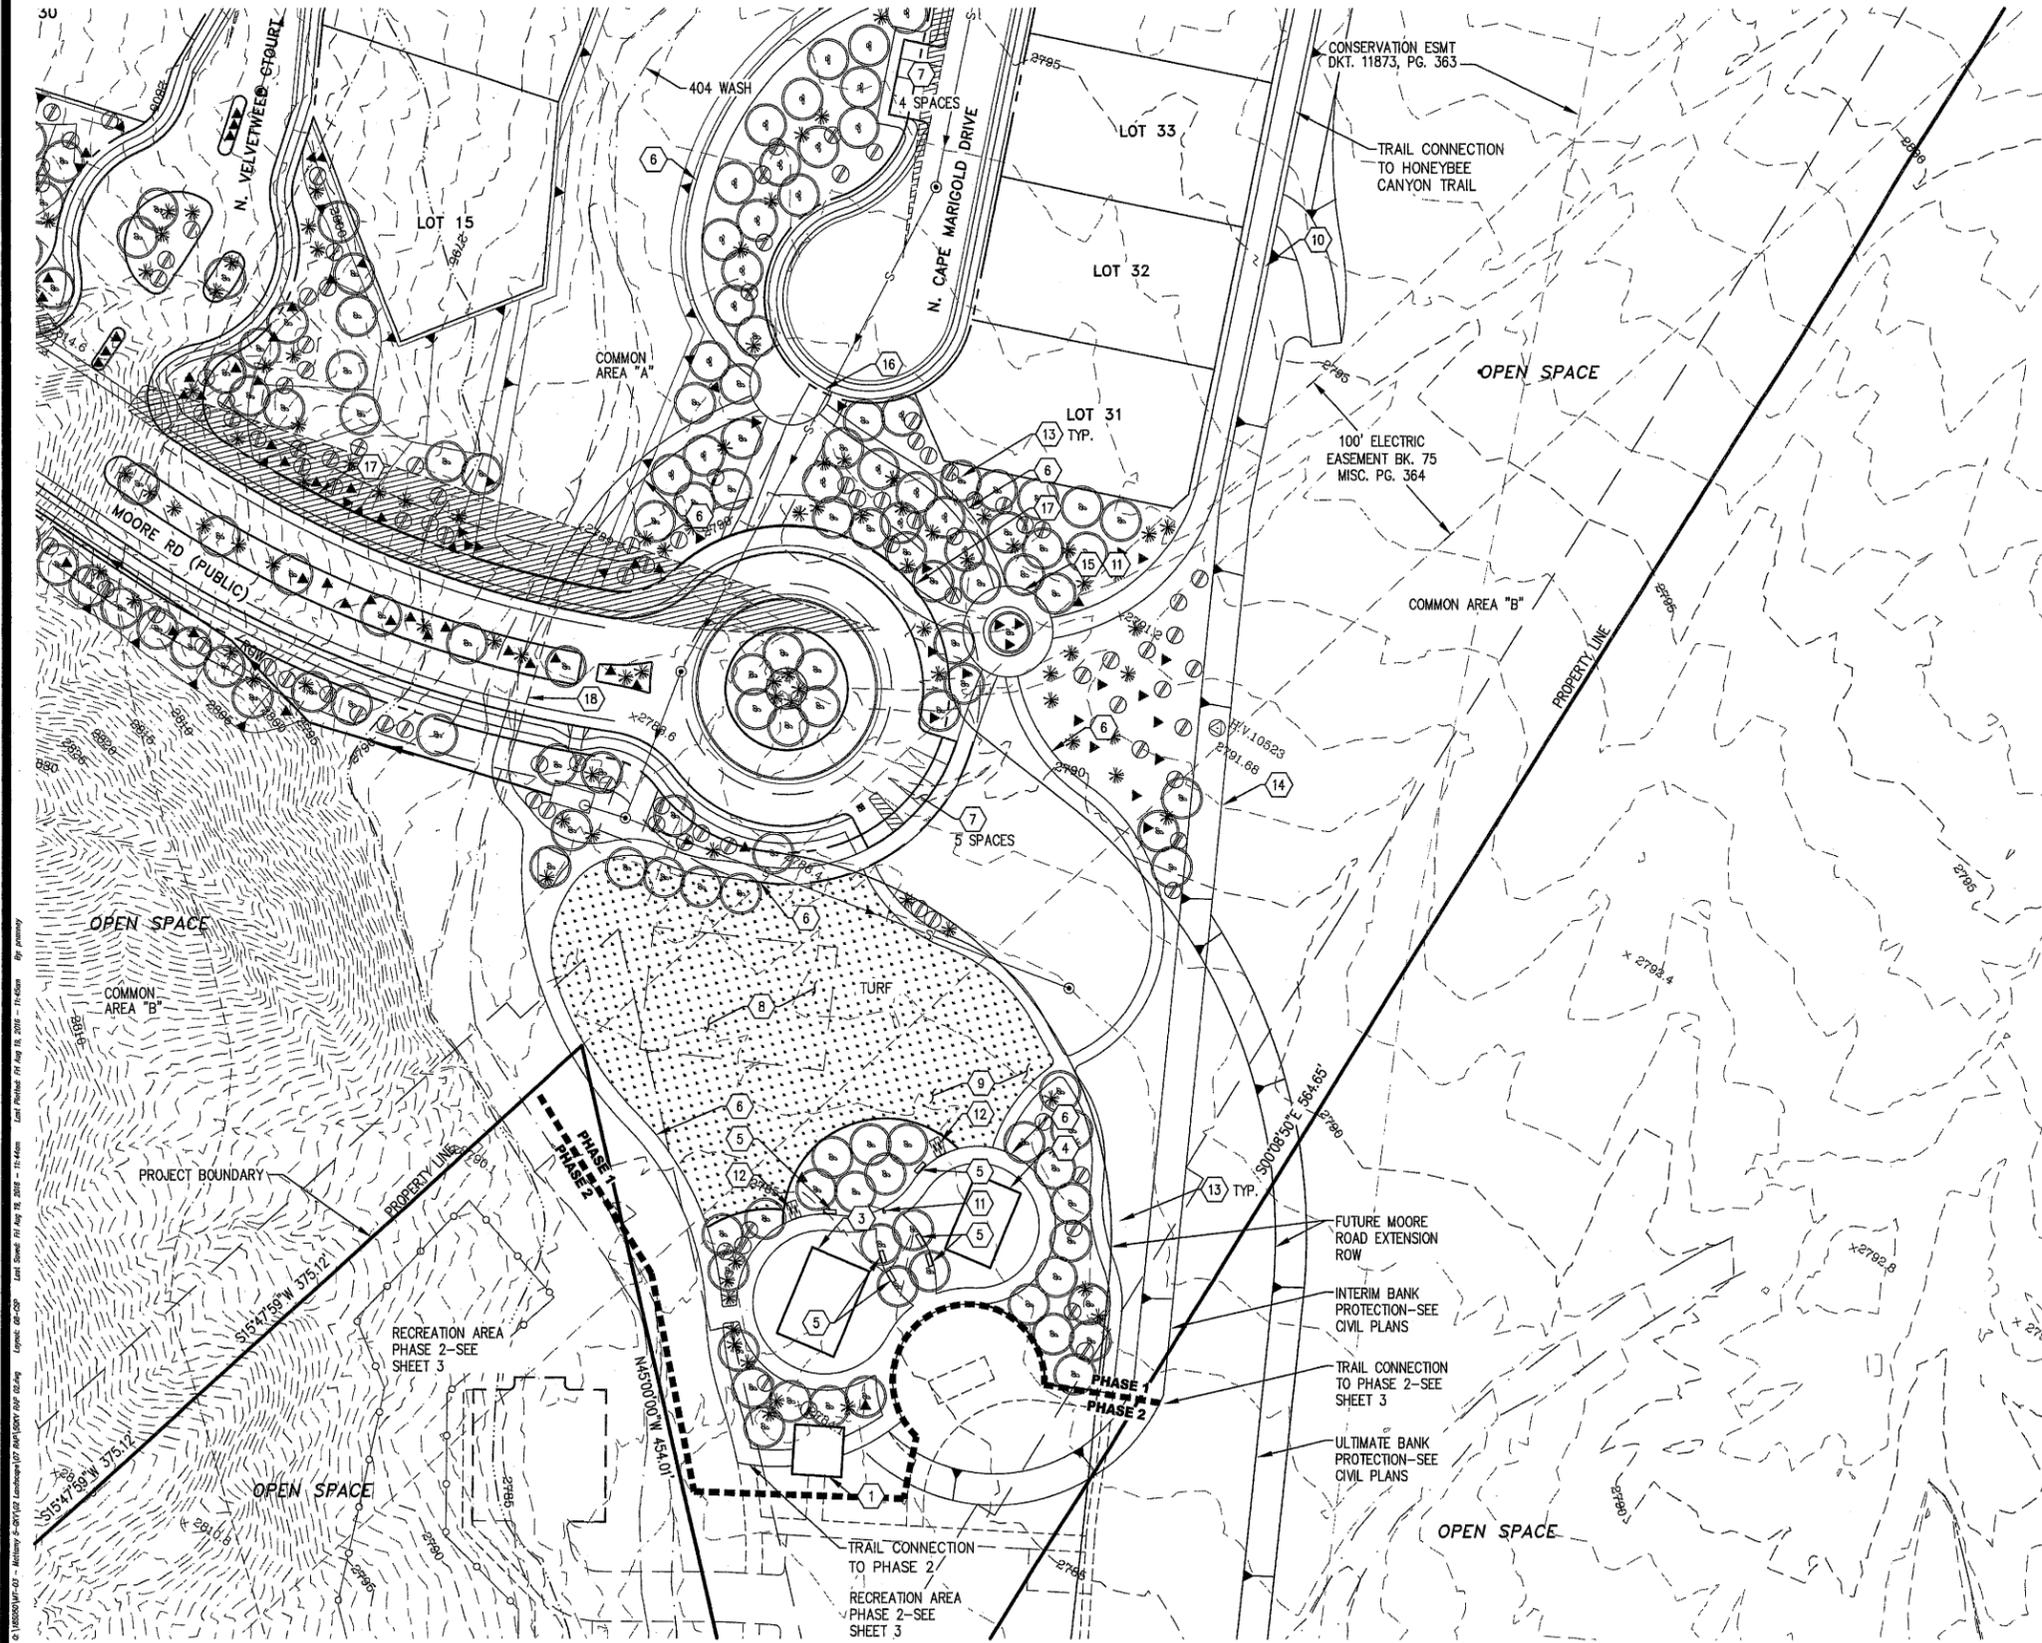
PHASE 1 RECREATION AREA LAYOUT

PHASE 1 RECREATION EQUIPMENT KEYNOTES

- 1 RAMADA AND PICNIC TABLES WITH TRASH RECEPTACLE
- 2 PICNIC TABLES
- 3 PLAY EQUIPMENT 2-5 YRS WITH PLAY SAFETY SURFACE AND SHADE STRUCTURE. PLAY EQUIPMENT TO MEET IPEMA AND ASTM CURRENT STANDARDS.
- 4 PLAY EQUIPMENT 5-12 YRS WITH PLAY SAFETY SURFACE AND SHADE STRUCTURE. PLAY EQUIPMENT TO MEET IPEMA AND ASTM CURRENT STANDARDS.
- 5 BENCHES
- 6 PEDESTRIAN PATHWAY
- 7 TEMPORARY PARKING
- 8 U-8 SOCCER FIELD AREA (NO GOALS OR STRIPE BY THIS PROJECT)
- 9 FREE PLAY LAWN
- 10 MULTI-USE PATH / ACCESS ROAD BY CIVIL PLANS
- 11 DRINKING FOUNTAIN
- 12 BICYCLE PARKING
- 13 LANDSCAPING BY LANDSCAPE PLANS
- 14 BANK PROTECTION BY CIVIL PLANS
- 15 PRIMARY TRAILHEAD
- 16 SECONDARY TRAILHEAD
- 17 MULTI-USE PATH BY CIVIL PLANS
- 18 PEDESTRIAN UNDERPASS UNDER MOORE RD.

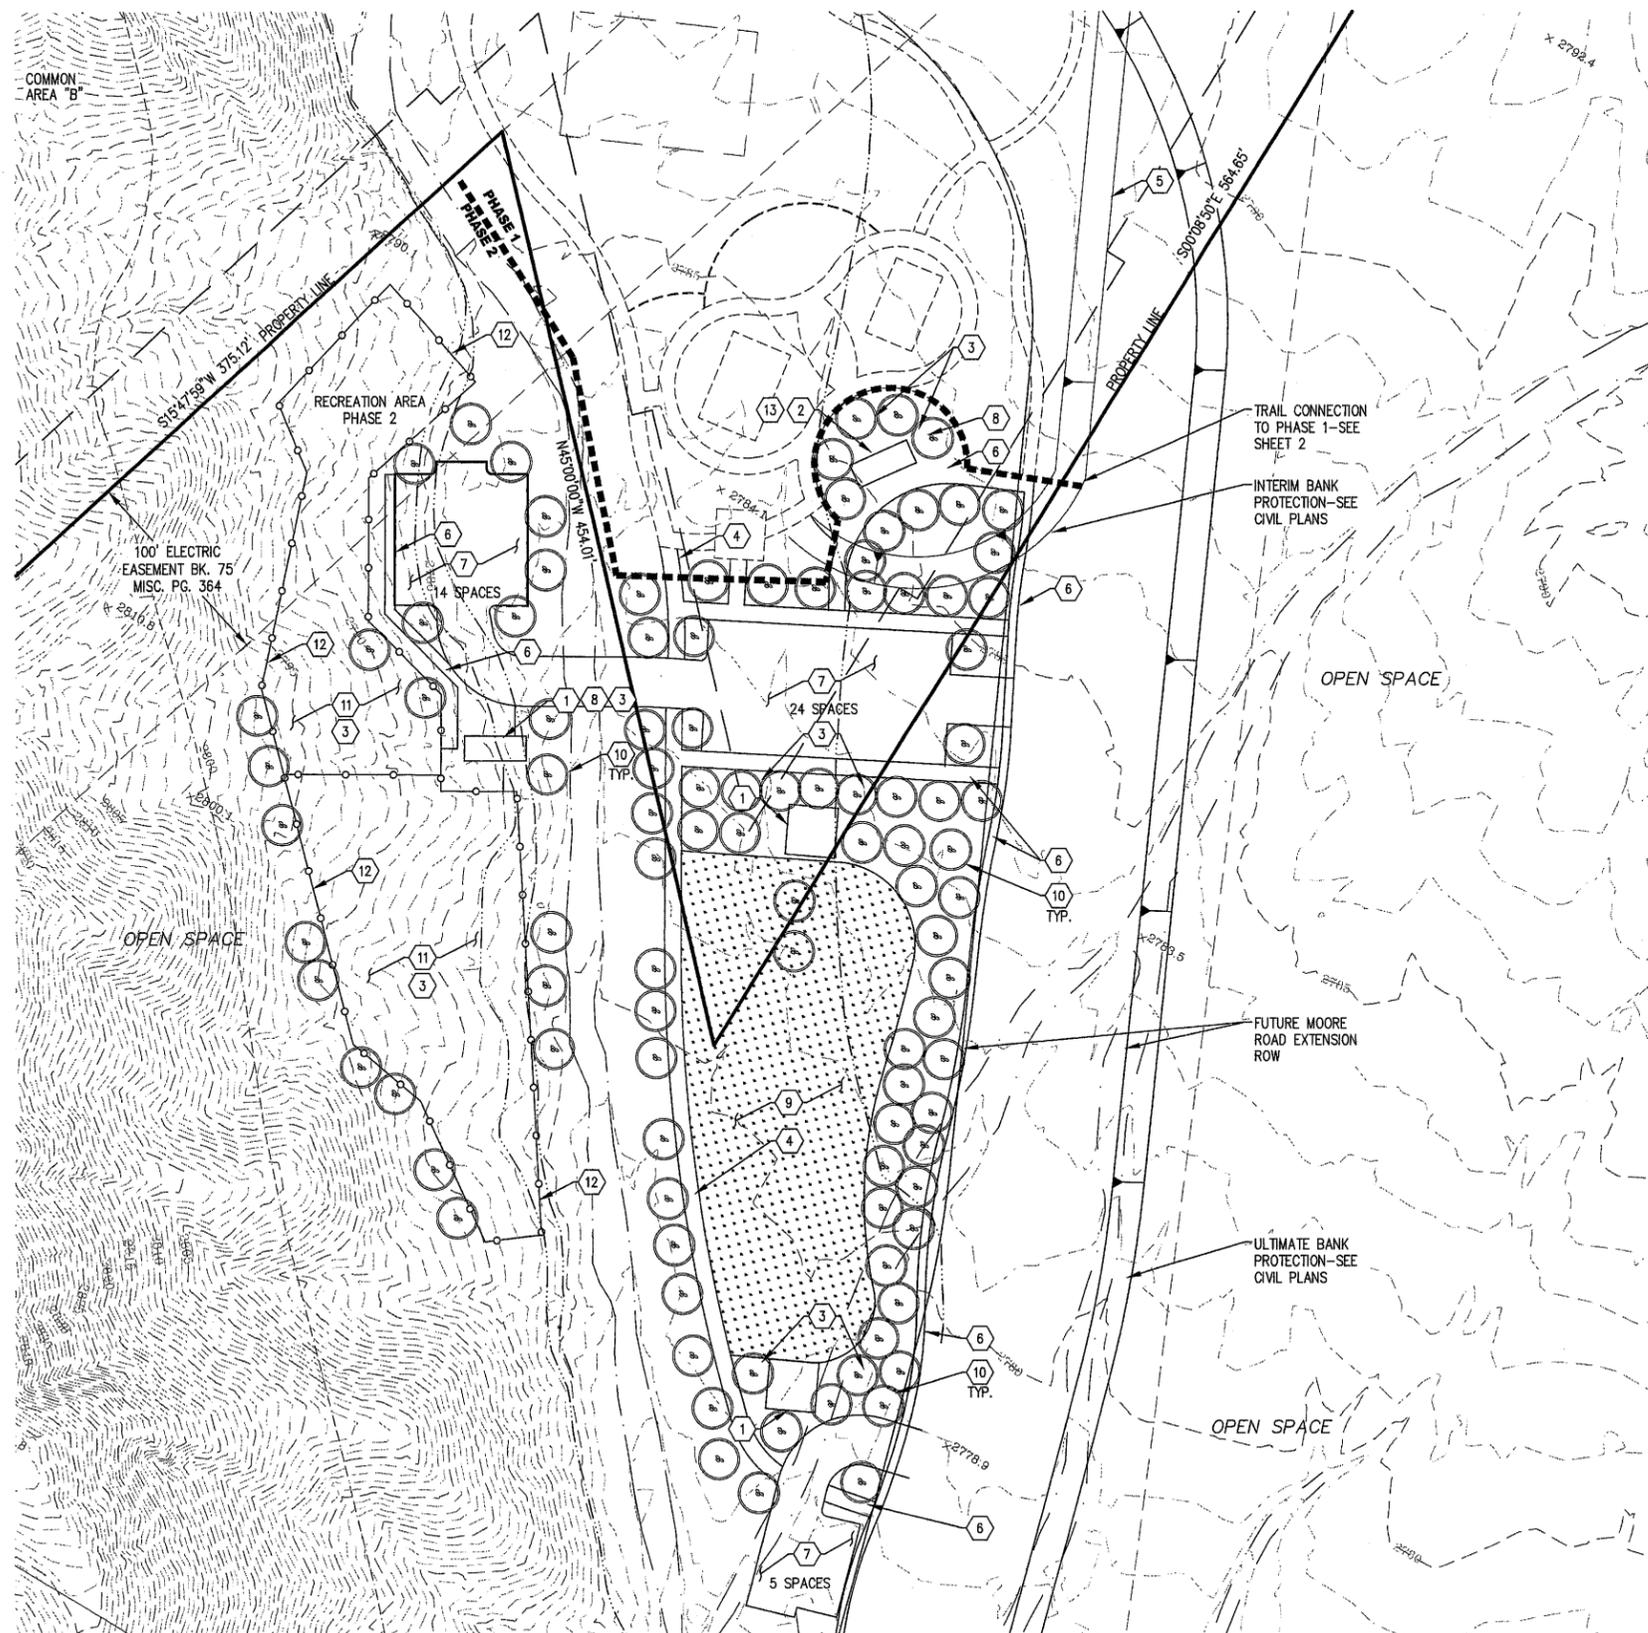
PHASE 2 RECREATION AREA LAYOUT

PHASE 2 RECREATION EQUIPMENT KEYNOTES

- 1 RAMADA AND PICNIC TABLES WITH TRASH RECEPTACLE
- 2 RESTROOM BUILDING BY SEPARATE PERMIT
- 3 BENCHES
- 4 MULTI-USE PATH
- 5 PHASE 1 BANK PROTECTION BY CIVIL PLANS
- 6 PEDESTRIAN PATHWAY
- 7 PARKING
- 8 BICYCLE PARKING
- 9 FREE PLAY LAWN
- 10 LANDSCAPING BY FUTURE LANDSCAPE PLANS-FOR ILLUSTRATIVE PURPOSES ONLY
- 11 DOG PARK
- 12 DOG PARK FENCE
- 13 DRINKING FOUNTAIN
